**[Docket No. FAA-2005-23221; Directorate Identifier 2005-CE-51-AD; Amendment 39-14459; AD 2006-02-51]**

#### **Airworthiness Directives; Raytheon Aircraft Company Model 390 Airplanes**

**2006-02-51 Raytheon Aircraft Company:** Amendment 39-14459; Docket No. FAA-2005-23221; Directorate Identifier 2005-CE-51-AD.

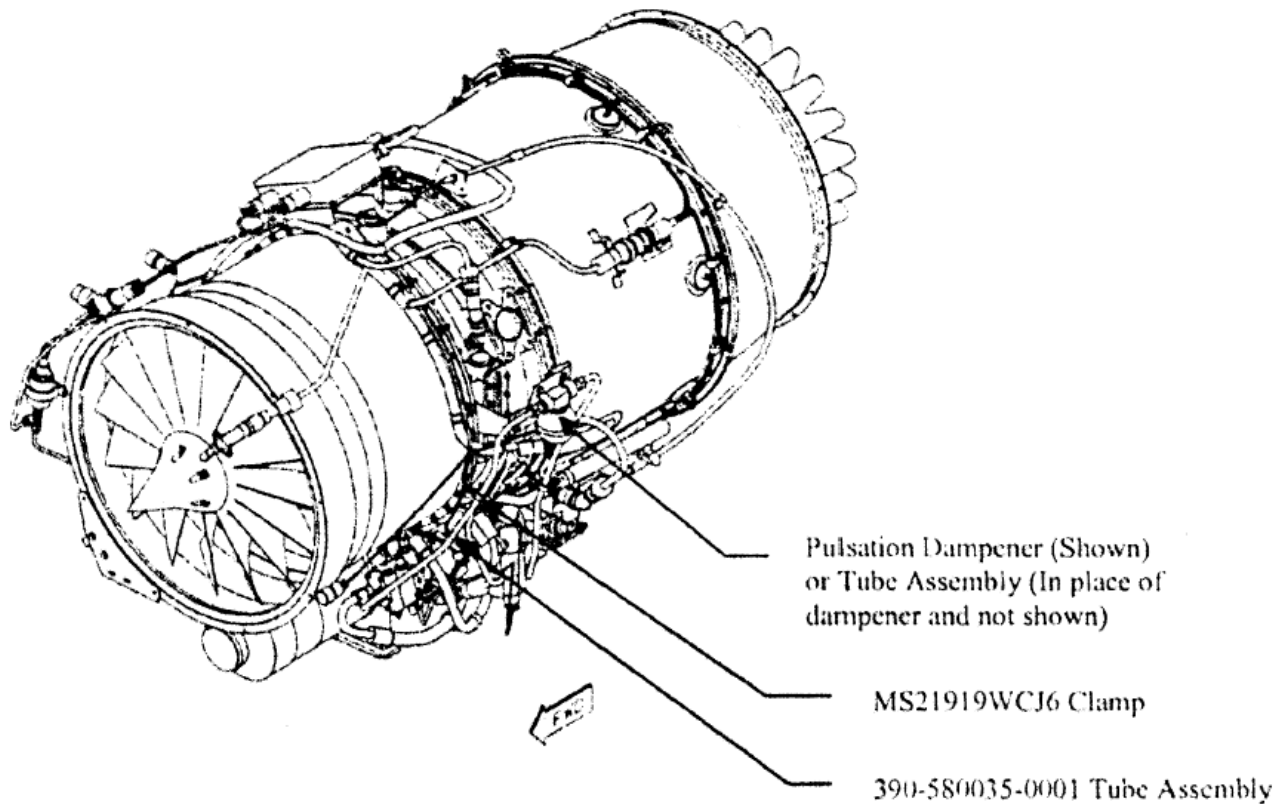
The FAA received reports of four failures of the part number (P/N) 390-580035-0001 hydraulic tube assembly located on the left engine assembly of Raytheon Model 390 airplanes. The failures resulted in in-flight loss of hydraulic fluid. The tube is installed between the hydraulic pump and the hydraulic pulsation damper and carries hydraulic pump output pressure.

(d) This AD is the result of failure of the hydraulic tube assembly, which caused in-flight loss of hydraulic fluid. We are issuing this AD to prevent failure of the hydraulic tube assembly and the clamp and consequent leaking of hydraulic fluid. This failure could result in loss of hydraulic system functions and risk of fire because of flammable fluid leakage in the engine nacelle and lead to loss of control of the airplane.

Figure 1. Hydraulic Tube Assembly with Clamp on Left Hand Engine.

Actions	Compliance	Procedures
<p>(1) Perform a one-time visual inspection of the hydraulic tube assembly and clamp using Raytheon Safety Communique No. 267, dated January 2006. Perform repetitive detailed inspections thereafter per Raytheon Mandatory Service Bulletin No. SB 29-3771, dated January, 2006.</p> <p>(i) The tube assembly part number is P/N 390-580035-0001 or P/N 390-580035-0005).</p> <p>(ii) The clamp part number is P/N MS21919WCJ6 or P/N MS21919WCJ7.</p>	<p>Visually inspect before further flight after February 2, 2006 (the effective date of this AD), except for those who received emergency AD 2006-02-51, issued January 19, 2006, unless already done. Perform the detailed inspection within 10 hours time-in-service (TIS) after February 2, 2006 (the effective date of this AD), except for those who received emergency AD 2006-02-51, issued January 19, 2006, unless already done. Inspect thereafter at intervals not to exceed 50 hours TIS. You may perform the detailed inspection before further flight instead of the visual inspection. Emergency AD 2006-02-51 contained the requirements of this amendment and became effective immediately upon receipt.</p>	<p>For the visual inspection, use Raytheon Safety Communique No. 267, dated January, 2006. For the detailed inspections, use the procedures in Raytheon Mandatory Service Bulletin No. SB 29-3771, dated January, 2006.</p>

<p>(2) Replace the hydraulic tube assembly (P/N 390-580035-0001 or P/N 390-580035-0005) and the clamp (P/N MS21919WCJ6 or P/N MS21919WCJ7) (or FAA-approved equivalent part numbers) with new P/N 390-580035-0001 or P/N 390-580035-0005 and P/N MS21919WCJ7 (or FAA-approved equivalent part numbers) or used parts.</p>	<p>Replace the clamp at each inspection. Replace the tube assembly prior to further flight after any inspection where evidence of chafing, excessive vibration, wear, deterioration, or hydraulic fluid leakage is found. Refer to SB 29-3771, dated January, 2006 for acceptance/rejection information for the tube assembly.</p>	<p>Follow the procedures in Raytheon Mandatory Service Bulletin No. SB 29-3771, dated January, 2006.</p>
