Diamond DA 42 training accident Unintentionally entering into spinn - presentation on weight / balance issue during flight training operations

Inspector of Accidents Tor Nørstegård NSIA, Norway

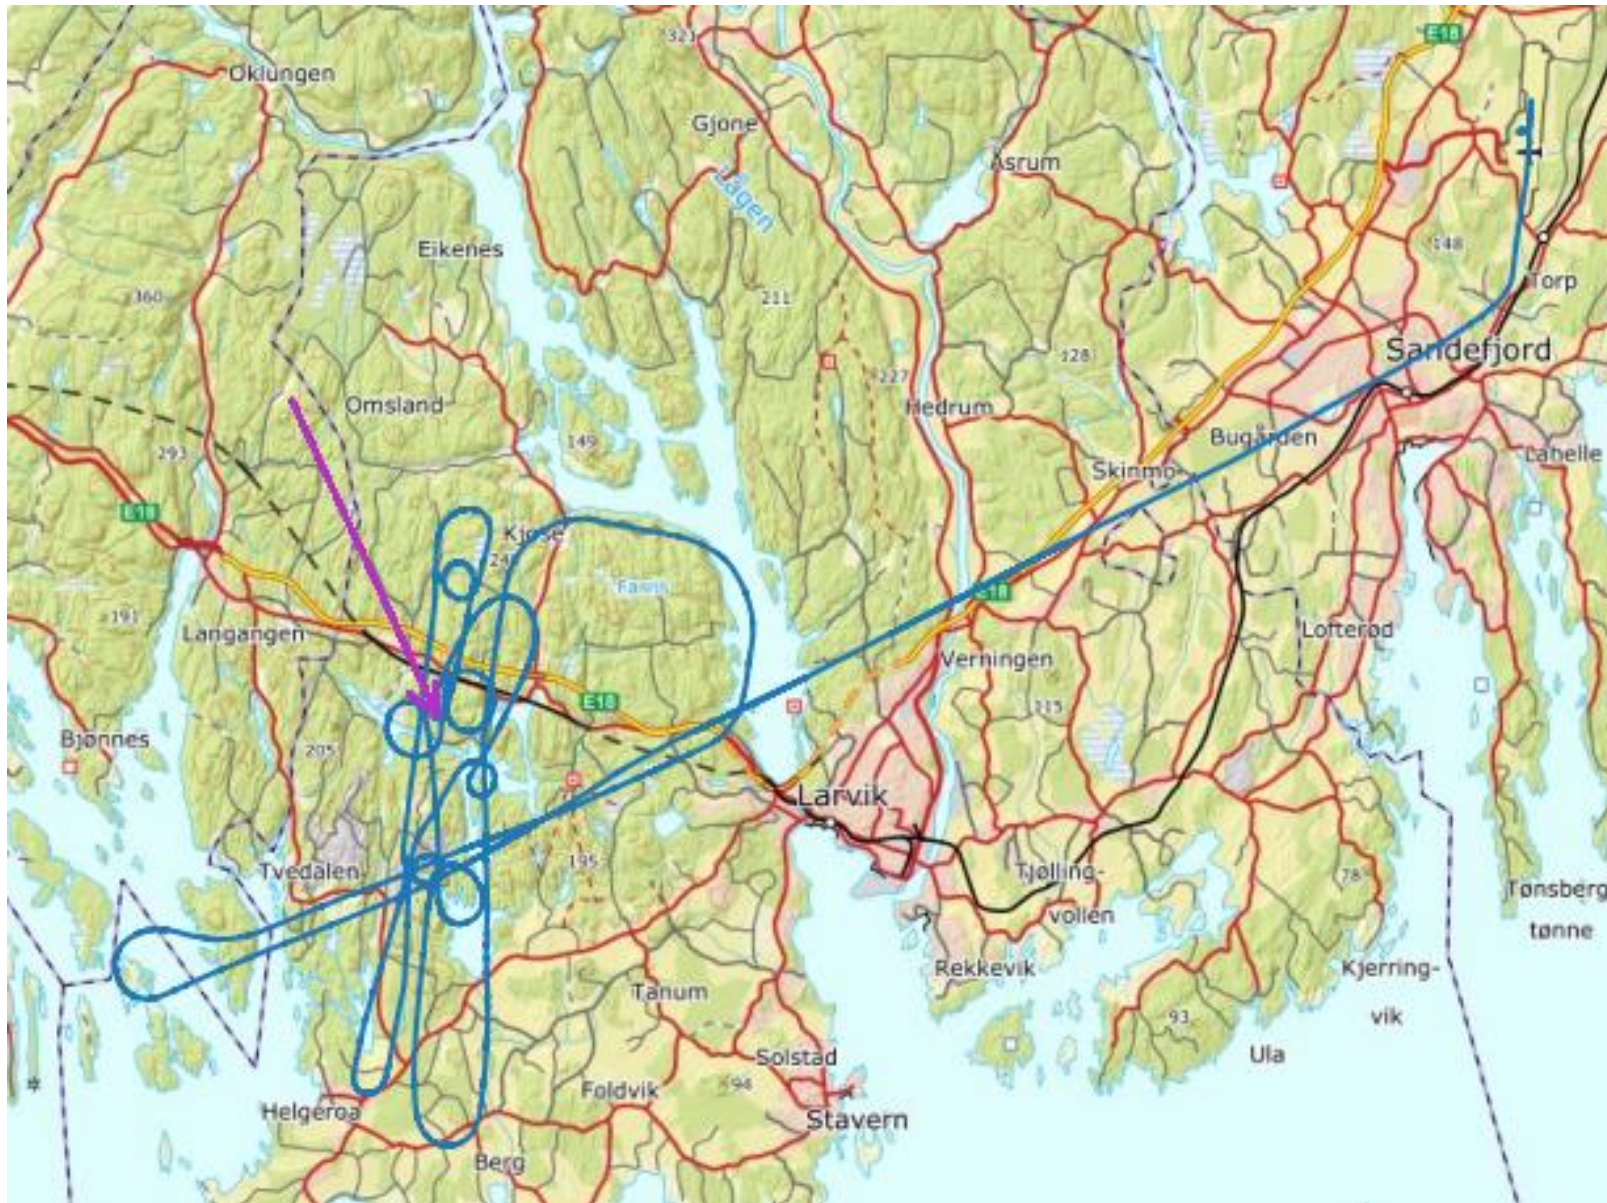
- 3,600 ft above ground
- Fair weather conditions
- Third sequence with slow flight
- Gear and flaps down
- 65 KIAS
- Rolled 7° left
- Rate of descend increased to 8,000 ft/min
- One witness saw a sequence of the AC spinning vertically

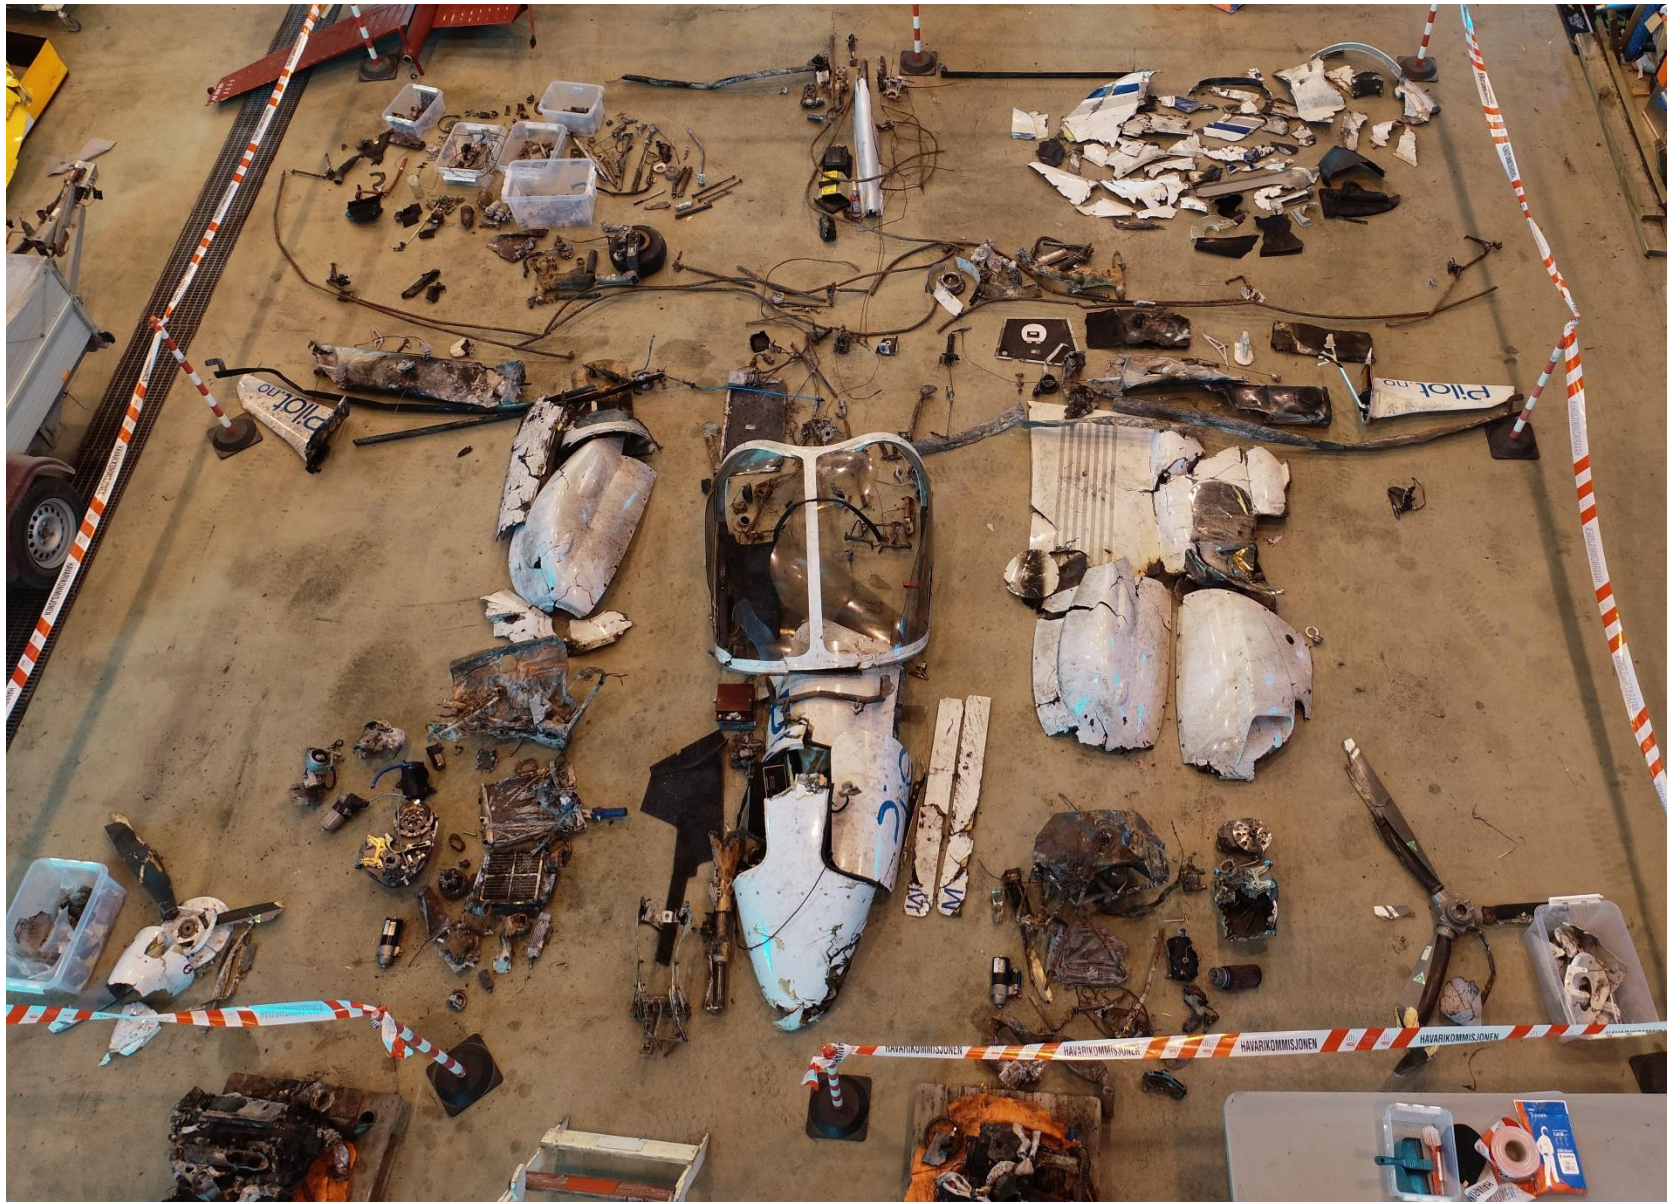
- The wreckage showed heavy damage and it has not been possible to determine what caused loss of control of the airplane based on examinations of the wreckage parts.
- No signs of unsafe maneuvering or reckless behavior.
- The Diamond DA 42 NG is sensitive regarding load distribution. The content of anti-icing fluid in the noes compartment tank greatly affects the balance. A single flight bag positioned in the passenger seat, or in the aft luggage compartment can make a great difference.
- There are no requirements for multi-engine airplanes in the normal category (CS-23) to be certified for spins.
- Demonstration of spin characteristics is only required for single-engine airplanes.
- Spins are generally trickier to handle with an aft CG.
