Integrity improvement of rotorcraft main gear box

REPORT NUMBER:	D1-1
REPORT CLASSIFICATION:	UNCLASSIFIED
DATE:	14 January 2022
KNOWLEDGE AREA(S):	Research, rotorcraft MGB, configuration and component design
DESCRIPTOR(S):	Potential weaknesses, single point of failure, failure flow analysis
CUSTOMER:	European Aviation Safety Agency
CONTRACT NUMBER:	EASA.2019.C15
OWNER:	European Aviation Safety Agency
DISTRIBUTION:	Limited
CLASSIFICATION OF TITLE:	UNCLASSIFIED
Author(s):	W. Riesen, S. Hilleke

EVALUATE AND DEFINE ROTOR AND ROTOR DRIVE SYSTEM DESIGN
OPTIONS TO PREVENT SINGLE POINTS OF CATASTROPHIC FAILURE

Review of the state-of-the-art rotorcraft gearbox configurations and component designs

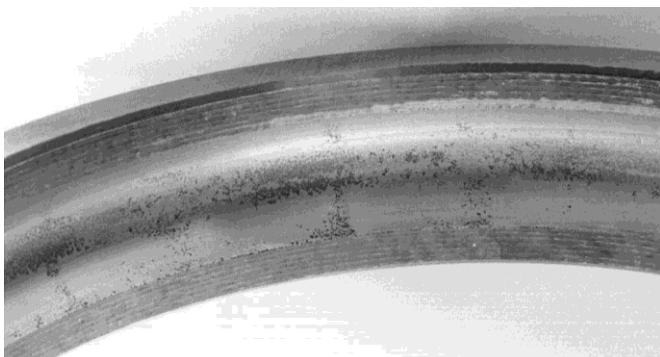
General corrosion is indicated by rust scours on the surface, which may be caused by the ingress of water, by condensation forming under unfavourable operating conditions, or by oil ageing in such quantities that the lubricant cannot provide protection for the steel surfaces, as well as by storage conditions. Figure 19 shows corrosion spots on a helical gear and on a raceway. Figure 20 show chemical attacked bearing raceway, Figure 21 gives an example on a light corrosion.

Figure 19: General corrosion [16]

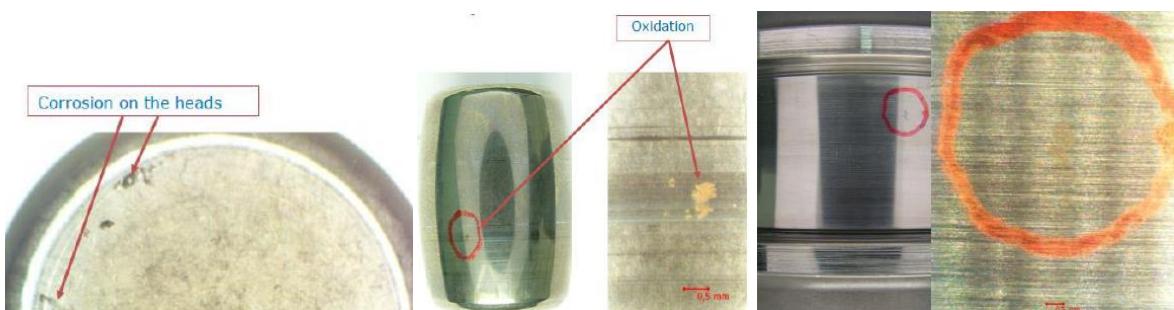
Figure 21: Example of observed light corrosion damages [17]

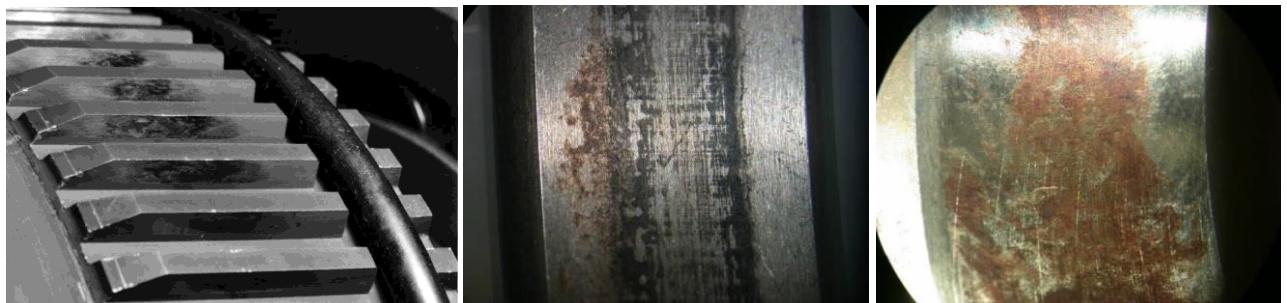
Figure 23 shows areas of rust on the outside surface of a gearing and the outer ring or in the bore of the inner ring. The raceway path pattern is heavily marked at corresponding positions. If the thin oxide film is penetrated, oxidation will proceed deeper into the material. An instance of this is the corrosion that occurs when there is a small relative movement between bearing ring and shaft or housing, on account of the fit being too loose. The relative movement may also cause small particles of material to become detached from the surface. These particles oxidize quickly when exposed to the oxygen in the atmosphere.

As a result of the fretting corrosion, the bearing rings may not be evenly supported and this has a detrimental effect on the load distribution in the bearings. Rusted areas also act as fracture notches. [17]

Figure 23: Fretting on gearing (left) [16] and inner ring bore diameter (middle/right) [17]

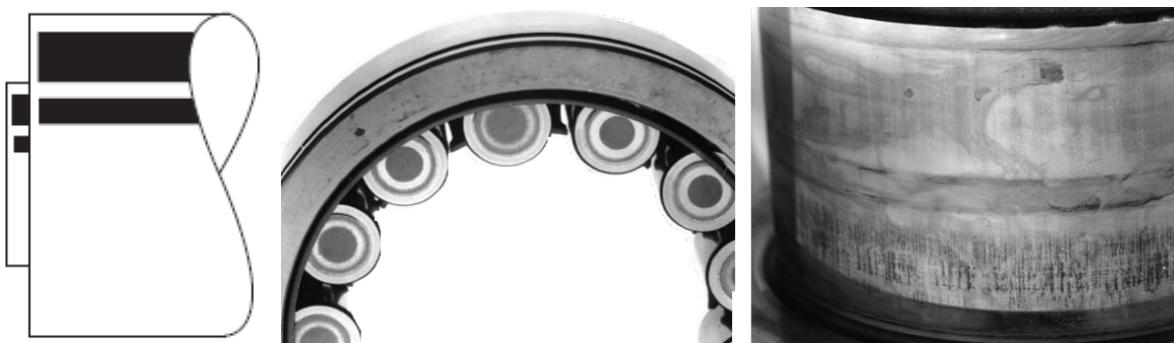
Figure 26: Worn on roller and races like axial protrusion (left) and grey staining (right) [16]

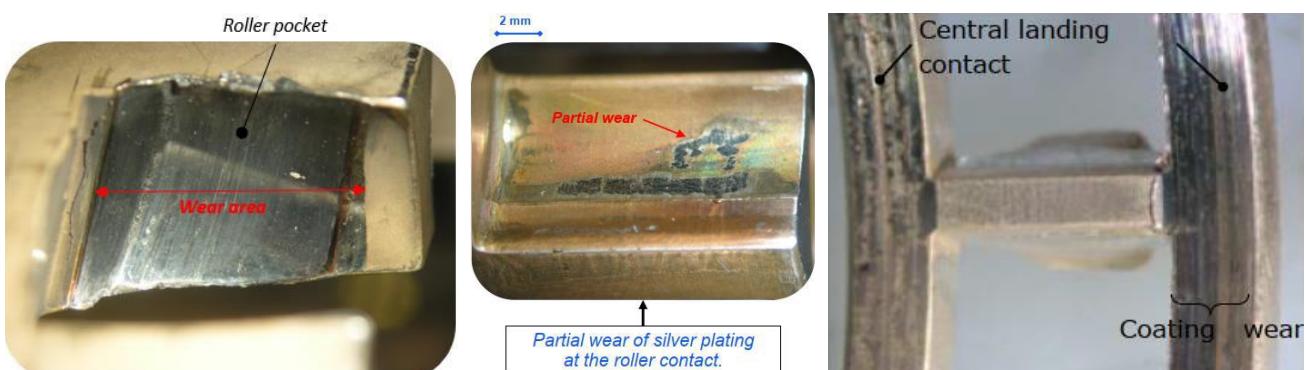
Cage wear in the cage-roller contact or cage-ring landing area may be caused by inadequate lubrication, by excessive roller skew, by high temperature, or by abrasive particles (Figure 27). The idea with rolling bearings is of course to avoid sliding friction. However, where the cages are concerned, sliding cannot be eliminated in the contacts with the other components of the bearing. This explains why the cages are the first components to be affected when the lubrication becomes inadequate.

Figure 27: Example of cage wear, various wear level and cage area [17]

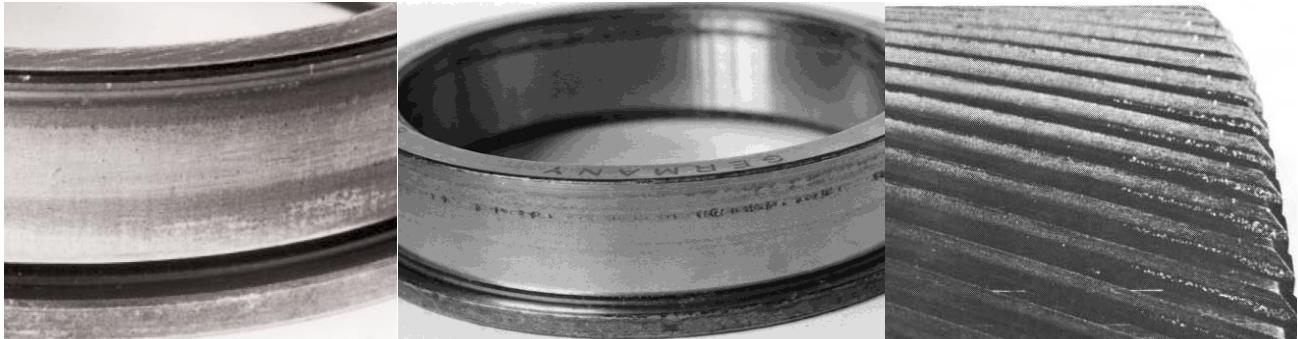
chips (Figure 37; middle). There is micro-fracture formation in zones close to the surface also subject to load. Breakage cracks proceed obliquely towards the surface starting from these micro-fractures. As a result, pieces of the material break off and the consequential pitting continues to spread. The broken material shards are over rolled and lead to local overloads (Figure 37; right).

Figure 37: Gray spots (left), pitting formation (middle) and initial pitting (right) [13], [16]

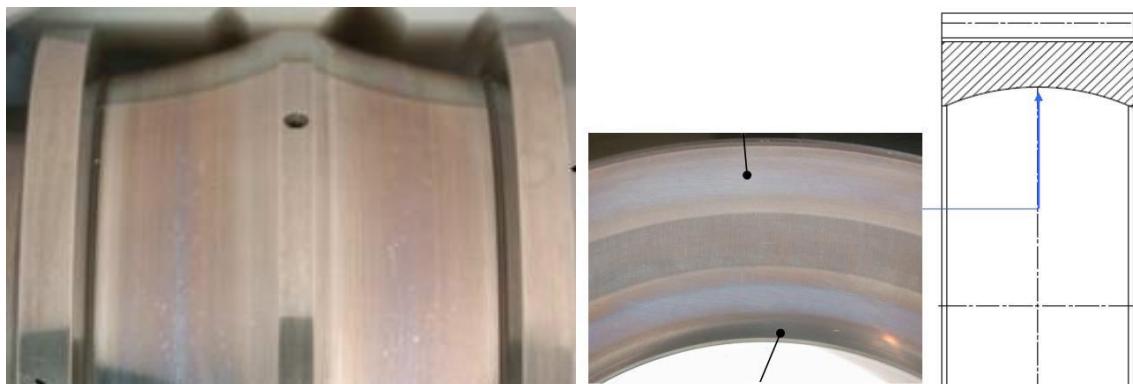
In its initial phase, the wear that then results has roughly the same effect as lapping. The peaks of the microscopic asperities that remain after the production processes are torn off. At the same time, a certain rolling-out effect is obtained. This gives the surfaces concerned a varying degree of mirror-like finish. At this stage, surface distress can also arise. If the lubrication is overly poor, the temperature will rise rapidly and the surfaces then show blue to brown discolouration bands. The coloured worn bands are not detrimental until this surface distress generates a primary surface initiated damage, as shown in Figure 41.

Figure 41: Example of worn and coloured bands on inner ring and outer rings [17]

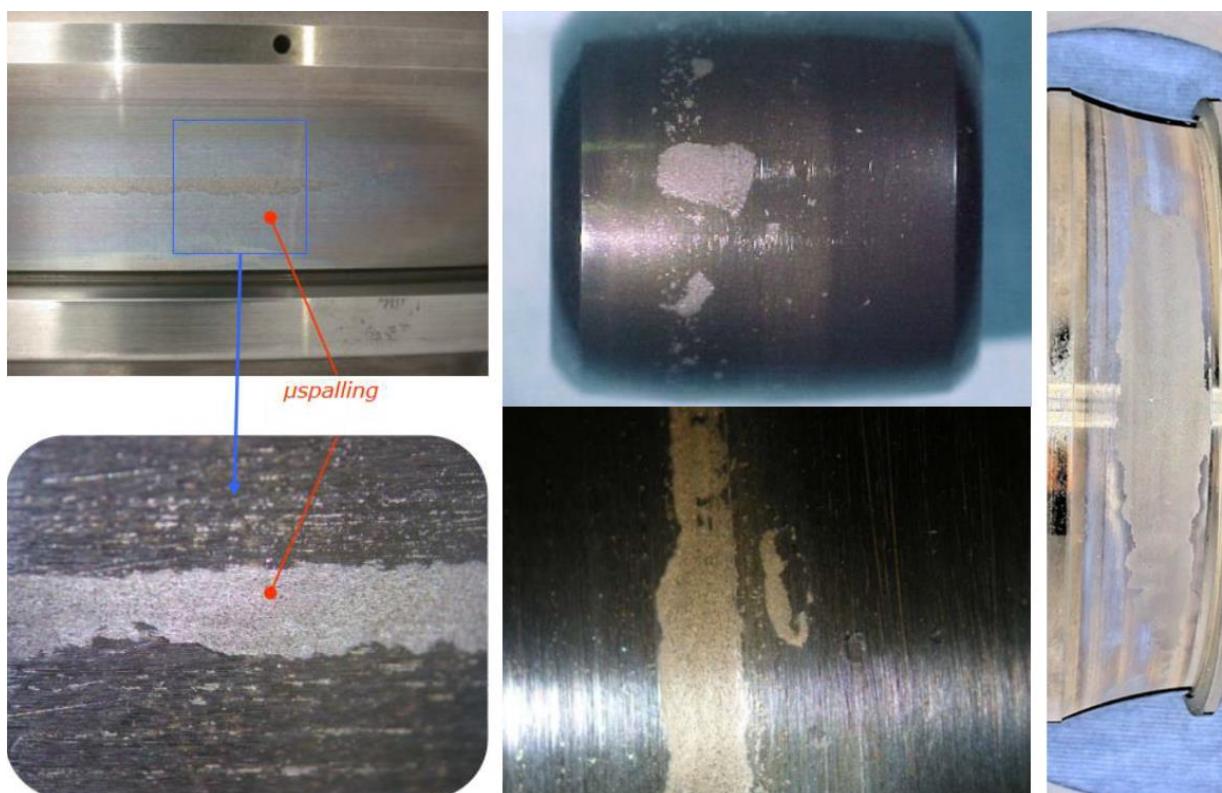
The initial micro-spalling damage is not visible to the naked eye. A more advanced stage is marked by small, shallow craters with crystalline fracture surfaces. In later stages, micro-spalling is characterized by low depth material removal and high roughness area. Small cracks then form in the surfaces, known as surface distress. These cracks must not be confused with the fatigue cracks that originate beneath the surface and lead to flaking. The surface distress cracks are microscopically small and increase very gradually to such a size that they interfere with the smooth running of the part, as shown in Figure 42.

Figure 42: Micro-spalling and discolouration [17]

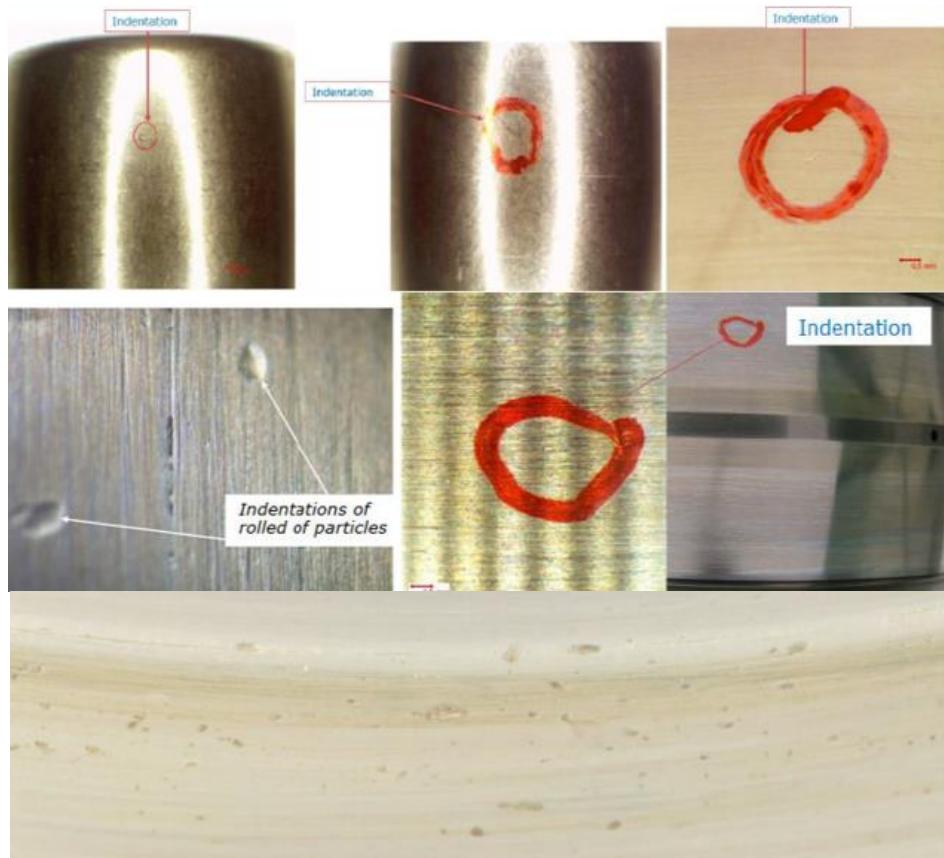
Another case is the small indentations as shown in Figure 43, which may be distributed around the raceways of both rings and on the rollers by foreign particles, and not necessarily hard ones.

Figure 43: Indentation on raceway and roller due to foreign particles [17]

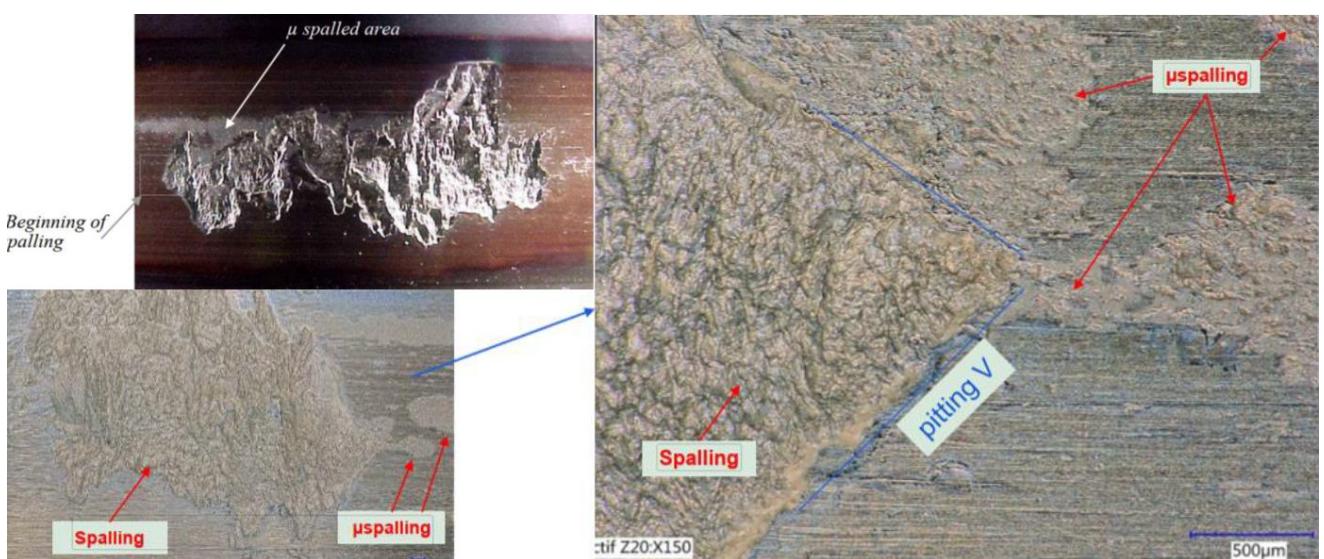
All these preliminary damages can lead to major defects. Several cases of severe spalling have been observed due to surface distress. Major flaking created from surface are characterized by the typical “V shape” at the initiation location as shown in Figure 44.

Figure 44: Massive spalling initiated by micro-spalling [17]

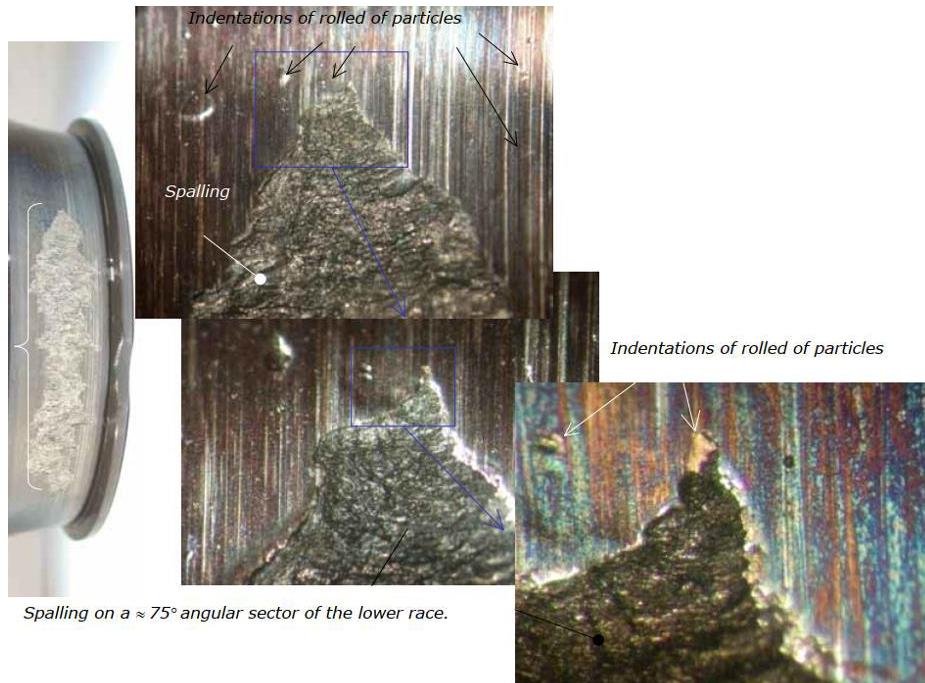
Figure 45: Massive spalling initiated by surface indentation [17]

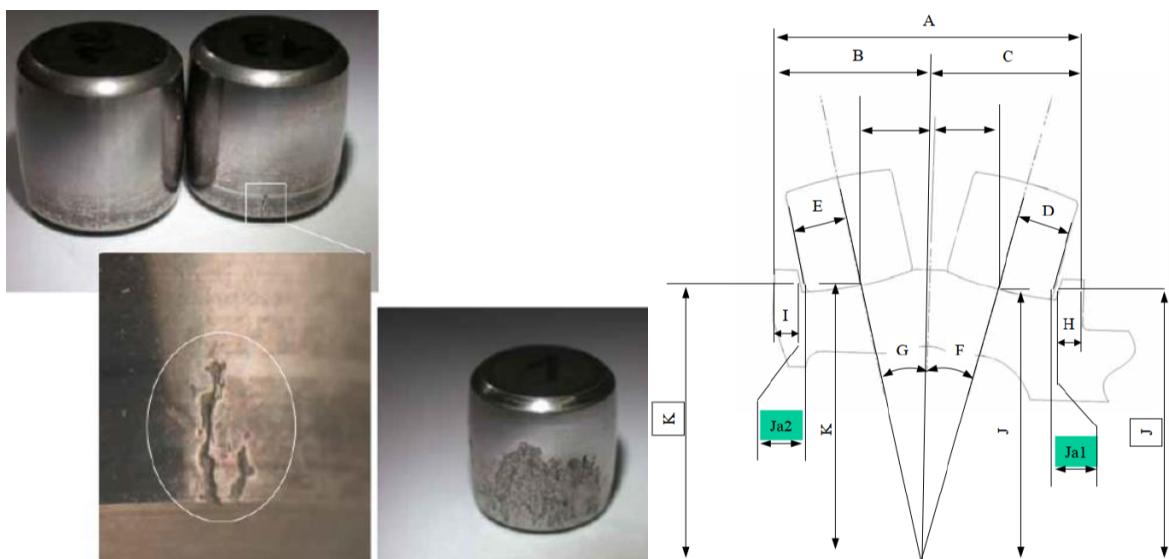
It can also be noted that even if both inner and outer rings are running in poor lubrication conditions, the major failures mainly occur on the inner ring (~90% of SKF cases), more precisely on the upper row in cases of double row spherical roller bearing. Indeed, as already mentioned, the inner ring contact pressure is generally higher than that of the outer ring and the upper row's poor lubrication condition is worsened by the effect of gravity. Another issue is the management of the axial clearance as one of the key parameters in the design of the spherical roller bearings. Roller spalling could start from the roller-edge contact zone or from the roller edge/corner as shown in Figure 46. Indeed, the contact between the rollers and ring shoulders can induce very high stress and significant friction wear, rapidly leading to spalling. On the other hand, an overly large clearance can lead to excessive roller skewing and can induce ring surfaces to wear. This kind of interference could occur due to not adapting the design, so that the clearance between inner ring shoulders and rollers is not ensured. [17]

Figure 46: Example of roller spalling due to interference with the inner ring shoulder (left); Ja = Negative interference of the rollers with the inner ring shoulder (right) [17]

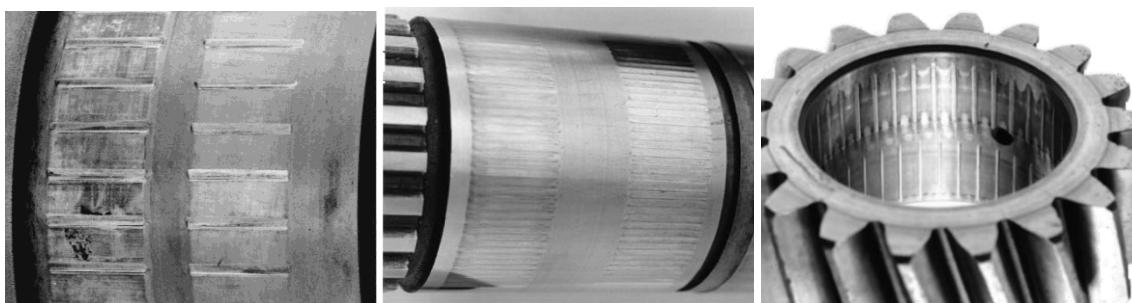
This kind of damage is critical due to the very high increase in radial play on helically cut gears. This can result in contact pattern displacement on the mating gears and can even ultimately lead to tooth failure caused by several vibrations. Figure 48 (left) shows clearly detectable recesses in the circumferential face, spaced identically to and caused by the roller bodies of the bearing. Another case is closely grouped rows of indentations, which can be seen and felt as shown in the middle of Figure 48. The right picture in Figure 48 shows brinelling in the bore of a helical gear mounted on a needle bearing. If the bearing only performs a supporting function over a longer period, i.e. there is no relative movement between the gear and the supporting shaft, the bearing contact areas may show signs of fretting corrosion.

Figure 48: Recesses in the circumferential face (left); Fine brinelling marks (middle); Brinelling in the bore of a helical gear (right) [16]

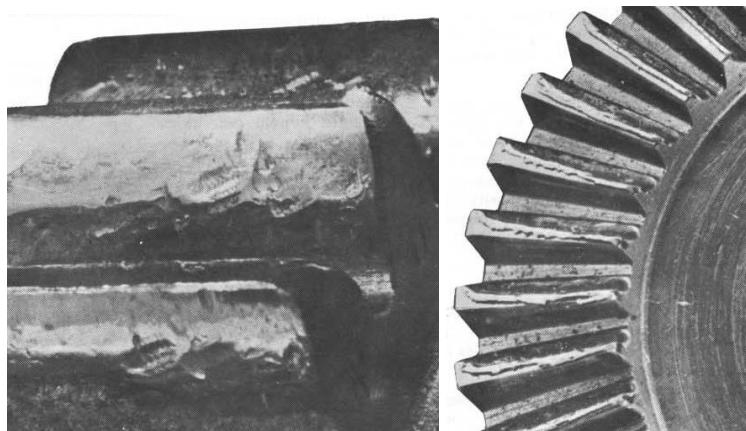
In this type of failure, the surface and subsurface material show evidence of metal flow, where surface material has been worked over the tips of the gear teeth giving a finned appearance, or the tooth tips are heavily rounded-over and a depression appears on the contacting surface as the contact stress is too high or the hardness of the material is too low. Under heavy load, the rolling and peening action of the mesh cold-works the surface and subsurface material. If the contact stresses are high enough, the sliding action tends to push or pull the material in the direction of sliding. The dents and battered appearance of the surface are the result of dynamic loading caused by errors produced during the manufacturing process, or by continuous operation while the profile is in the process of deteriorating from a combination of cold-working and wear as is illustrated in Figure 49.

Figure 49: Examples: Cold flow [13]

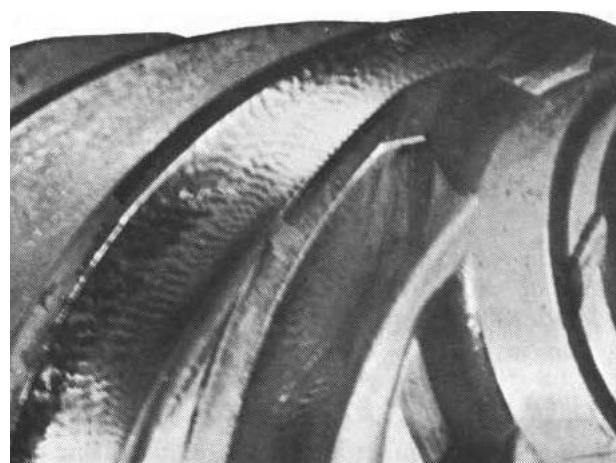
Rippling is a periodic wave-like formation at right angles to the direction of sliding or motion and is not always considered a surface failure unless it has progressed to an advanced stage. High contact stresses under cyclic operation tend to roll and knead the surface, causing the immediate subsurface material to flow. Slow-speed operation is usually associated with this type of failure because it does not build up adequate elastic-hydrodynamic film thickness. This combination of high contact stress, repeated cycles, and an inadequate lubrication film will produce a rippled surface with a fish-scale appearance is usually observed on hardened gear surfaces under certain conditions, as can be seen in Figure 50.

Figure 50: Example: Rippling [13]

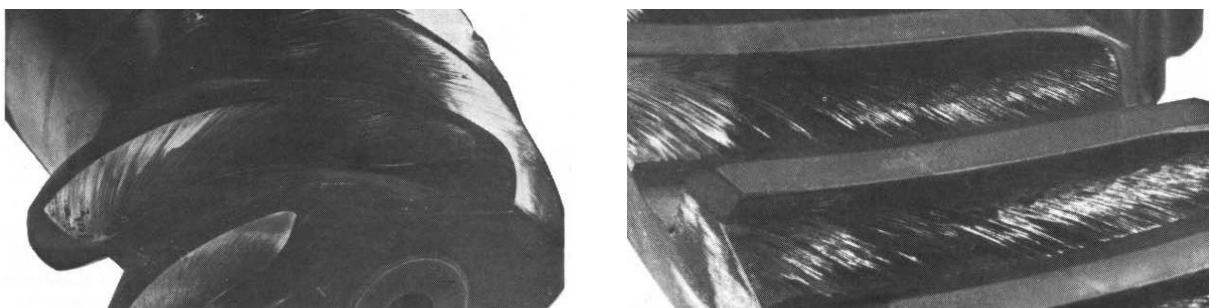
Ridging is caused by the plastic flow of surface and subsurface material due to high contact compressive stresses and high relative sliding velocities. It is often present on heavily loaded worm and worm wheel drives and on hypoid pinions and gear drives. Often, ridging exists on low-hardness materials but may also be present in high-hardness materials if the contact stresses are high, such as in case-hardened hypoid rear axles. The formation of deep ridges due to plastic flow of surface and subsurface material show definite peaks and valleys or ridges across the surface in the direction of sliding as seen in Figure 51.

Figure 51: Examples: Ridging [13]

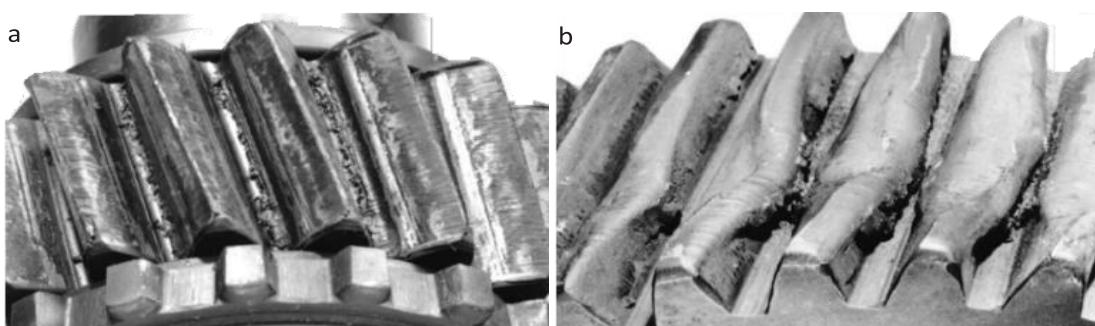
Insufficient or inadequate lubrication is primarily the basis for overheating, which causes a reduction in hardness and a greyish to bluish-black discoloration of the part and therefore scored or grooved flank wear in the direction of sliding. More extreme overheating causes greater distortion of the part, up to deformation as shown in Figure 53.

Figure 53: a) Gear, which has overheated as the result of a lack of oil. In this failure mode, there is blue or grey-black discoloration of the teeth. b) Thermal deformation of a gear caused by a lack of oil [16]

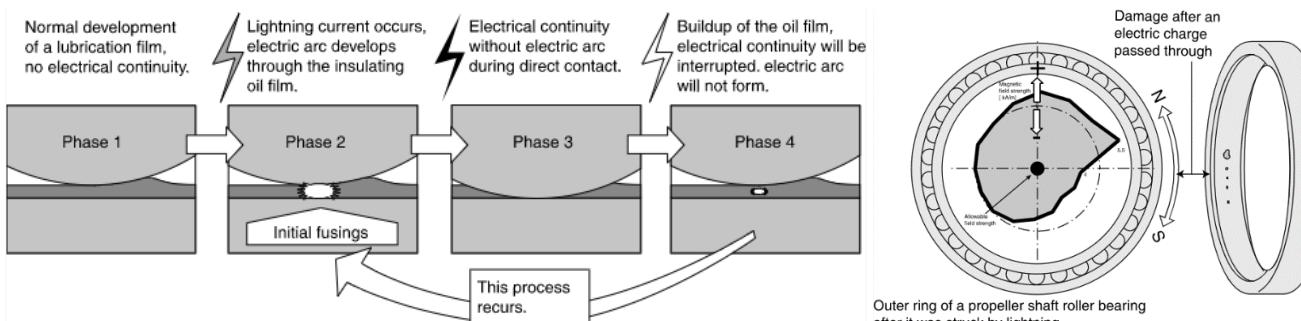
In cases of lightning strikes, the sharp edges and corners on the rotors are primarily affected. Lightning enters and exits through the rotors. However, this can also lead to increasing vibrations, leakage, and failure of moving parts, especially various bearings. It leaves craters of various sizes as shown in Figure 56 (left) as well as metal wear such as pitting in the bearing tracks and on the faces of transmission gear teeth (Figure 56, right).

Figure 56: Initial fusions and positioning at the races of anti-friction bearings during electrical continuity (left) and characteristic traces (right) by lightning strike [31]

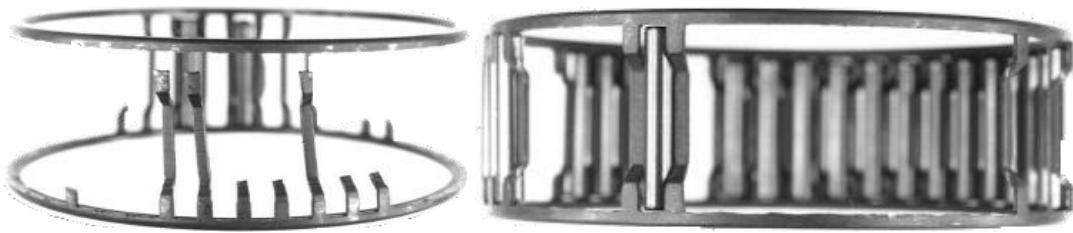
Other example of fatigue failure is the failure of bearing cages as a result of vibrations, which may be cause by different issues, e.g. imbalance on the shaft. The damage is not induced by the bearing itself and leads to failure of the bearing due to hairline cracks which propagate until the cage cracks fully through as shown in Figure 62.

Figure 62: Cage breakage [16]

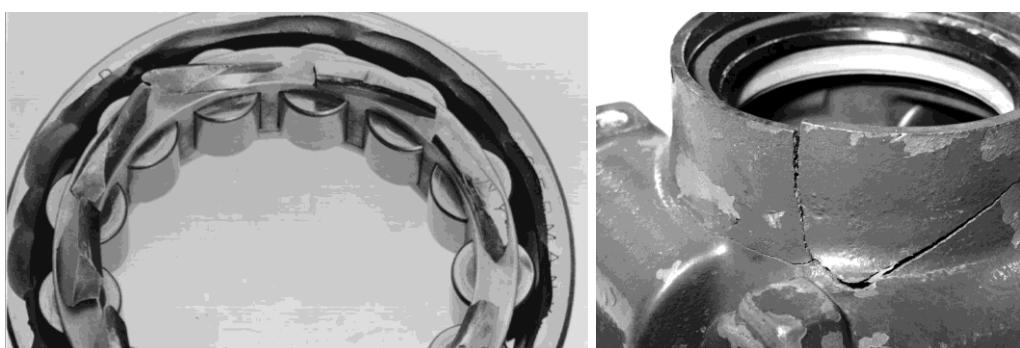
Figure 64: Example of an overloaded/broken bearing collar (left) and housing (right) [16]

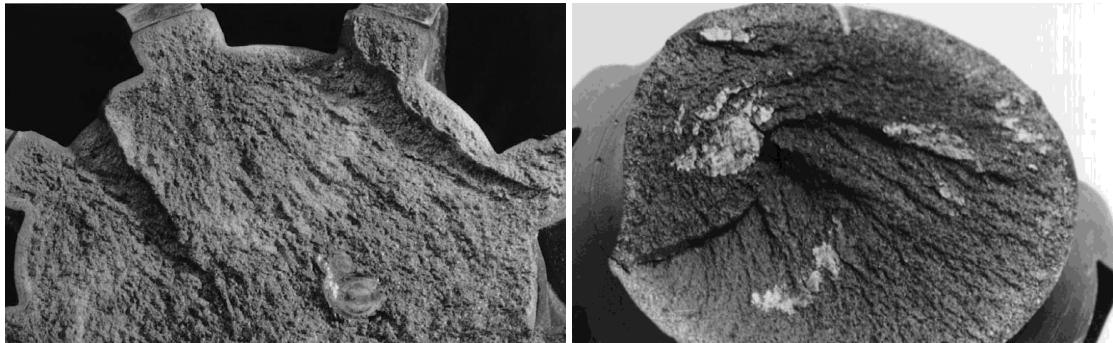
Figure 65: Bending overload failure [16]

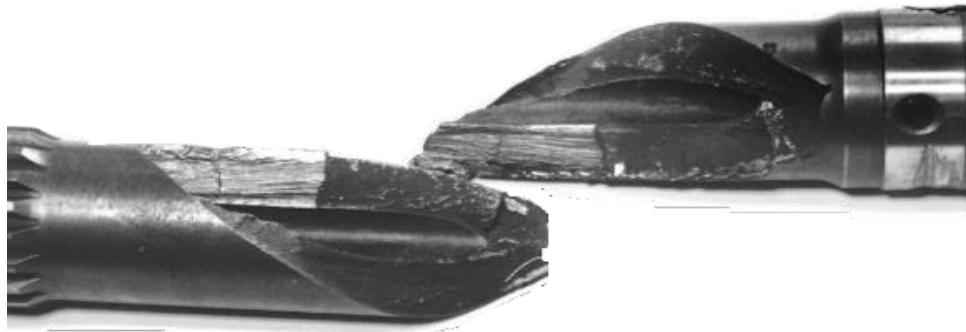
Figure 66: Breakage through torsion [16]

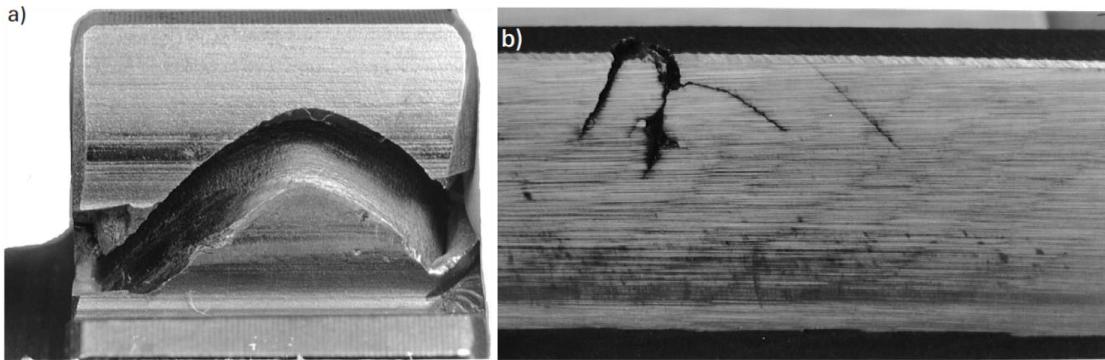
Figure 68: a) tooth breakage; b) cracks in the flank [16]

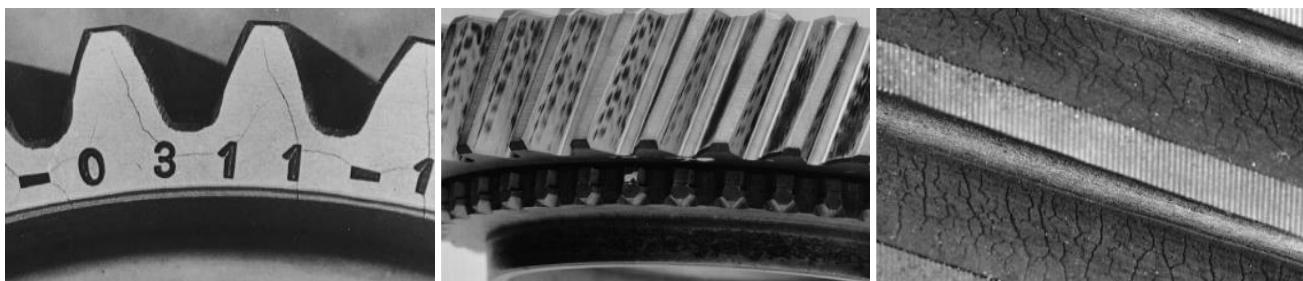
Figure 69: Hardening cracks (left), grinding burns (middle) and cracks (right) [16]

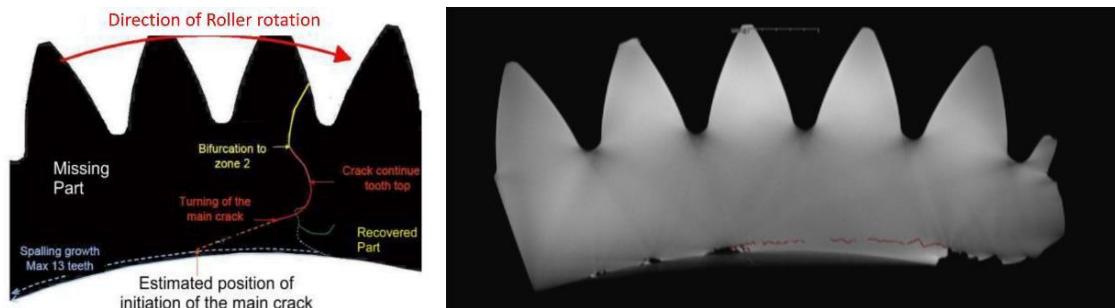
Figure 70: Stress model estimation of crack growth from the G-REDL accident at left, compared with the CT scan from the LN-OJF gear with the crack in red

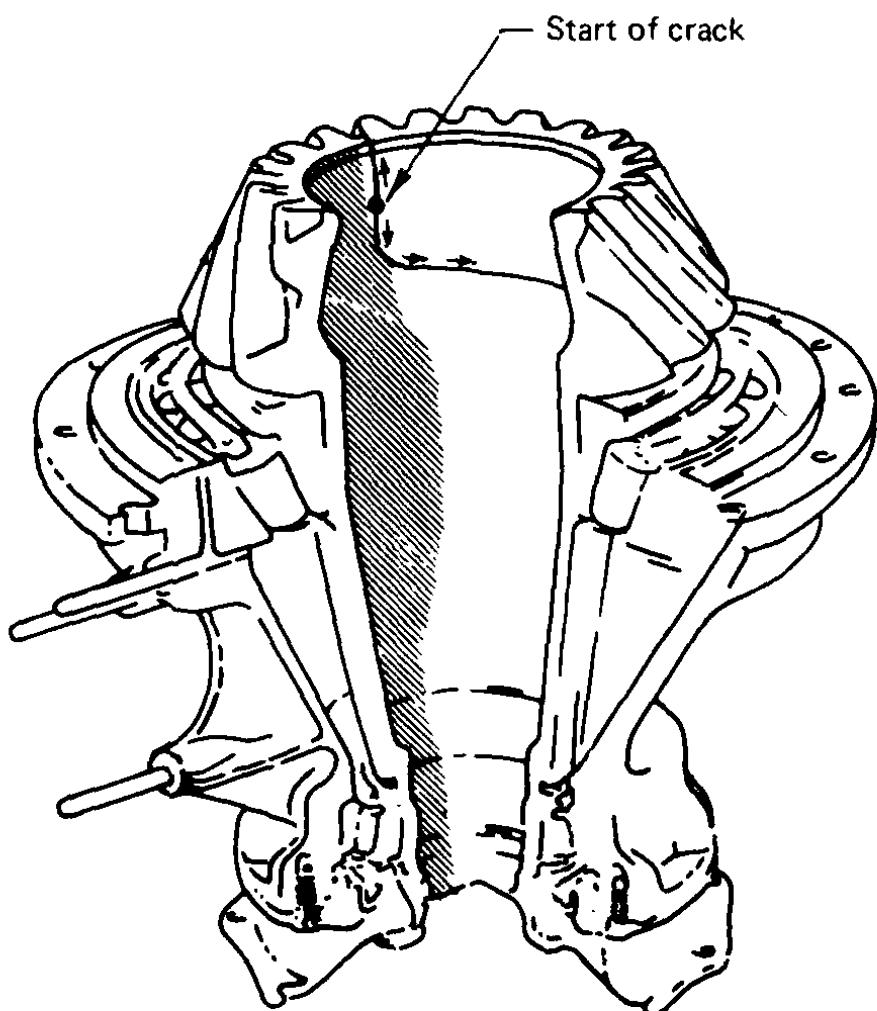
Figure 72: Path of the fatigue crack in the pinion

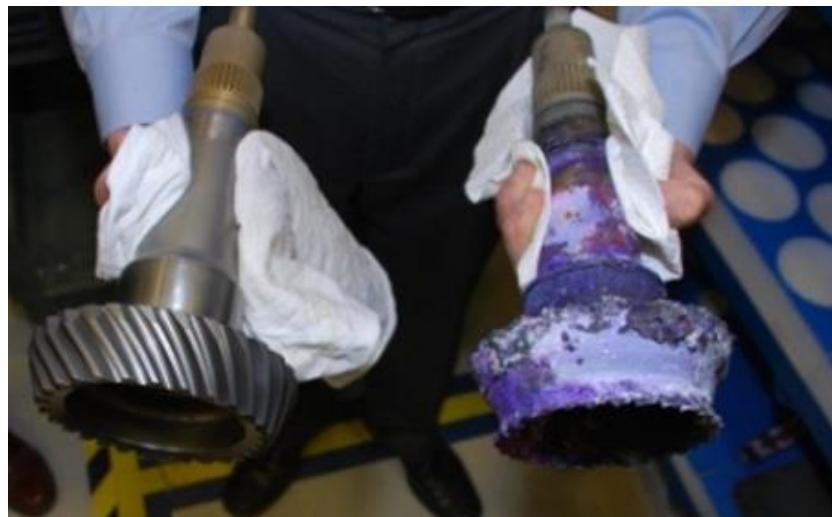
Figure 73: Damaged tail take-off pinion (right) in comparison to a new one (left)

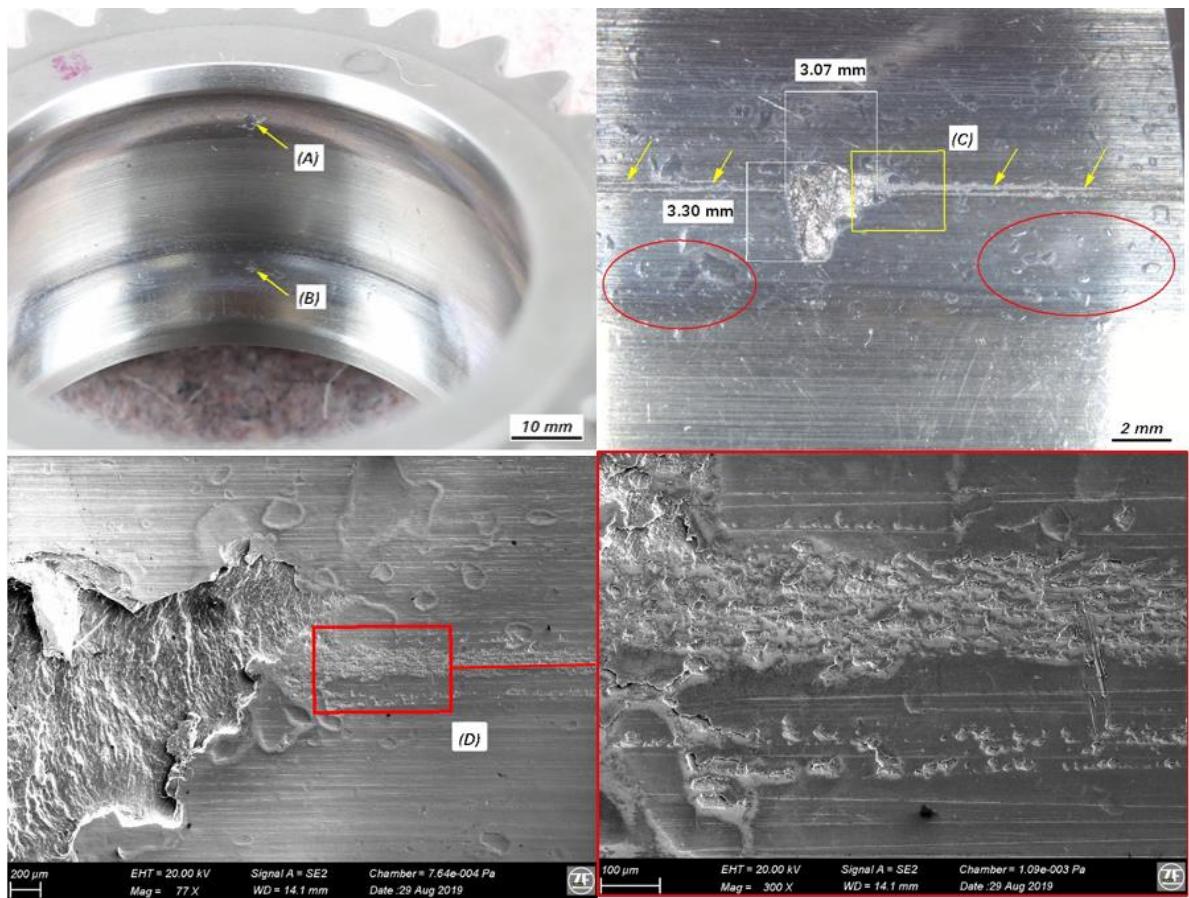
Figure 74: Spalling on raceways and band of micro-pitting and indentations from metal particles

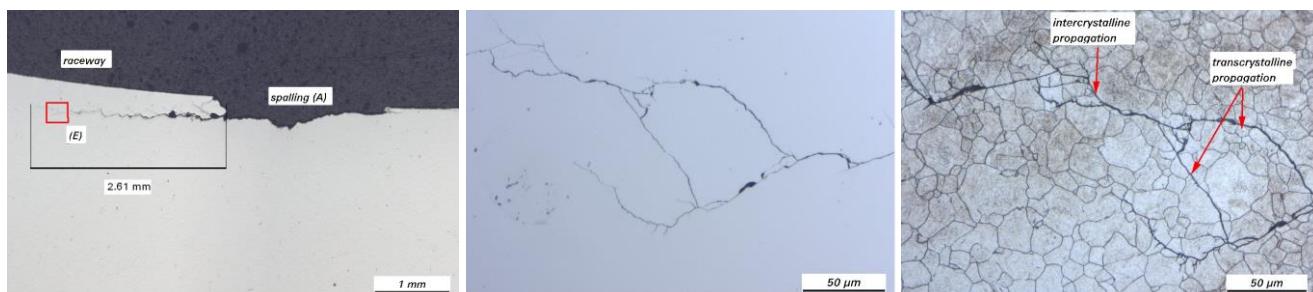
Figure 75: Beginning of the crack (left); detailed crack propagation (middle); inter- and trans-crystalline propagations (right)

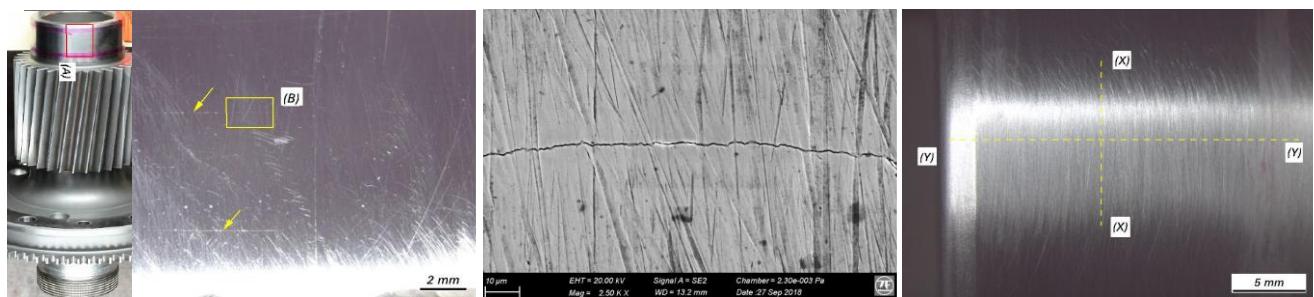
Figure 76: Fine axial cracks (left/middle) and crossed and curved machining marks (right)

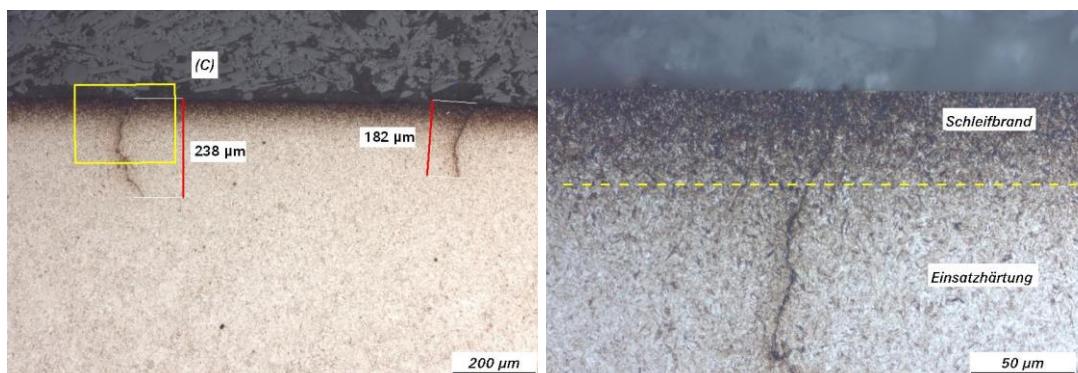
Figure 77: Initial cracks in the surface (left), Tempered martensite visible on the surface (right)

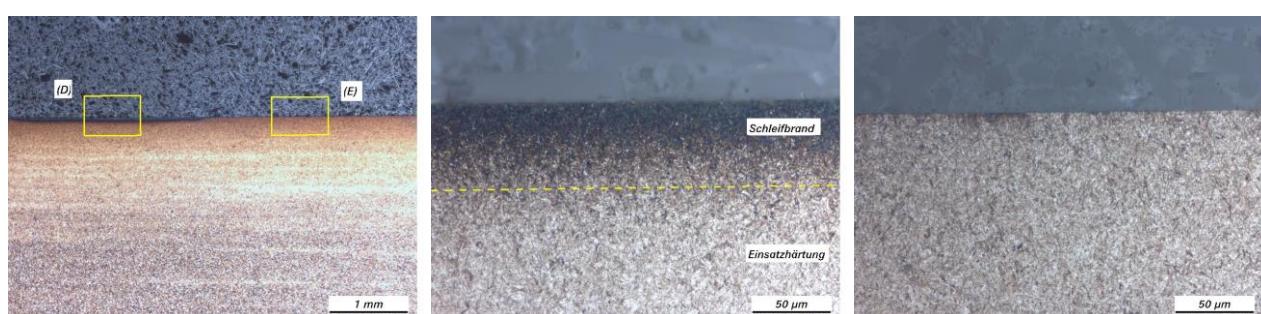
Figure 78: Grinding burn: Non-uniform (left); Tempered martensite visible on the surface (middle); None (right)

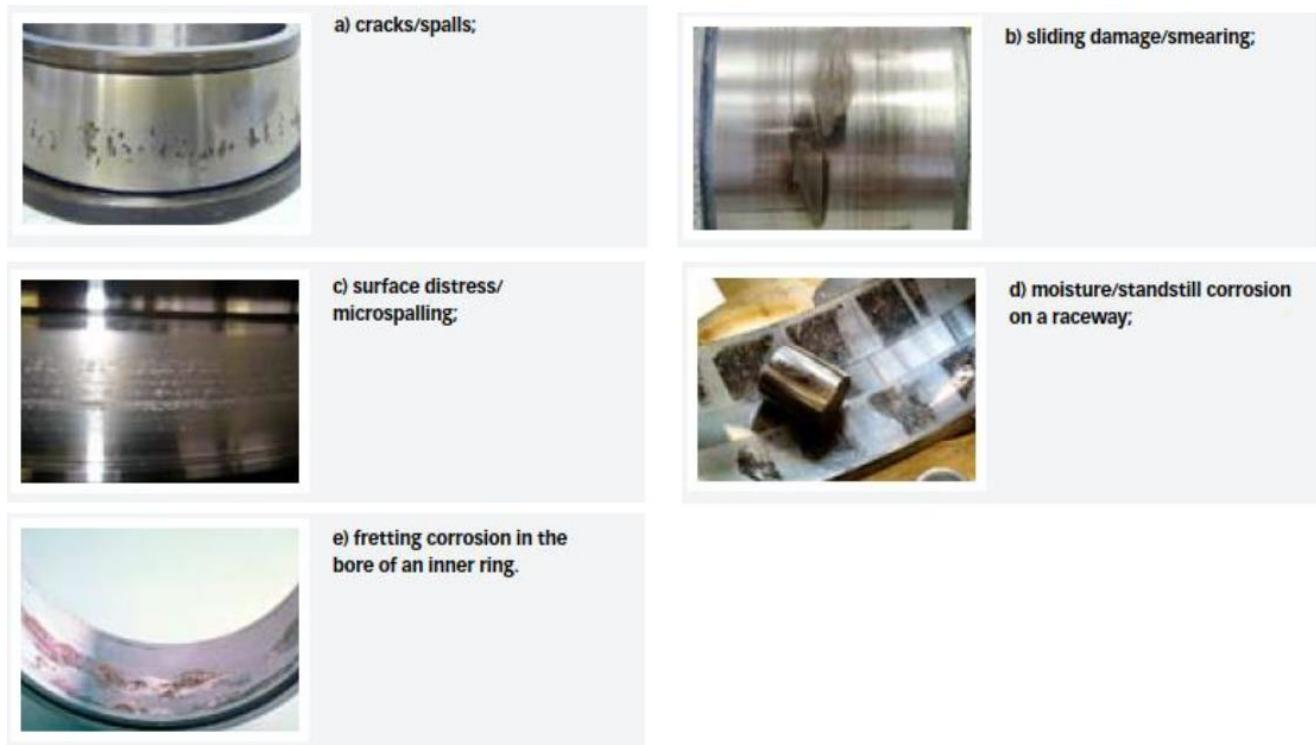
Figure 81: Wind gearbox bearing damages [17]
