AIRWORTHINESS DIRECTIVE

Gippsland Aeronautics GA8 Series Aeroplanes

**AD/GA8/5
Amdt 1**

Horizontal Stabiliser Inspection

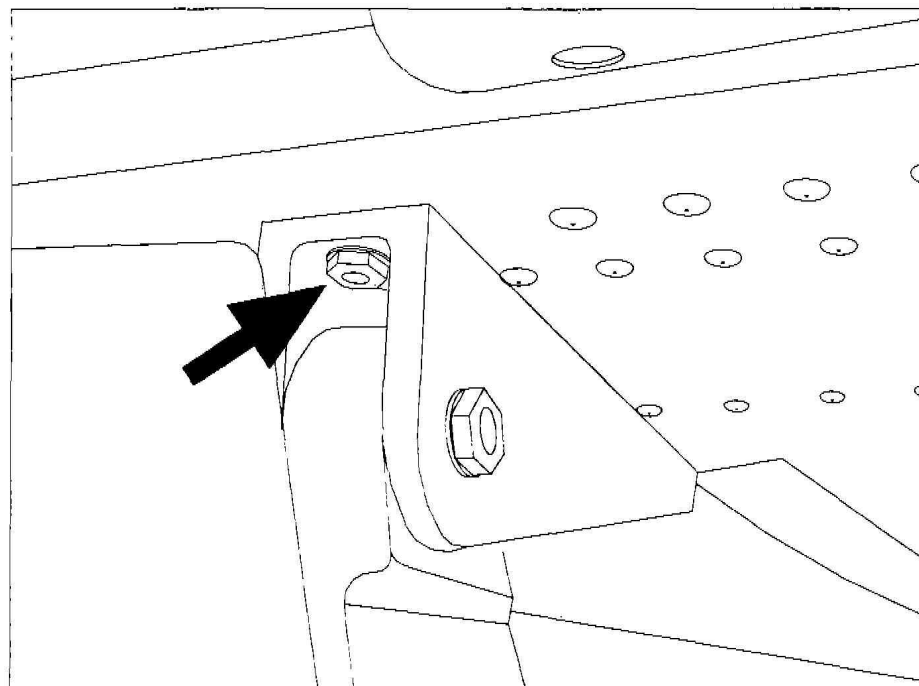
Figure 1 - Horizontal Stabiliser Attach Bolt

Visually inspect the integrity of the rearmost vertical Horizontal Stabiliser attach bolt and nut on both left and right sides, see Figure 1 below. This inspection can be carried out externally to the aircraft without removing any fairings or structure.

- (a) Remove the rearmost vertical Horizontal Stabiliser attach bolt and nut from both left and right sides as indicated in figure 1.
- (b) **Ensure the bolt and nut mating faces are square.** Spotface either side as required.
- (c) Install new **NAS6603-8** bolt and MS21042-3 nut. Ensure both bolt and nut sit square to surrounding material. Use AN960-10 washers under the nut as required. Torque bolts to 20-25 in lb. Follow instruction as recommended by AC43.13-lb, Section 7.40 in torquing bolts with friction locking nuts.
Caution - do not over torque the bolt.
- (d) Compliance with this part and part 3 (Rear Pivot Attachment Inspection) cancels the requirement to perform the Daily Visual Inspection of this area.

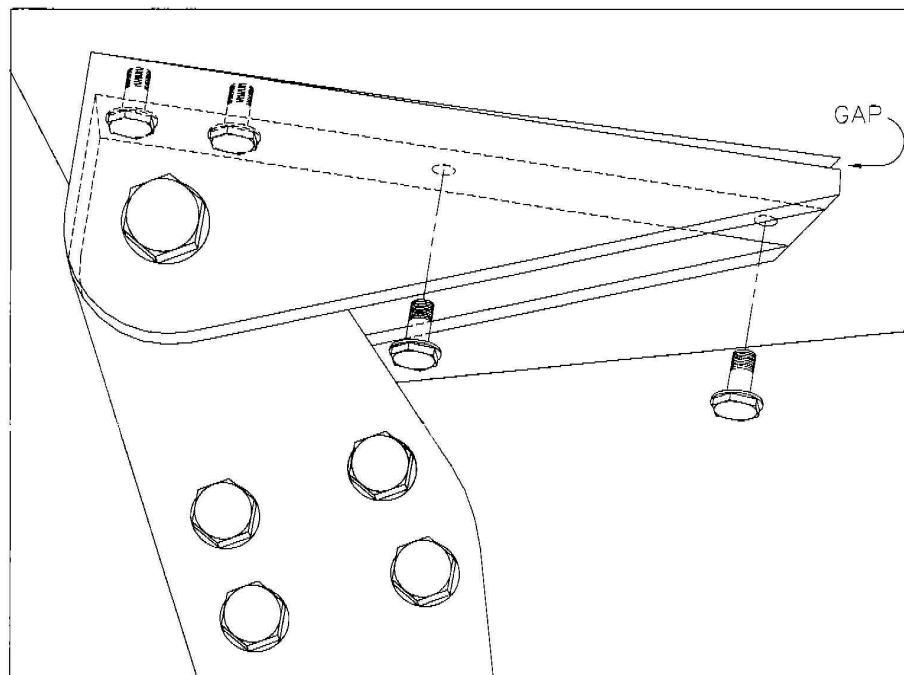
Figure 2 - Rear Pivot Attachment

- (a) Remove the lower Horizontal Stabiliser fairings.
- (b) Unscrew the two front bolts from each pivot attachment, leaving the rear two bolts done up tight, as shown in Figure 2 below. Anchor nuts were used to retain these bolts on early aircraft. Later aircraft have loose nuts and washer, access to which can be gained through the upper Horizontal Stabiliser access panel.

- (c) If a gap appears, as indicated in Figure 2 above, manufacture a tapered packer from 2024-T3 Aluminium sheet metal, 1.25" wide and as long as required to fill the gap.

- (d) Coat the packer with suitable primer and paint, as specified in the GA8 Service Manual.
- (e) Install the packer and reinstall bolts. Torque bolts to 20-25 in lb. Follow instruction as recommended by AC43.13-lb, Section 7.40 in torquing bolts with friction locking nuts.
- (f) Replace the lower Horizontal Stabiliser fairings.

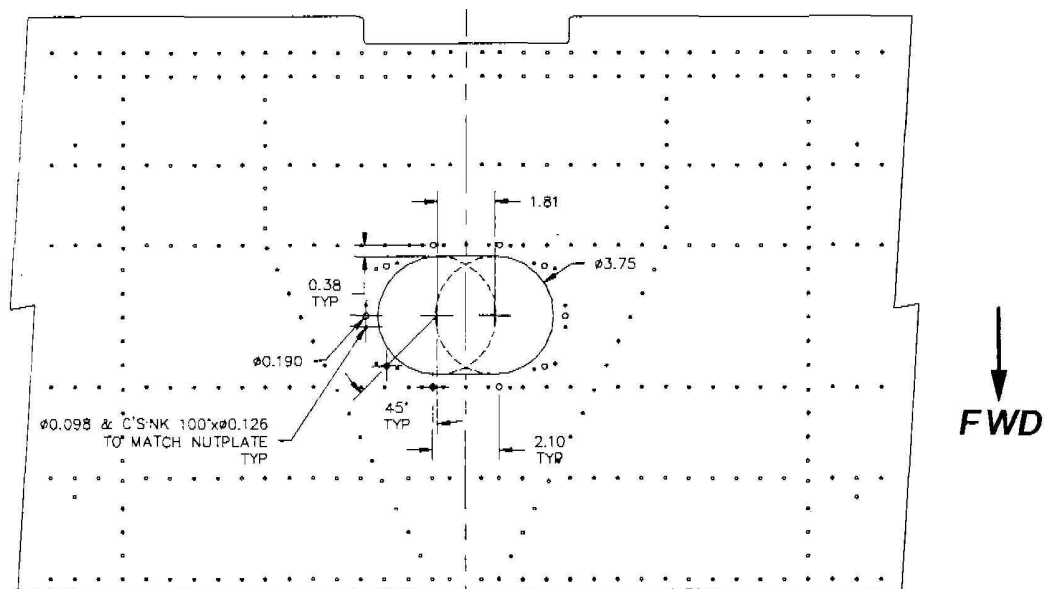
Figure 3 - Access hole

- (e) Visually inspect for cracking in the lower flange of the rear spar splice plate and in the inboard ribs around the Horizontal Stabiliser rear pivot attachment.

- (a) Remove the upper Horizontal Stabiliser fairings.
- (b) If the Horizontal Stabiliser contains a centreline upper skin access panel, remove the panel and skip to part (e).
- (c) Unscrew the lower Horizontal Stabiliser fairings. Disconnect the control cables from the Rudder and the pushrods from the Elevators. Remove Dorsal Fin and disconnect Fin electrical wiring. Remove the Rudder and then the Fin. Restrain the Elevators in the neutral position and carefully remove Horizontal Stabiliser/elevators assembly from the aircraft.
- (d) Cut an access hole as per the figure 3 below.
