Research Project EASA.2012/2

MASH - Metallurgical Assessment of Standard Hardware

European Aviation Safety Agency - Metallurgical Assessment of Standard Hardware, EASA reference E2.2012.C.02.

ES/13/49

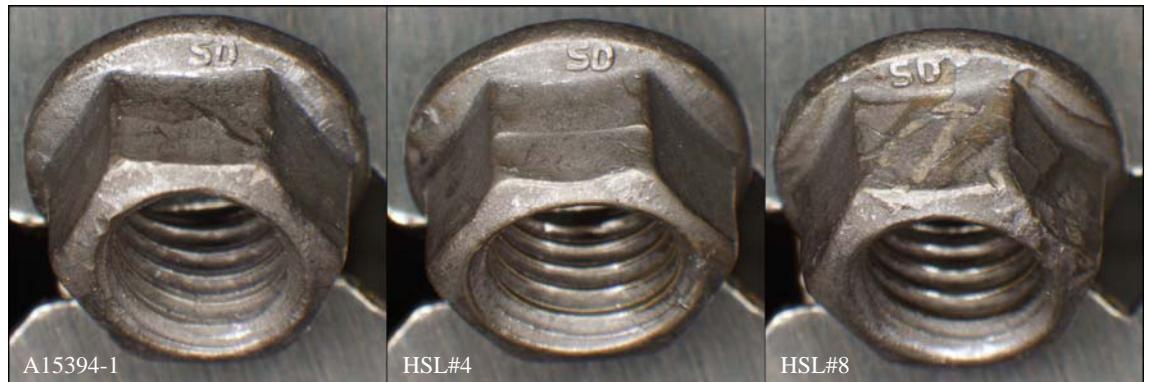
Figure 1. Typical examples of submitted items.

These examples include; one of the separated nuts, which had a gouge/deformation in the flange, see the right hand quadrant of A15394-1, a nut of relatively good appearance (HSL #4), and a nut with a poor quality appearance (HSL#8). The marks on the upper flat of #4 and the right hand flat of #8 are the physical manifestations of the crimping operation carried out to produce the deformation in the threadform that produces a self-locking action. Such distortion and tool marks are permitted although they "shall blend smoothly without abrupt change" according to the National Aerospace Standard NASM25027 (rev.1) "Nuts, self-locking, 250^oF, 450^oF, and 800^oF". This Standard is referenced in NAS1291 as the procurement specification for these nuts. Although there were some differences in the appearance of these marks across the batch of all eighteen nuts, in the author's opinion they all satisfied this requirement of the Standard.

Visually, all of the nuts were similar in appearance. What differences there were included: varying degrees of mechanical damage to the edges of the flange on individual nuts (nuts A15394 1-3 had noticeable examples of this damage), the appearance and depth of the marks left by the crimping of the top of the nut and the general appearance and evenness of the surface coating. Despite the variability of the crimp marks none of them appeared to be bad enough to discard the nuts on the grounds of the clause in the standard which stated that such marks "shall blend smoothly without abrupt change". On a subjective basis and from the author's experience, it was not thought that anything in the external appearance of the submitted nuts indicated that there would have been any problems with the functionality or fitness for purpose of any of the nuts.

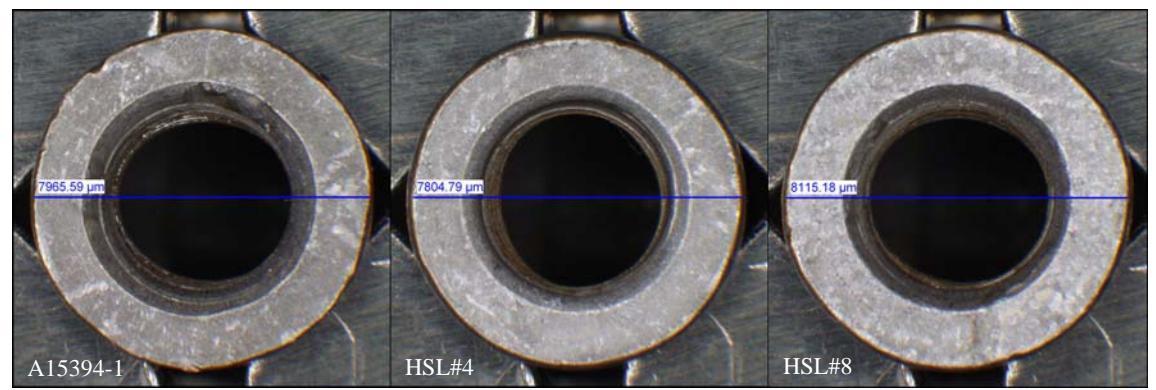
Figure 2. Bearing surfaces of example nuts.

Figure 2 shows the bearing surfaces of the same three nuts. The gouge/deformation in the flange of A15394-1 is clearly visible. All the flange edge damage seen on the eighteen nuts appeared to be mechanical damage resulting from external contact rather than defects arising from manufacture.

The un-scored condition of the bearing surfaces of all eighteen nuts indicated that none of them had been used.

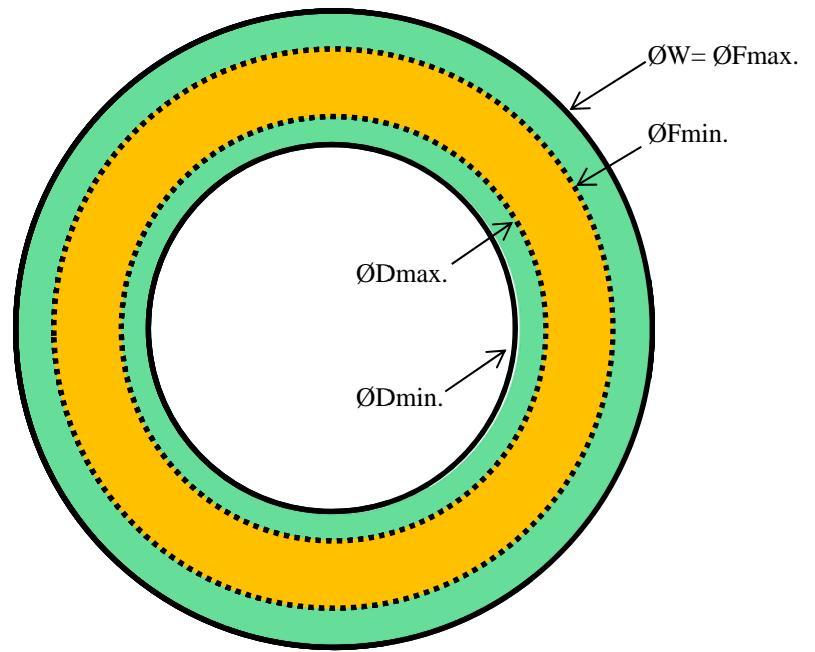
Figure 4. Range of bearing surface contact areas: (Green = maximum possible contact area, Orange = minimum acceptable contact area).

It can be seen from the red highlighted results that four of the submitted samples fail the dimensional requirements and another two only satisfy these requirements, with respect to the maximum value of diameter D (i.e. the inner diameter of the annular bearing surface), if measurement error is taken into account. It should be noted however, that despite this discrepancy the actual contact bearing areas of all the six samples are well within the wide range of contact bearing areas which can be calculated from the specified dimensions, see the area limits given in the final column of Table 1. The calculated annular bearing contact surface area in all cases (right hand column) was greater than the absolute minimum value that would have been permitted by the specified dimensions, i.e. 5.56mm², see Figure 4 below

Whilst it is acknowledged that these results take the six samples out of conformance with the specification, it is not thought that these minimal failings would have had any significant effect on the performance of the nuts or would have played any contributory role in producing the type of longitudinal cracking reported in other examples of these nuts. The results are a possible indication of a lack of quality control which is rigorous enough to detect such failings.

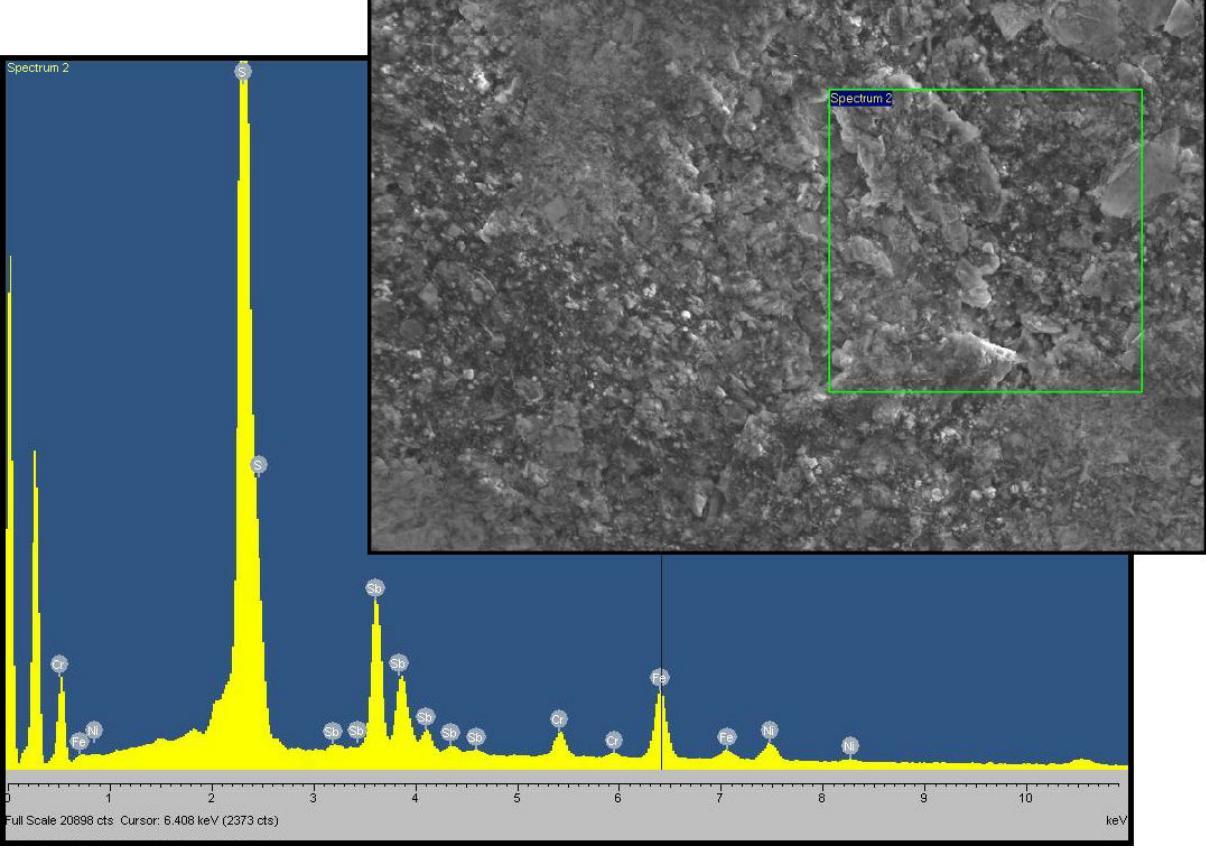
Figure 5. Surface image and analysis spectrum HSL#8.

This preliminary scanning electron microscopy and energy dispersive spectroscopy, carried out on nut HSL#8, found no indication of any cracking on the bearing surface or the upper parts of the nut, nor was there any indication of the presence of any cadmium plating. Figure 5 shows an image of the external surface of this nut with the EDS spectrum from the indicated area.

The surface was covered in sulphur rich particles (probably sulphates/sulphides). The origin of which was determined subsequently, see later in this Section. There was no indication of any cadmium plating anywhere on the surface of this nut.

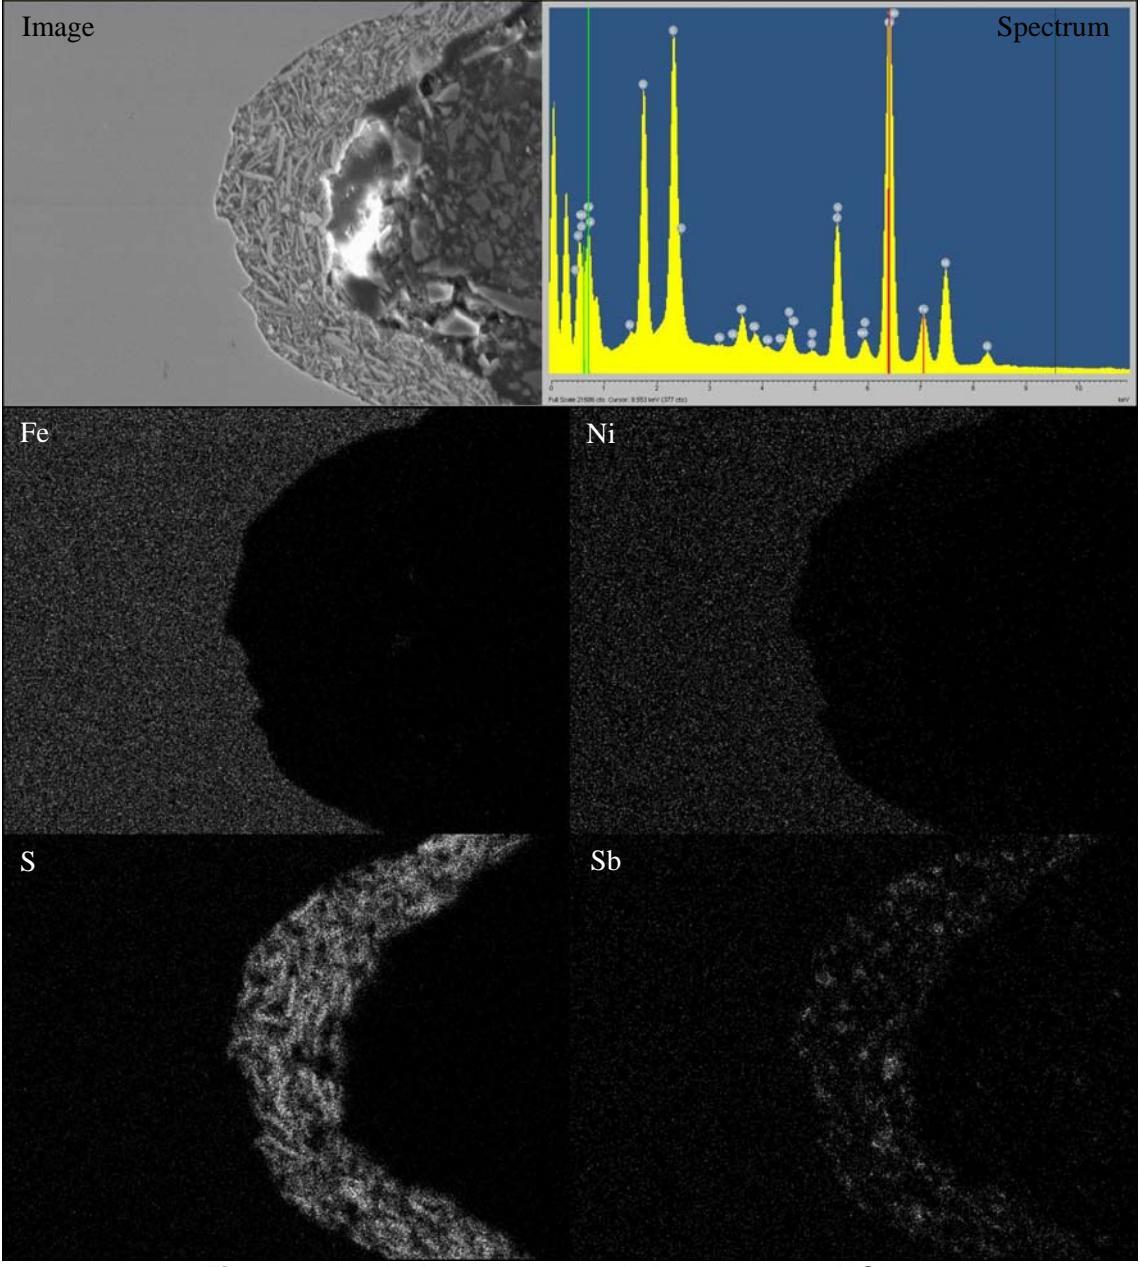
Figure 6. Analysis spectrum and element maps, HSL#7.

The EDS analysis suggests that there is a coating on the nuts which contains significant amounts of sulphur and measurable levels of antimony.

A relatively simple internet/www search revealed that the coating was most probably a bonded dry film lubricant coating comprised of molybdenum disulphide and antimony trioxide.

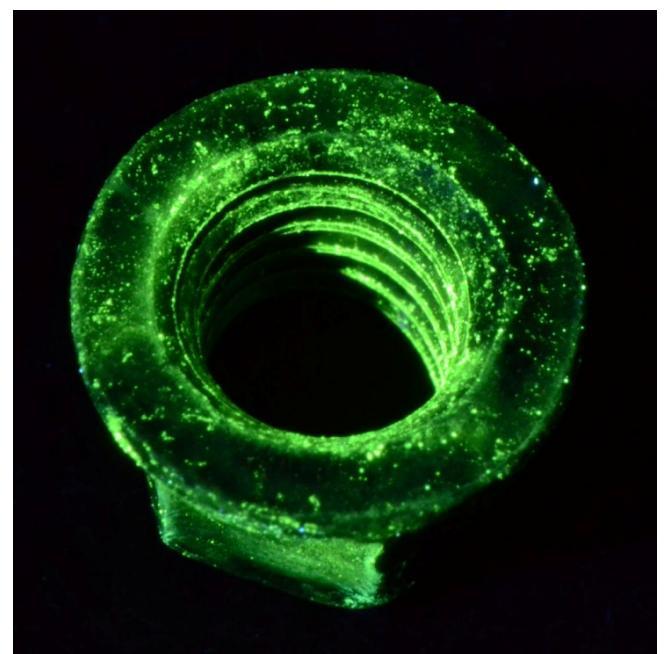
Figure 7. Nut A15394-1 UV light.

Figure 7, there were no obvious indications on this sample; it had been selected randomly for polishing to represent the A15394 group of three. No defects or cracking were revealed by the subsequent polishing and microscopical examination.

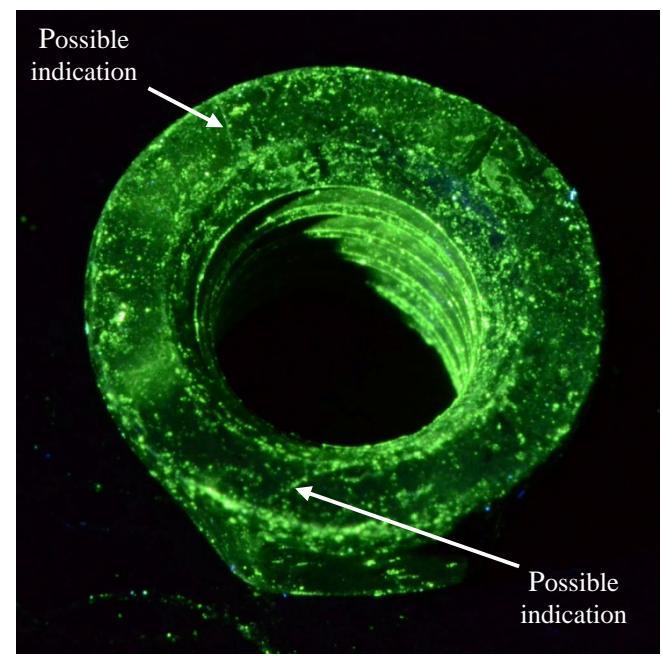
Figure 8. Nut #5 UV light.

Figure 8, there were some possible (tenuous) indications in the upper left quadrant and at the bottom of image. Polishing and microscopical examination subsequently revealed a very fine, shallow, circumferential manufacturing flaw over a 60° arc at the mid-width position on the flange bearing surface. This had not been revealed by the dye penetrant. No other defects or cracks were seen. The circumferential flaw has been attributed to the forming process for the nut flange. It is normal to (i.e. at 90° to) the longitudinal cracking that had been reported in other instances and therefore is thought to be of limited, if any, significance

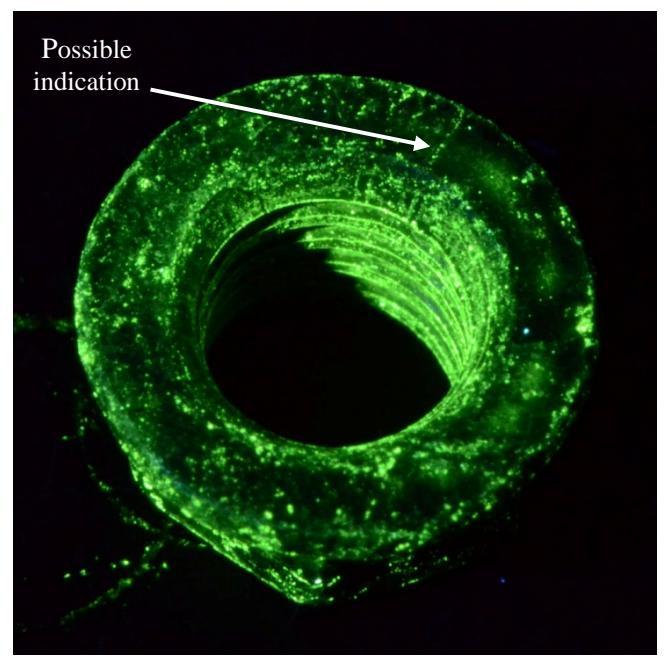
Figure 9. Nut #8 UV light.

Figure 9, there was a possible radial indication in upper right quadrant, also a diffuse circumferential indication at mid-width position on the flange bearing surface. After polishing the circumferential defect was found to be a manufacturing flaw as seen in #5, only more extensive (over $\sim 180^{\circ}$ of arc) and slightly deeper. This nut was mounted in resin and polished again; the extra polishing completely removed all traces of this flaw. No other defects or cracking were seen.

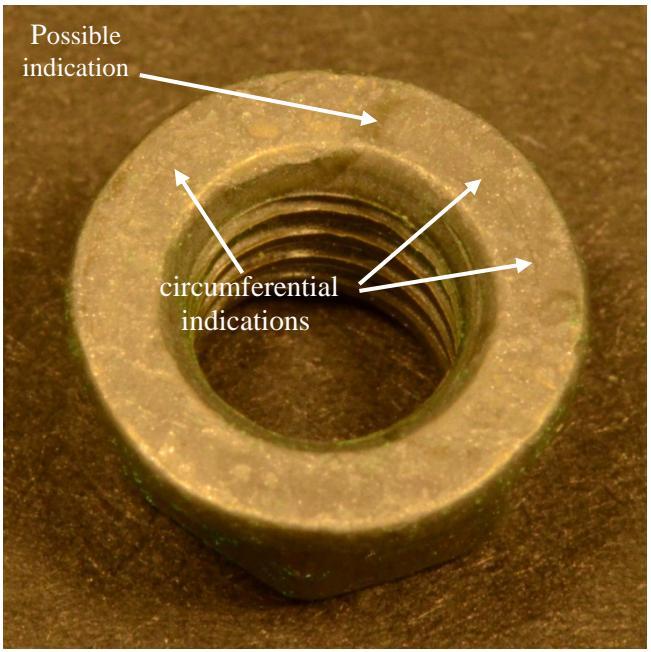
Figure 10. Nut #8 normal light.

Figure 10, in normal light the upper right defect can be seen to be a step in the coating. Some indications of the circumferential manufacturing flaw can be seen visually.

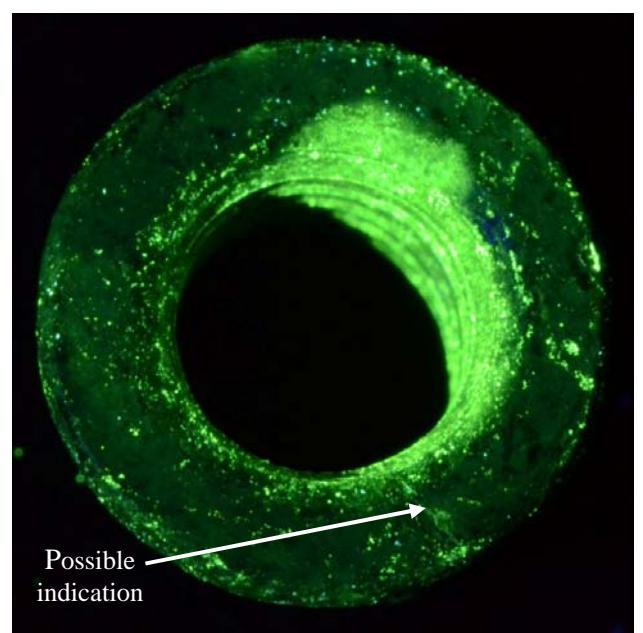
Figure 11. Nut #11 UV light.

Figure 11, there was one possible fine indication in the lower right quadrant, however polishing and microscopical examination revealed no defects or cracking. There was no circumferential manufacturing flaw on this sample.

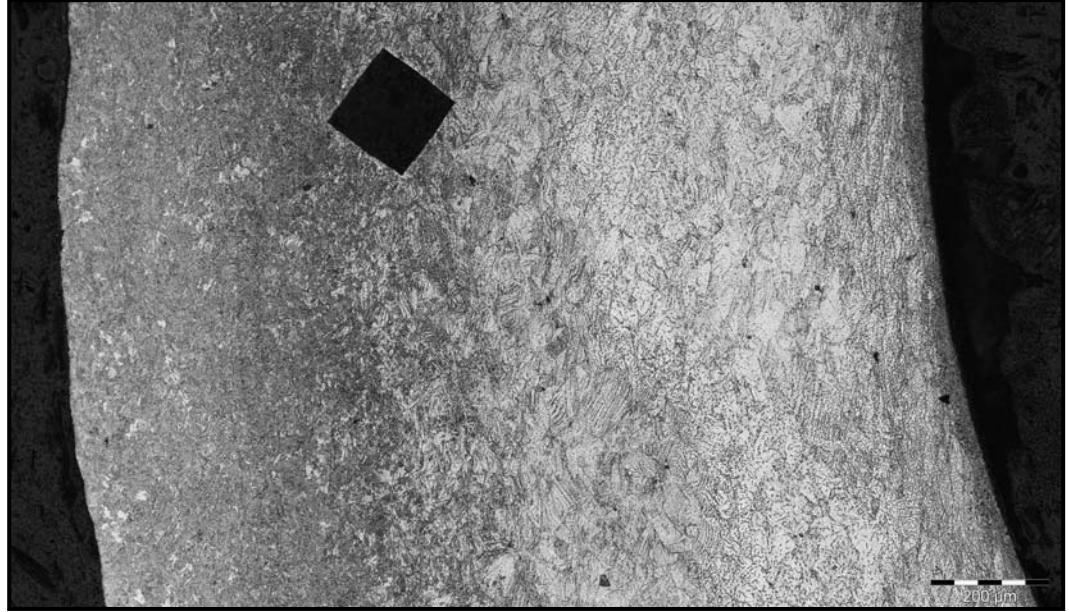
microscopically after etching in mixed acids (nitric, acetic and hydrochloric). This examination revealed that the structure consisted of deformed austenite containing variable levels of deformation twinning. Figure 15 shows the structure variation across the width of nut HSL#8. **Figure 15.** Structure variation across bearing surface of HSL#8.

It was apparent that the metal had undergone a greater degree of deformation toward the outer, flanged diameter, resulting in a higher concentration of deformation twinning. This would be expected as the flange would require more deformation during the forming process.

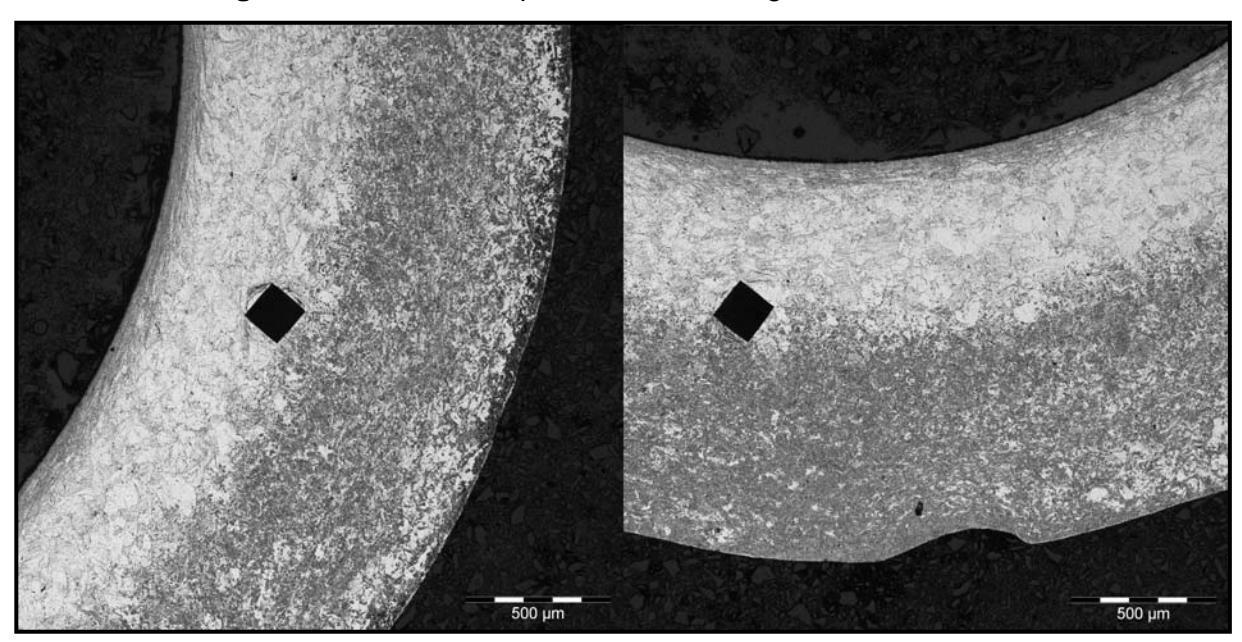
Figure 16. Hardness impressions in bearing surface of A15394.

Figure 15 shows a hardness impression wholly within the greatly deformed flange microstructure; Figure 16 shows impressions in the less deformed core metal and in the border between the two regions. This variation in the hardness locations would account, in itself, for the variations seen in the hardness values reported above.
