**SUBJECT** : **Position lighting system with protective tape in the lens – minimum intensities**

**REQUIREMENTS incl. Amdt.** : **CS 25.1389(b)(1)(2), 25.1391, 25.1393 at Amdt. 26**

**Equivalent Safety Finding to CS 25.1389(b)(1)(2), 25.1391 and 25.1393 at Amdt. 26**

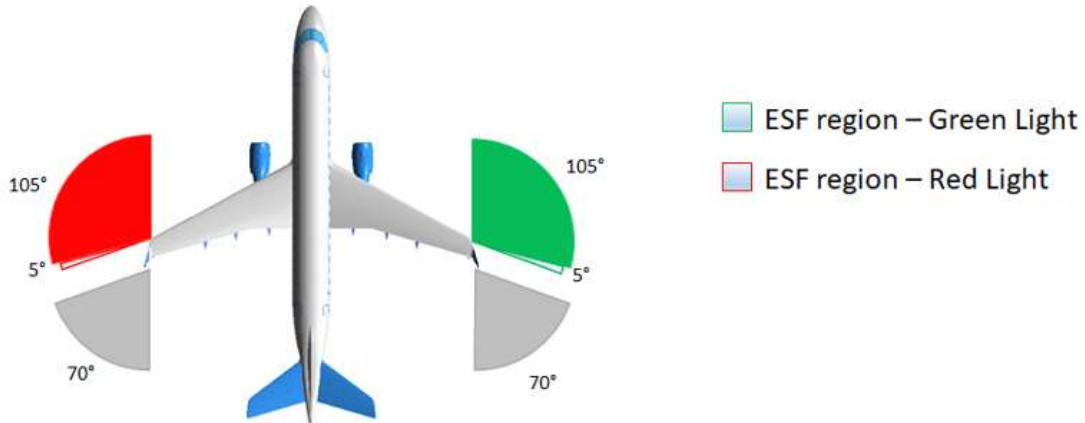
Figure 1: Position lighting system intensity coverage in normal operation

- Depending on the operating mode, the red and green lights of the position lighting system may be below the minimum intensity requirements at the extreme dihedral angles of 105 to 110 degrees, and in the area of 0 to 15 degrees up azimuth (see figure 1 in Appendix A).
- Only in the standby operating mode, the red light of the position lighting system may be below the minimum intensity requirements at the extreme dihedral angles of 15 to 20 degrees, and in the area of 0 to 5 degrees up azimuth (see figure 2 in Appendix A).

- a) The intensities at all other angles are well above the requirements.
- b) The shortcoming in the required intensity is less than one percent of the required area. It is compensated by the overall intensity provided over the rest of the coverage area. Moving up and down from the critical vertical angle at the same dihedral angle, the supplied light intensity is multiple times the minimum of the value required by the corresponding CS.

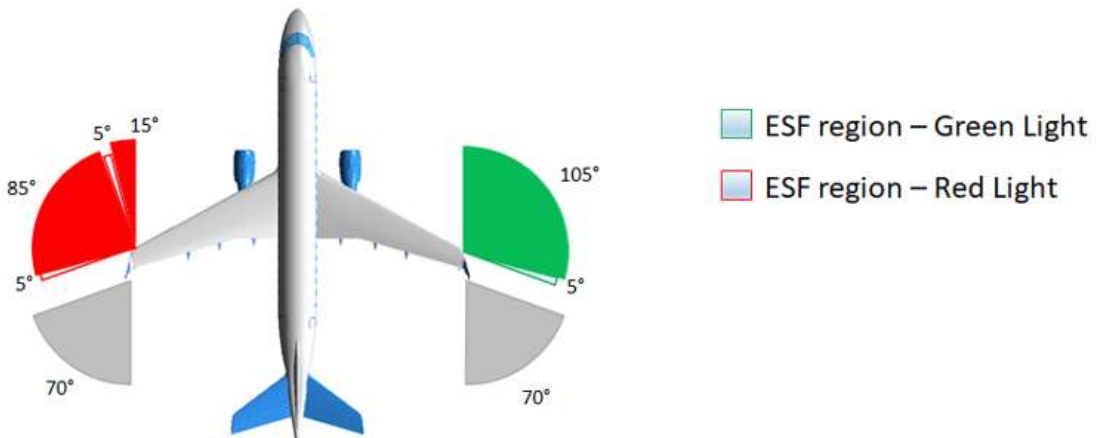
Figure 2: Position lighting system intensity coverage in stand by operation mode

- c) The shortcoming is limited to extreme dihedral angles, a very unlikely approach angle for a collision or it only occurs in a temporary failure scenario. Even if such an overtaking scenario did occur, the overtaking airplane will rapidly advance through the lower intensity area and into higher intensities further forward. The total angular range for which the minimum intensity requirements are not met is so narrow that it would be impossible for an overtaking aircraft to remain in that slot long enough that any issue of position light intensity would have an impact on the overtaking flight crew's ability to visually detect/identify the travelling direction and avoid the leading airplane.
