EASA
European Aviation Safety Agency

Final Report EASA_REP_RESEA_2008_2

Evaluation of Strength Degradation of Fabric Particularly Used for Cargo Nets

Service contract – EASA.2008.C11

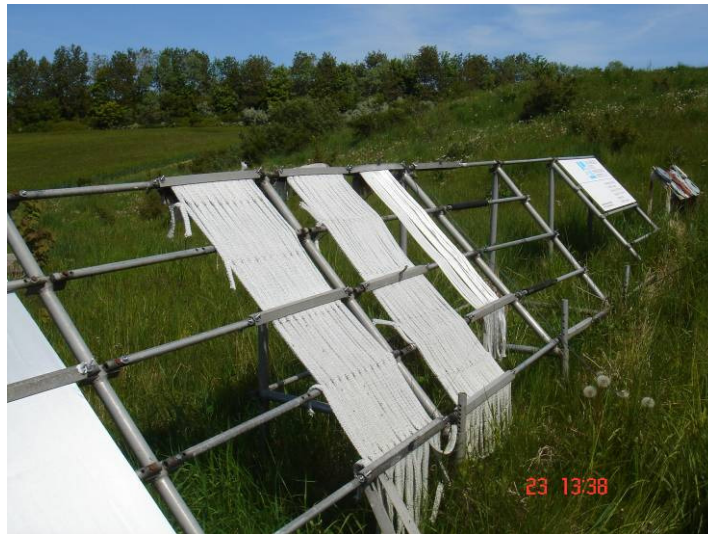
By using the natural exposure, test samples are stored outside for a certain defined time (e.g. in the centre of Europe) and physical parameters (e.g. Climate) are measured during exposure. The exposure time is divided in several parts (e.g. 6, 12, 18, 24 months). At the

end of the exposure the strength degradation is determined by tensile test or other test methods.

Figure 1: Natural exposure area of STFI e.V. – Kap Arkona, Germany

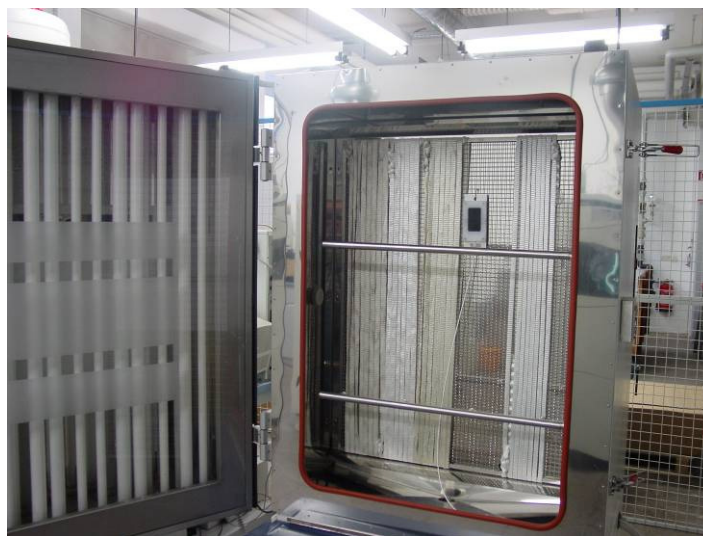
Figure 2: UV-Chamber at STFI – simulation of climate

For the artificial weathering special equipment is necessary. This equipment simulates only typical climatic parameters.

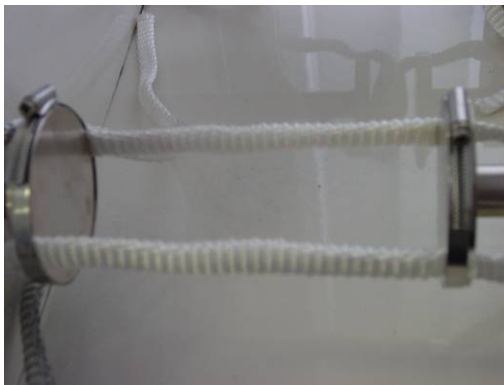
Figure 8: Crushing and torsion test – basic position (STFI e.V.) [11]

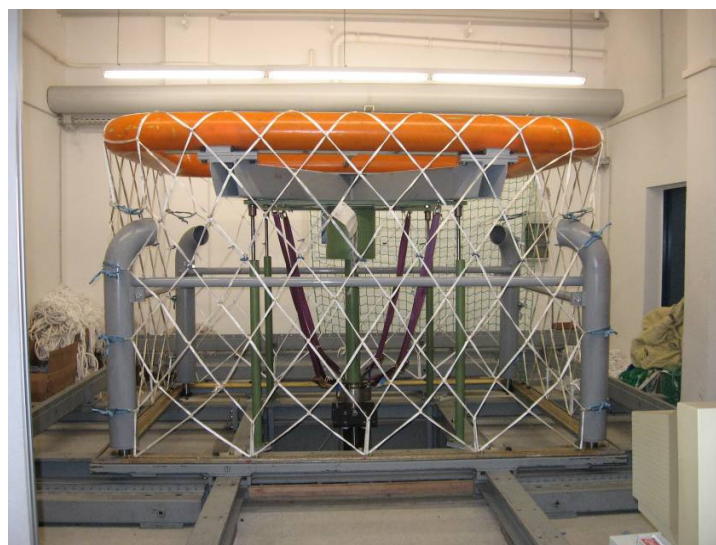
Figure 12: Test set-up for air cargo nets (size 96"x125"x118") at STFI e.V., (full scale test)

Advantages of this full scale test set-up are that all single parts of the net and the interaction of all ropes (braids) will be considered while testing. Also the influence of corner cords (lashing lines) and reefing hooks for shortening have to be considered. The STFI test method does address another essential issue, the interface net to pallet. For attaching the net to the pallet proper fastening elements (double studs) are used to achieve representative load transfer between net and pallet.

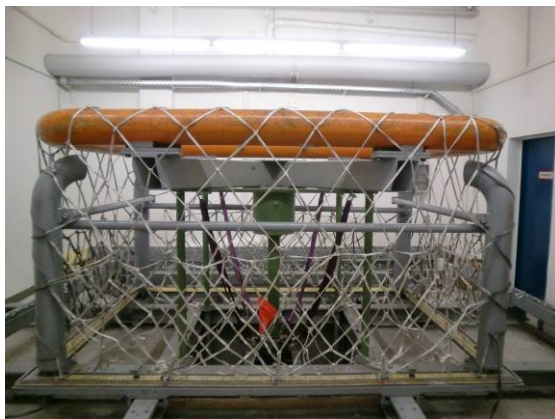
Figure 21: Net 3 years old

The category of different service life time of the nets was chosen to see the influence of the age of the net (new, 1 year, 2 years, 3 years). Each net is labelled with the date of manufacturer (DOM). For this project the service life time of a net was defined as from DOM up to storage in STFI. But it happened that e.g. a 1 year old net did appear to be more used than a 3 years old net (see figures 21, 22).

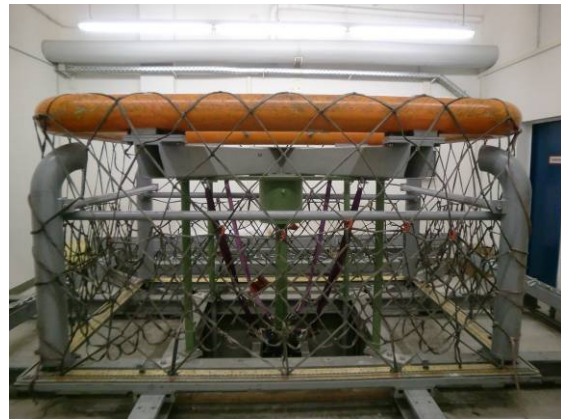
Figure 22: Net 1 year old

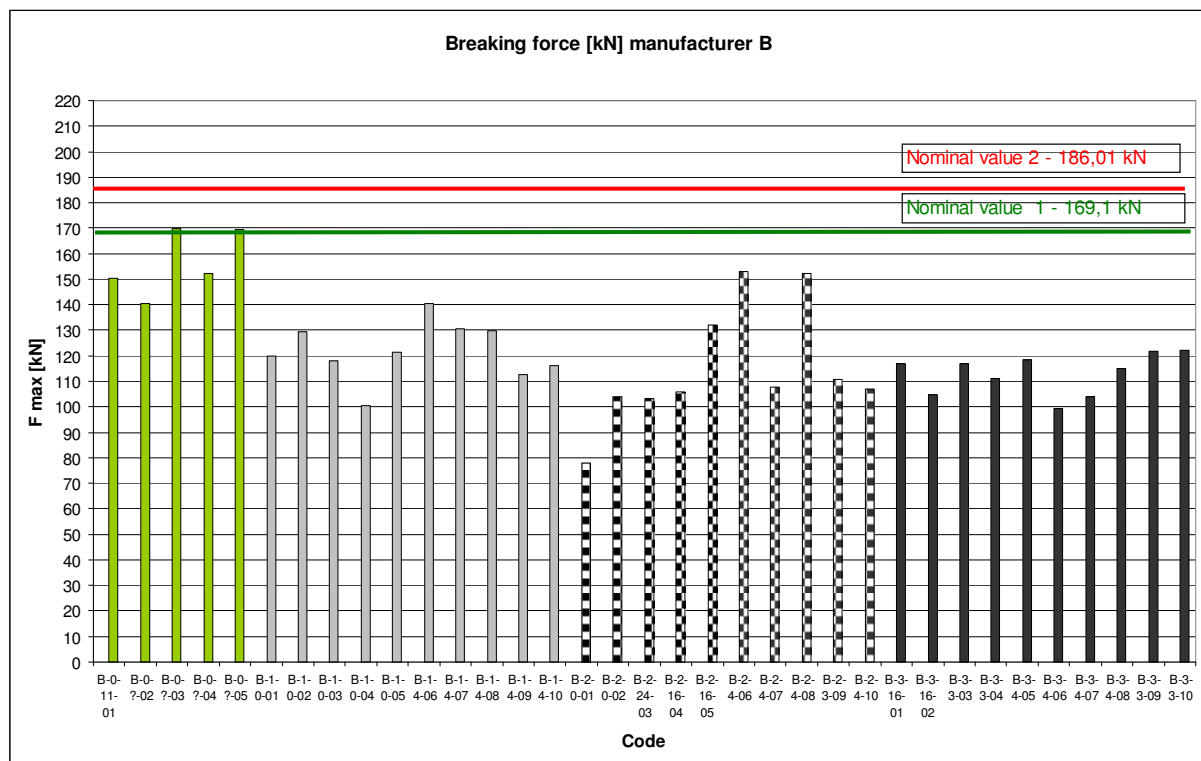
Figure 29: Test results of manufacturer B

The nets of manufacturer B are mostly with the highest weight. The results could be better if other (and more) hooks were used (see category H). Often the failure mode was hook rupture or net break near at hook.

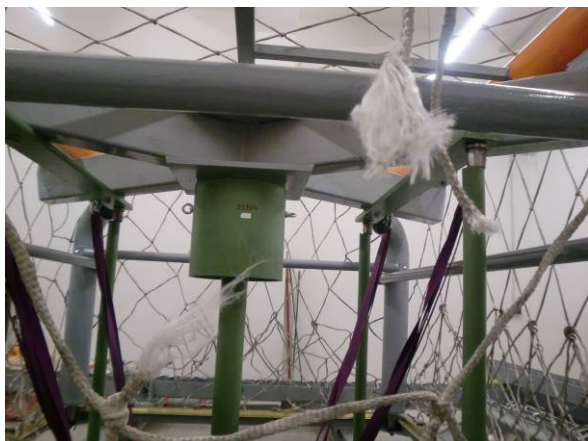
Typical net break

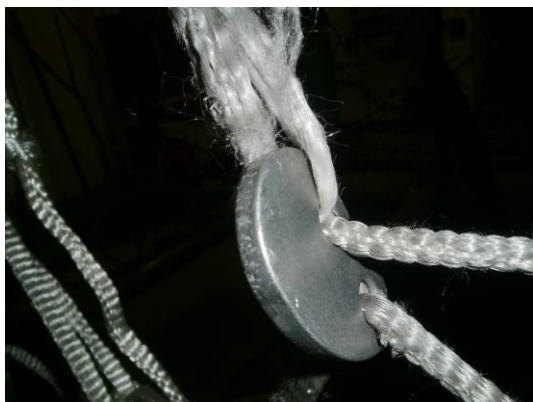
Influence of the hook

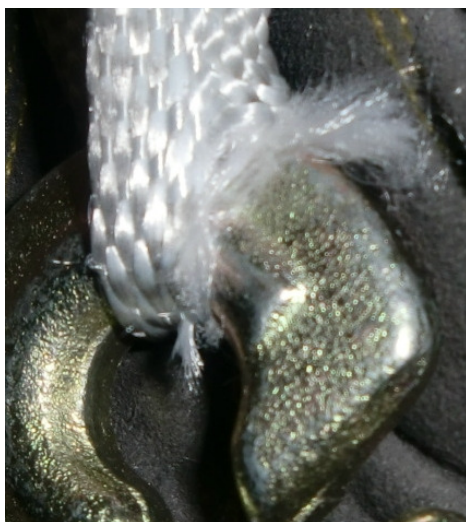
Cut by hook

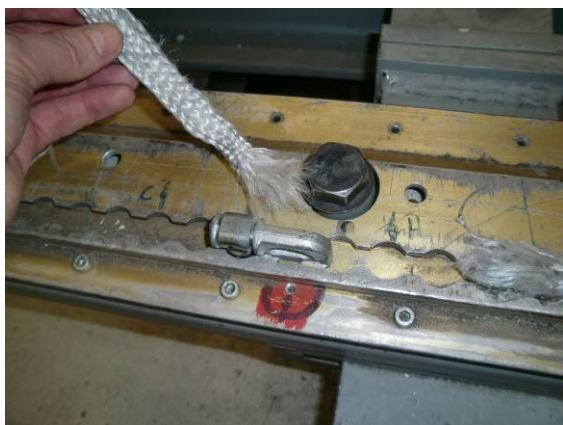
Failure on stud

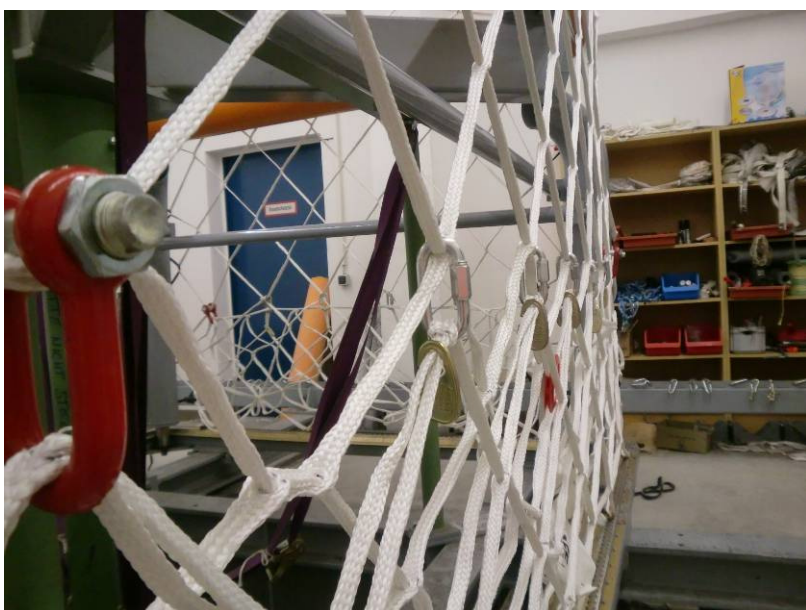
Hooks replaced by shackle (category H)

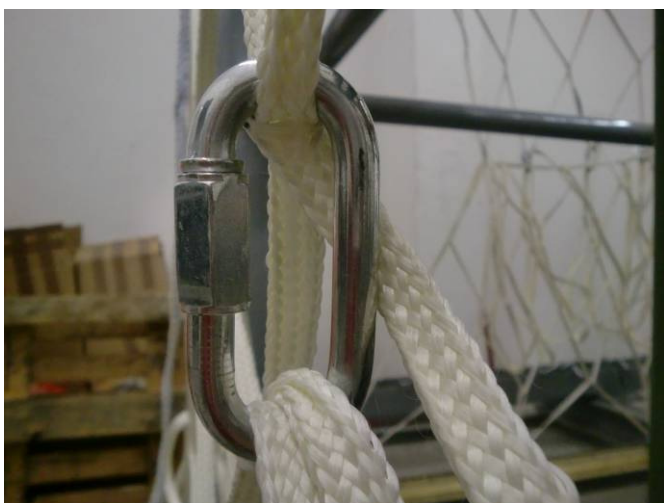
Sample of use of shackle (category H)

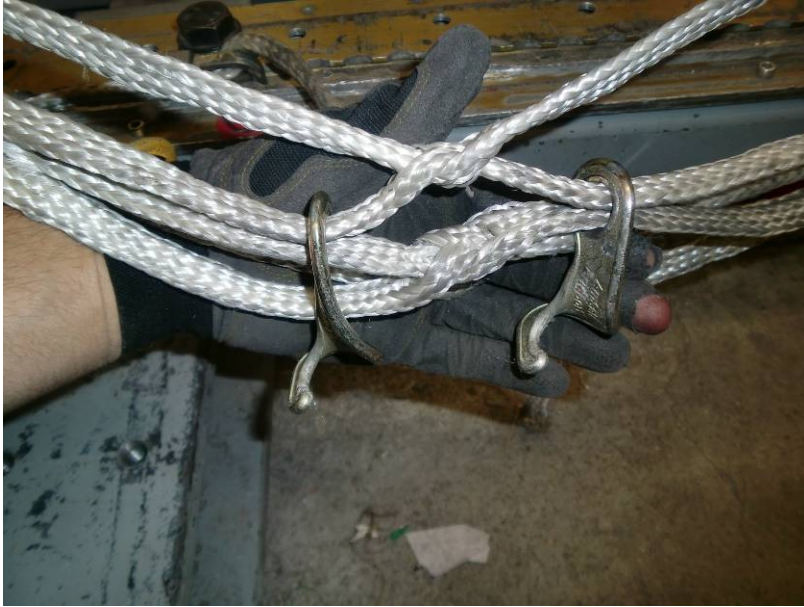
Hooks - bent open

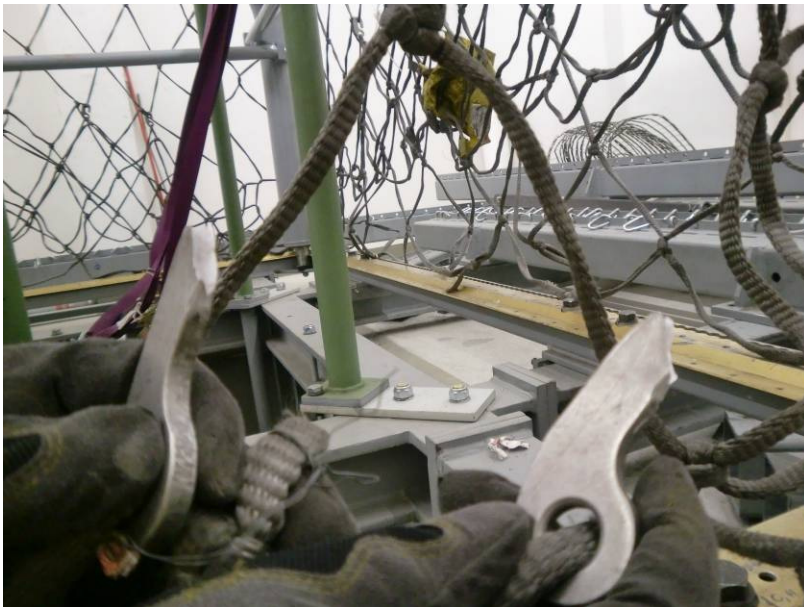
Hook rupture
