Investigation of a UAS Fly-away over The Hague

Investigation outcomes and experiences

Dutch Safety Board

9 May 2023

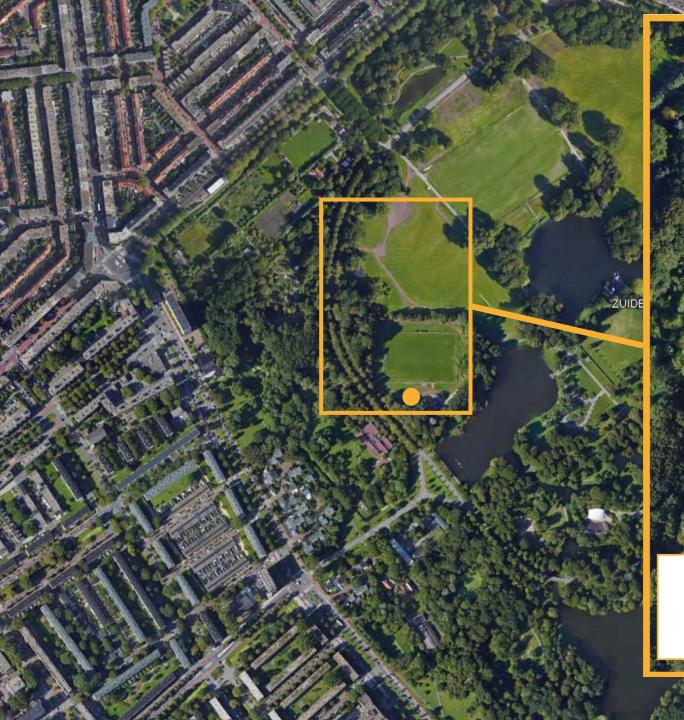
Loss of connection with RC

RTH mode activated

Loss of control

Take-off and crew location

Compass and IMU errors in log

Wind 110° 2 m/s

RTH mode activated on UAV

UAV crashed

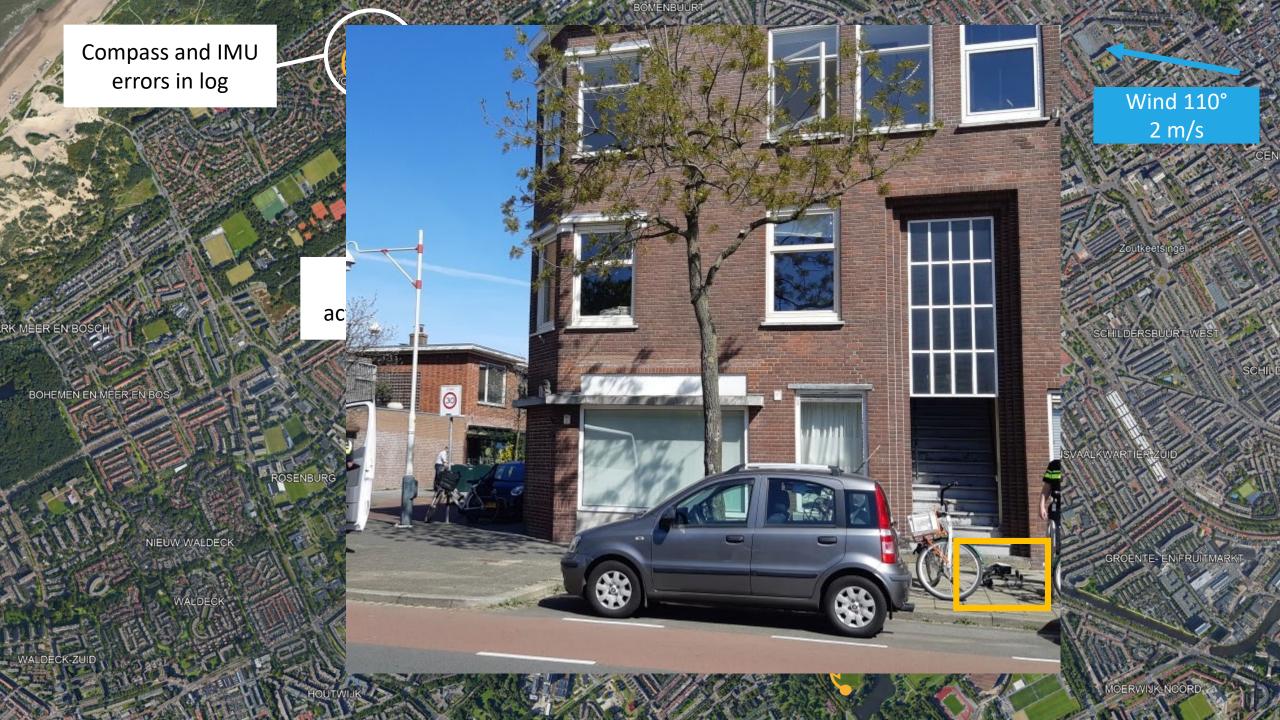
- Flight logs indicate offset yaw angle (IMU) and compass angle
- Different (third party) payload used during previous flight, no calibration performed after change (spoiler: complies with guidelines)
 - Fly-away simulated during flight tests performed by operator
- Pilot did not receive any warning from software, flight status GREEN/READY TO GO
