Annex B Full Scale Test Results

CONTRACT NUMBER:	EASA.2020.C02
CONTRACTOR / AUTHOR:	DART Aerospace
IPR OWNER:	European Union Aviation Safety Agency
DISTRIBUTION:	Public

The primary objective of the test is to verify the results of the buoyancy analysis performed on the HEFS and to validate the performance characteristics of a prototype HEFS concept. The following test conditions were performed to make a direct comparison with the buoyancy analysis: Fully capsized no damage float bags, fully capsized main EFS float bag damaged, and fully capsized HEFS float bag damaged. Additionally, a partial capsized side floating attitude condition was evaluated to validate a stable floating attitude in this orientation.

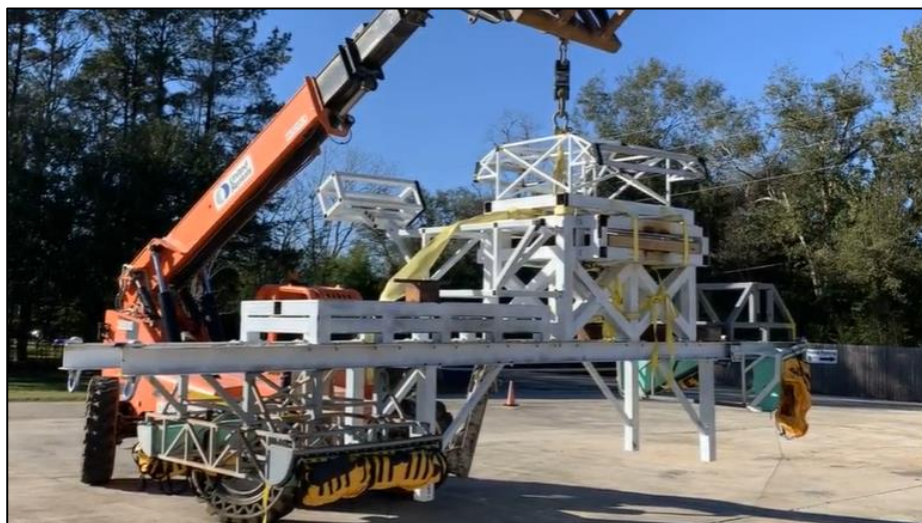
The test fixture used for conducting this test is illustrated in Figure 1 and Figure 2. Both the primary EFS and prototype HEFS were mounted directly to the fixture. The fixture was constructed from welded steel tubing and was designed to be representative of the AW139 helicopter which includes a removable mock hoist, to observe the HEFS interacting with the hoist during capsizing. Prior to the test, the test fixture was ballasted to achieve as close as practical to the buoyancy model's center of mass (CofM) and total weight.

Figure 2 Test Fixture

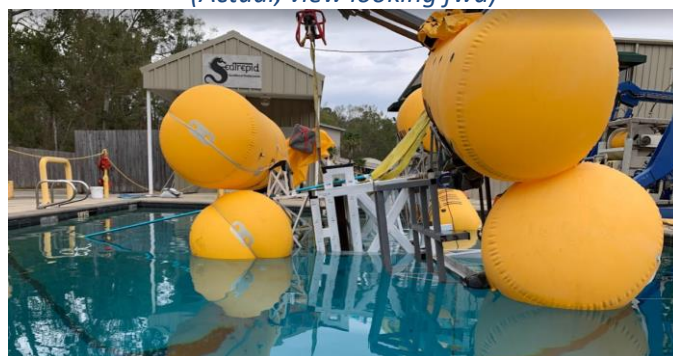
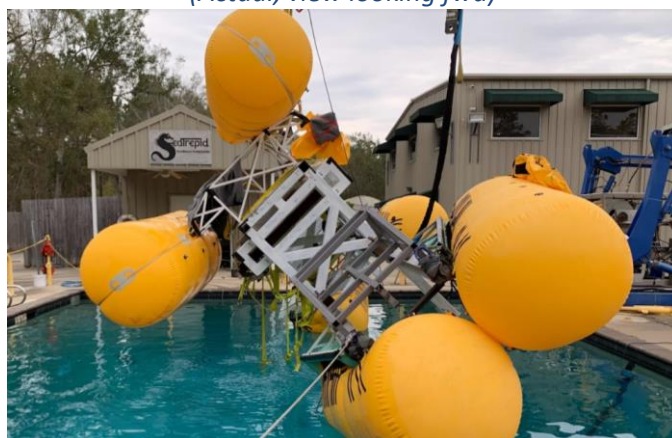
The objective of this test was to assess the dynamic stability and roll direction of the test fixture when influenced by forced perturbations (external loads). The test fixture was incrementally raised from the partially capsized attitude by means of a strap secured to the top of the fixture to varying perturbation roll angles. Once the desired roll angle was achieved the fixture was quickly released using a helicopter remote cargo hook. A total of five forced perturbation tests were sequentially conducted from a starting / drop attitude of -97° roll (11° of roll to stable floating position) all the way to -45° roll (63° of roll to stable floating position) as illustrated in Figure 10a/b/c/d/e.

*Figure 10a Forced Perturbation Test 1
(Actual, view looking fwd)*

*Figure 10b Forced Perturbation Test 2
(Actual, view looking fwd)*

*Figure 10c Forced Perturbation Test 3
(Actual, view looking fwd)*

*Figure 10d Forced Perturbation Test 4
(Actual, view looking fwd)*

*Figure 10e Forced Perturbation Test 5
(Actual, view looking fwd)*
