The Myth of Losing Tail Rotor Effectiveness

EASA Rotorcraft & VTOL Symposium 2019

A.M Dequin
10-11 December 2019

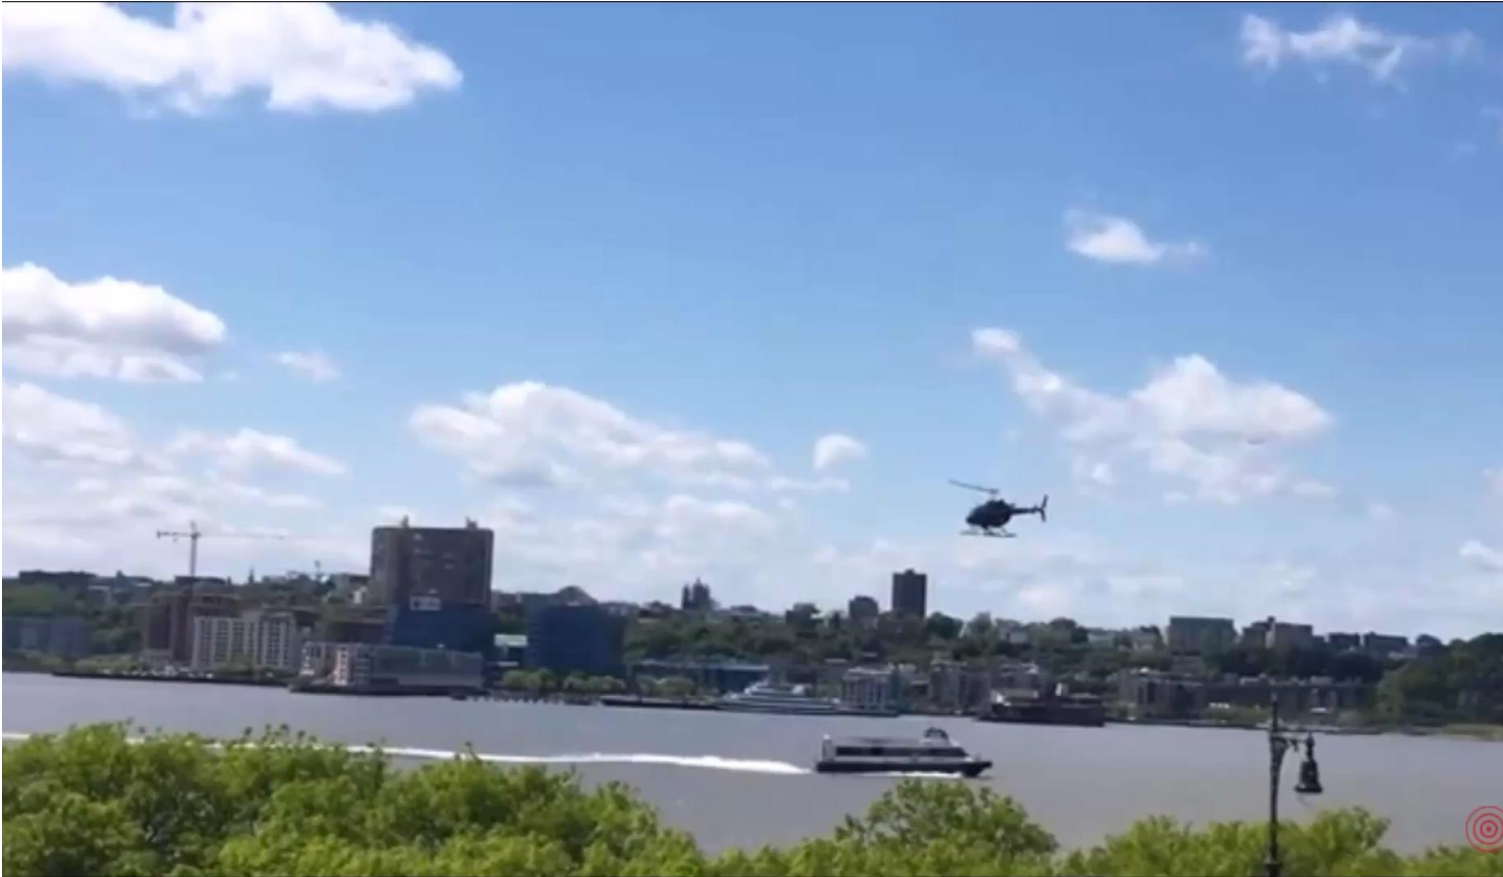
A Typical Unanticipated Yaw Accident

- ❑ A single rotor helicopter apparently yaws by its own accord, against the will of the pilot
- ❑ The pilot suspects that pedal is ineffective and does not succeed to stop the helicopter spinning
- ❑ The helicopter is landed with significant yaw rate, usually inducing significant damage
- ❑ Investigations show that the helicopter was fully operative
- ❑ Unanticipated Yaw is often designated as “Loss of Tail rotor Effectiveness” (LTE)

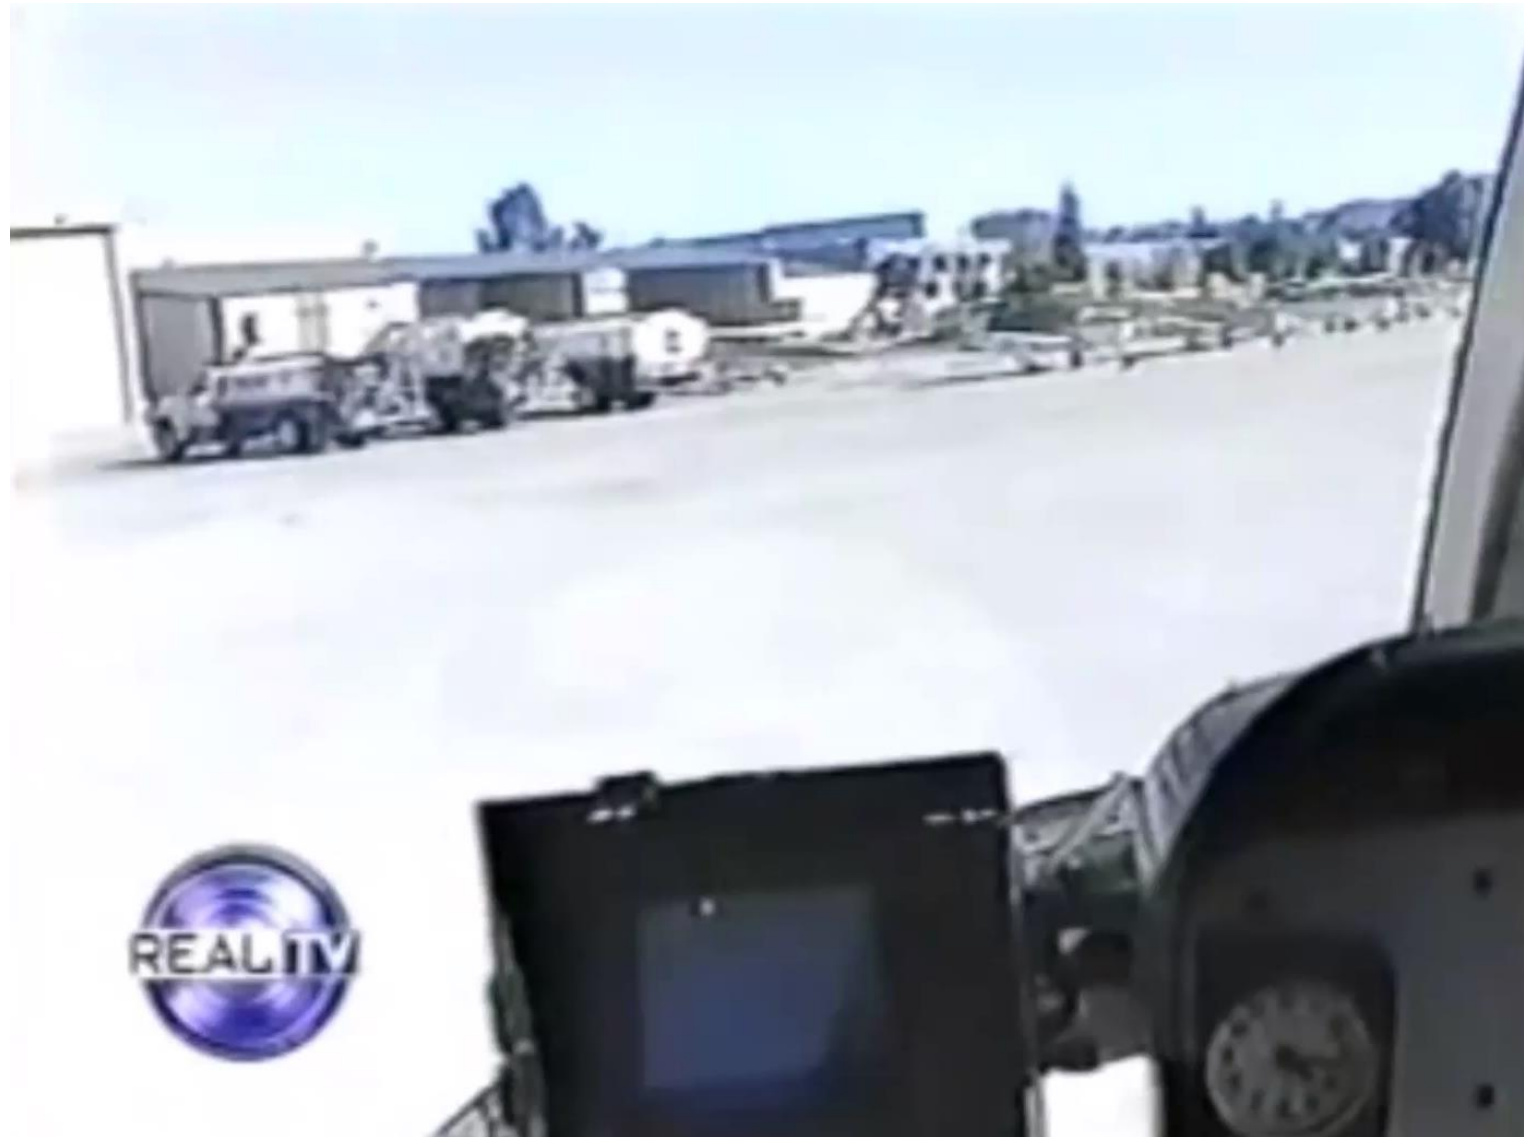
A specific case

When performance limited

- Close to performance limitations, the whole available power may already be spent in steady trim conditions
- Increasing the tail rotor pitch makes the tail rotor power increase. This means at best an over-torque and at worse — when the engine cannot provide the additional power — a rpm droop.

- This might be diverging unless some margin is available (height for example)
- When performance limited, it is of prime importance to avoid entering into unanticipated yaw. A close monitoring of the heading is mandatory. Using sideslip to minimize tail rotor power in those conditions, which might seem a safe approach, strongly increases the unanticipated yaw risk.
