EASA
European Aviation Safety Agency

Final Report EASA_REP_RESEA_2012_6

Vibration Health or Alternative Monitoring Technologies for Helicopters

Final Report

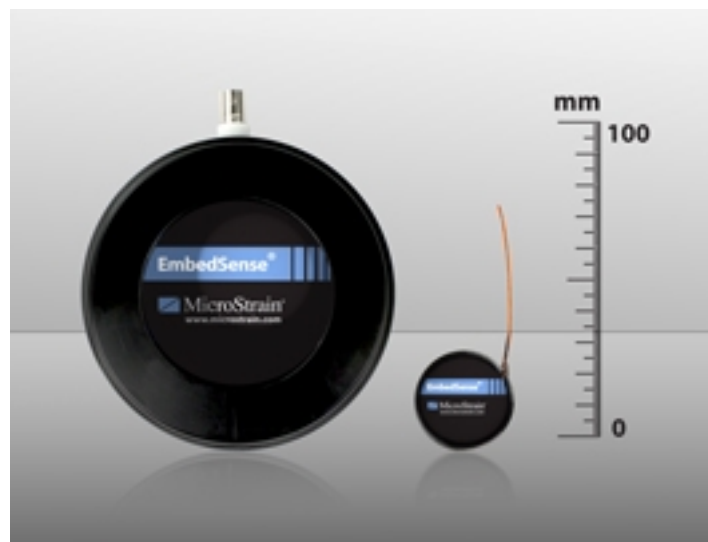
MicroStrain produce a sensor called the EmbedSense wireless sensor (see Figure 11).

Figure 11. MicroStrain EmbedSense wireless sensor

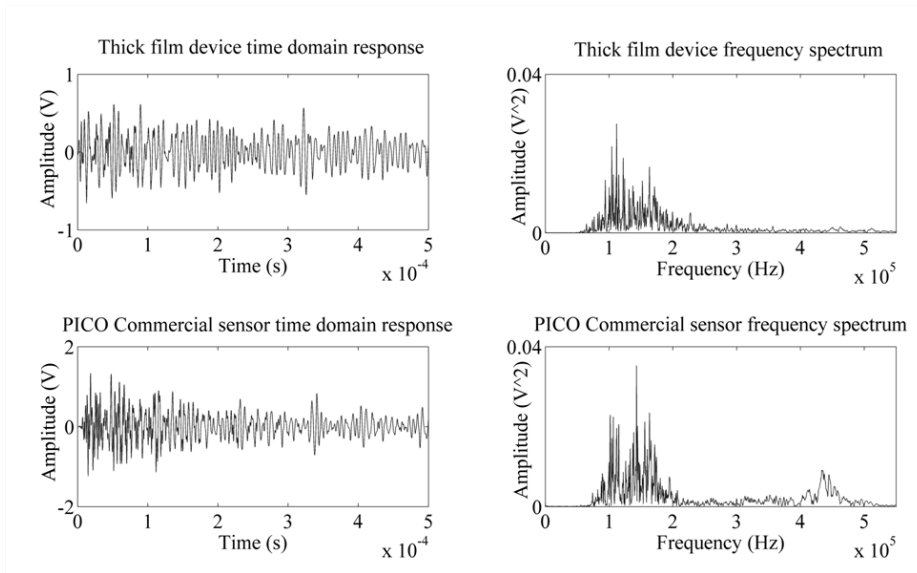
Figure 28. Comparison of thick film AE sensor with commercial sensor from [119]

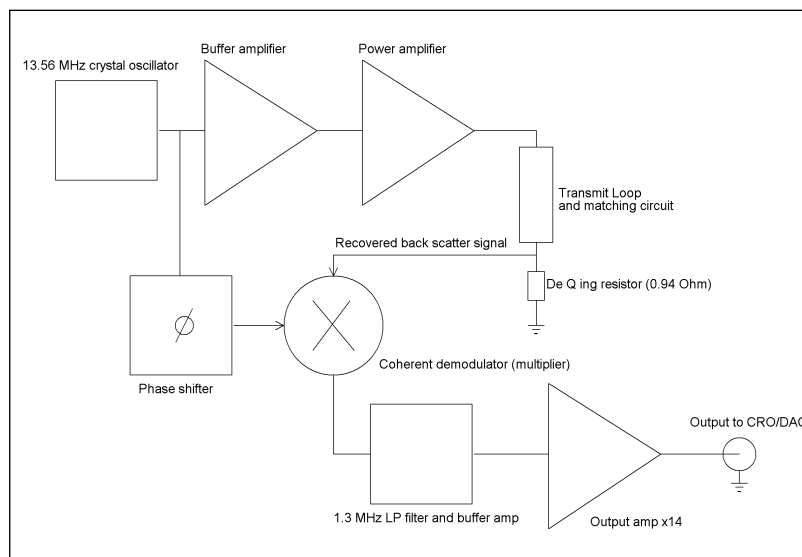
A homodyne receiver operating at 13.56 MHz was constructed, using magnetic coupling loops. The dc power for the sensor conditioning circuit is obtained by rectification of the illuminating field. The signal from the sensor is buffered and modulates the backscatter of the rotating coil. A coherent demodulator in the fixed part of the system recovers the baseband signal which can be fed to data acquisition. Figure 50 and Figure 51 below show the block diagrams for the fixed part (illuminator) and the rotating part (sensor):

Figure 50. Fixed part (illuminator)

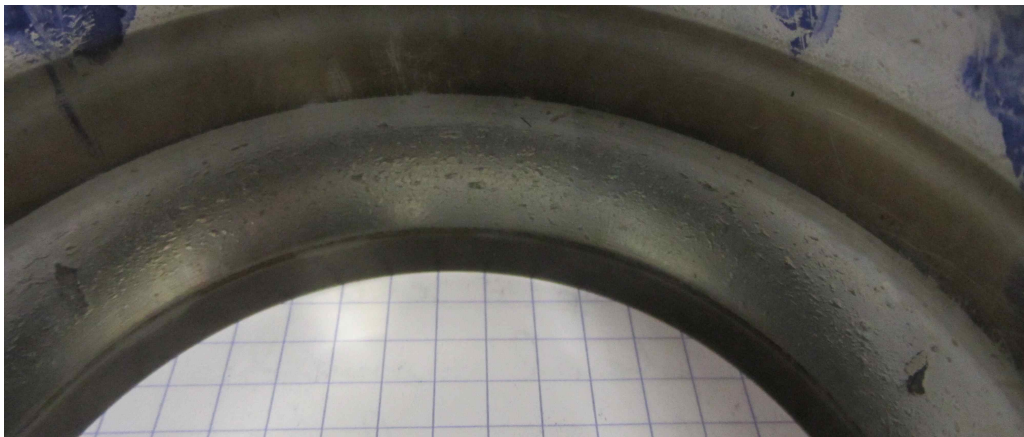
Figure 65. Existing outer race damage

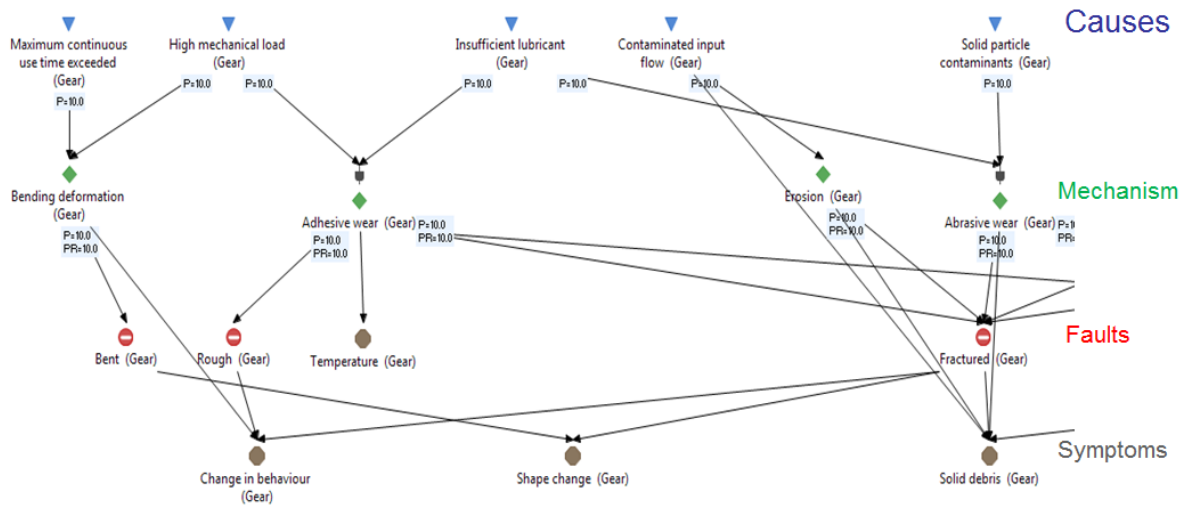
After the function is defined for each component, the next step is to define the failure path and link failure to the function of each component. The failure diagram consists of four levels: Causes, Mechanisms, Faults, and Symptoms. The faults are connected to the part/system/component function depending on the type of fault. For example, some faults only cause failure of the parts function and the component continues to perform its function. An example of a failure diagram for one gear part is shown in Figure A4.9 below.

Figure A4.9 - Failure diagram
