Research Project EASA.2010/5

SEBED - Seat belt degradation

**EASA.2010.C21/
EASA.E2.2011.C11
SEBED
(Phases I and II)
Seat Belt Degradation**

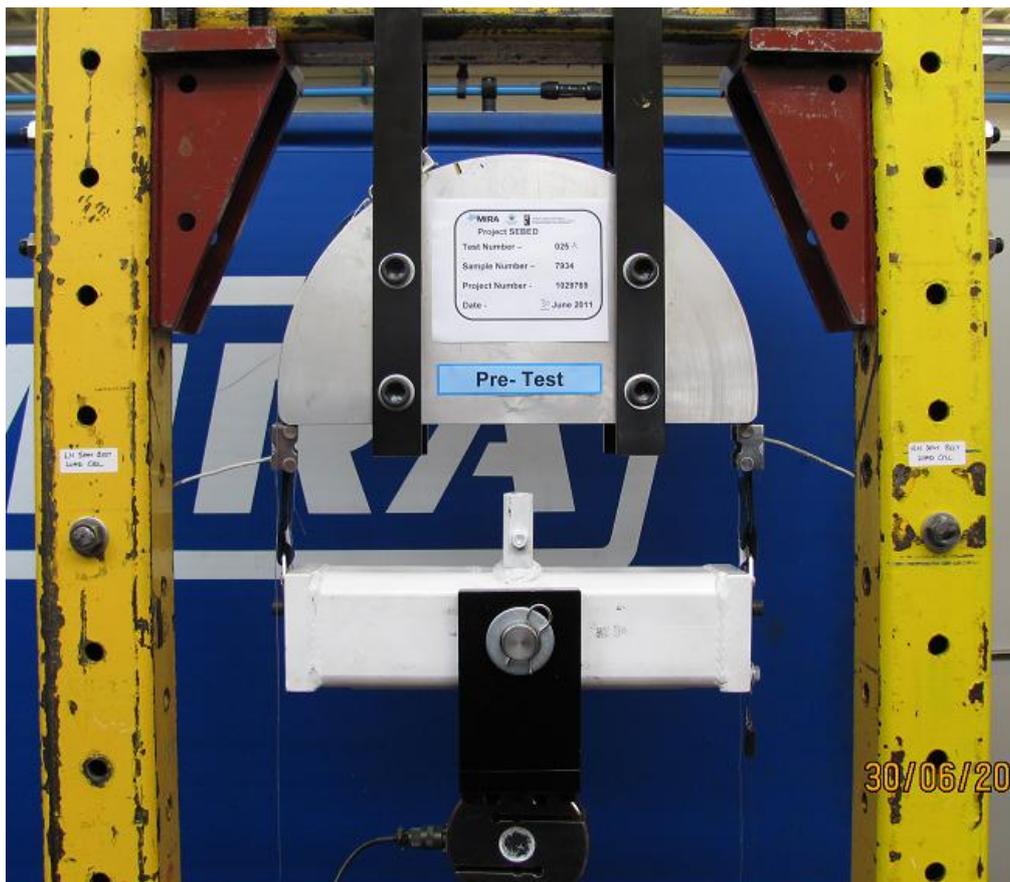
Full details of the test set-up, instrumentation and sample loading procedure are given in Appendix B.1. A test frame was constructed as shown in Figure 3, fully instrumented to allow measurement of the applied load via the ram load cell, belt loads on each side using seatbelt loadcells and the elongation of the belt, both total and on each side. A more detailed photograph showing the instrumentation can be seen in Appendix B.

Figure 3. Photograph of the Test Set-up showing Pelvis Block, Seat Belt Attachments and Balance Beam

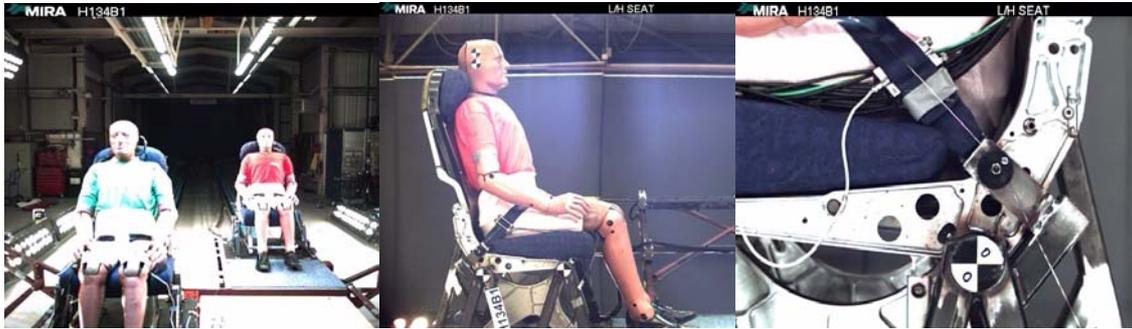
Figure 5. High speed video stills

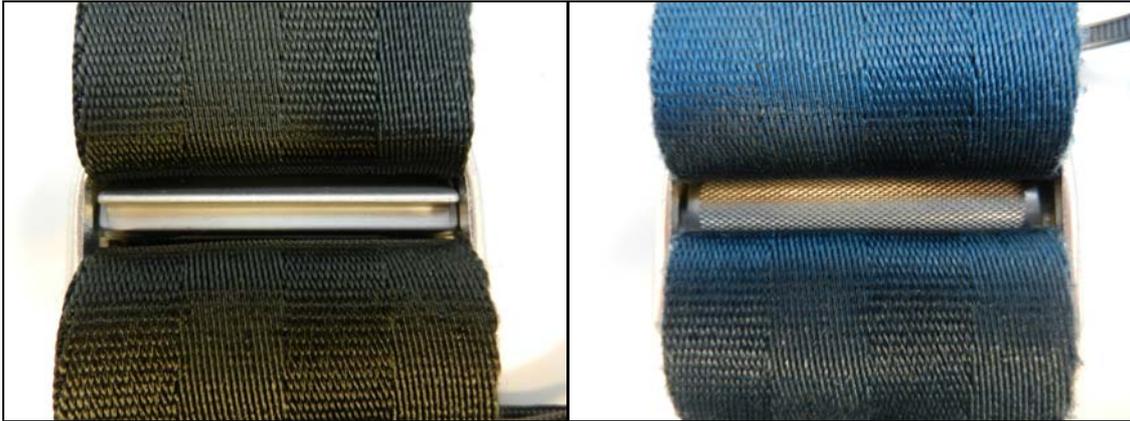
Slippage of the webbing through the buckle caused considerable damage to the used belts and damaged the new nylon belts to a lesser extent, but no such damage was caused to the new polyester belts. This may indicate that polyester webbing has a lower coefficient of friction than nylon webbing.

Figure 14 a) Stepped profile buckle slide bar (left) and b) knurled cylindrical slide bar (right)

Slippage of the webbing through the buckles of the belts was observed during static testing and it was found that those belts which exhibited large amounts of slippage all had buckles of the same design. Buckles with a smooth surfaced, stepped profile slider bar allowed slippage to occur in some cases. Buckles with a knurled, cylindrical slider bar showed little or no slippage.
