Diamond DA 42 training accident Unintentionally entering into spinn - presentation on weight / balance issue during flight training operations

Inspector of Accidents Tor Nørstegård NSIA, Norway

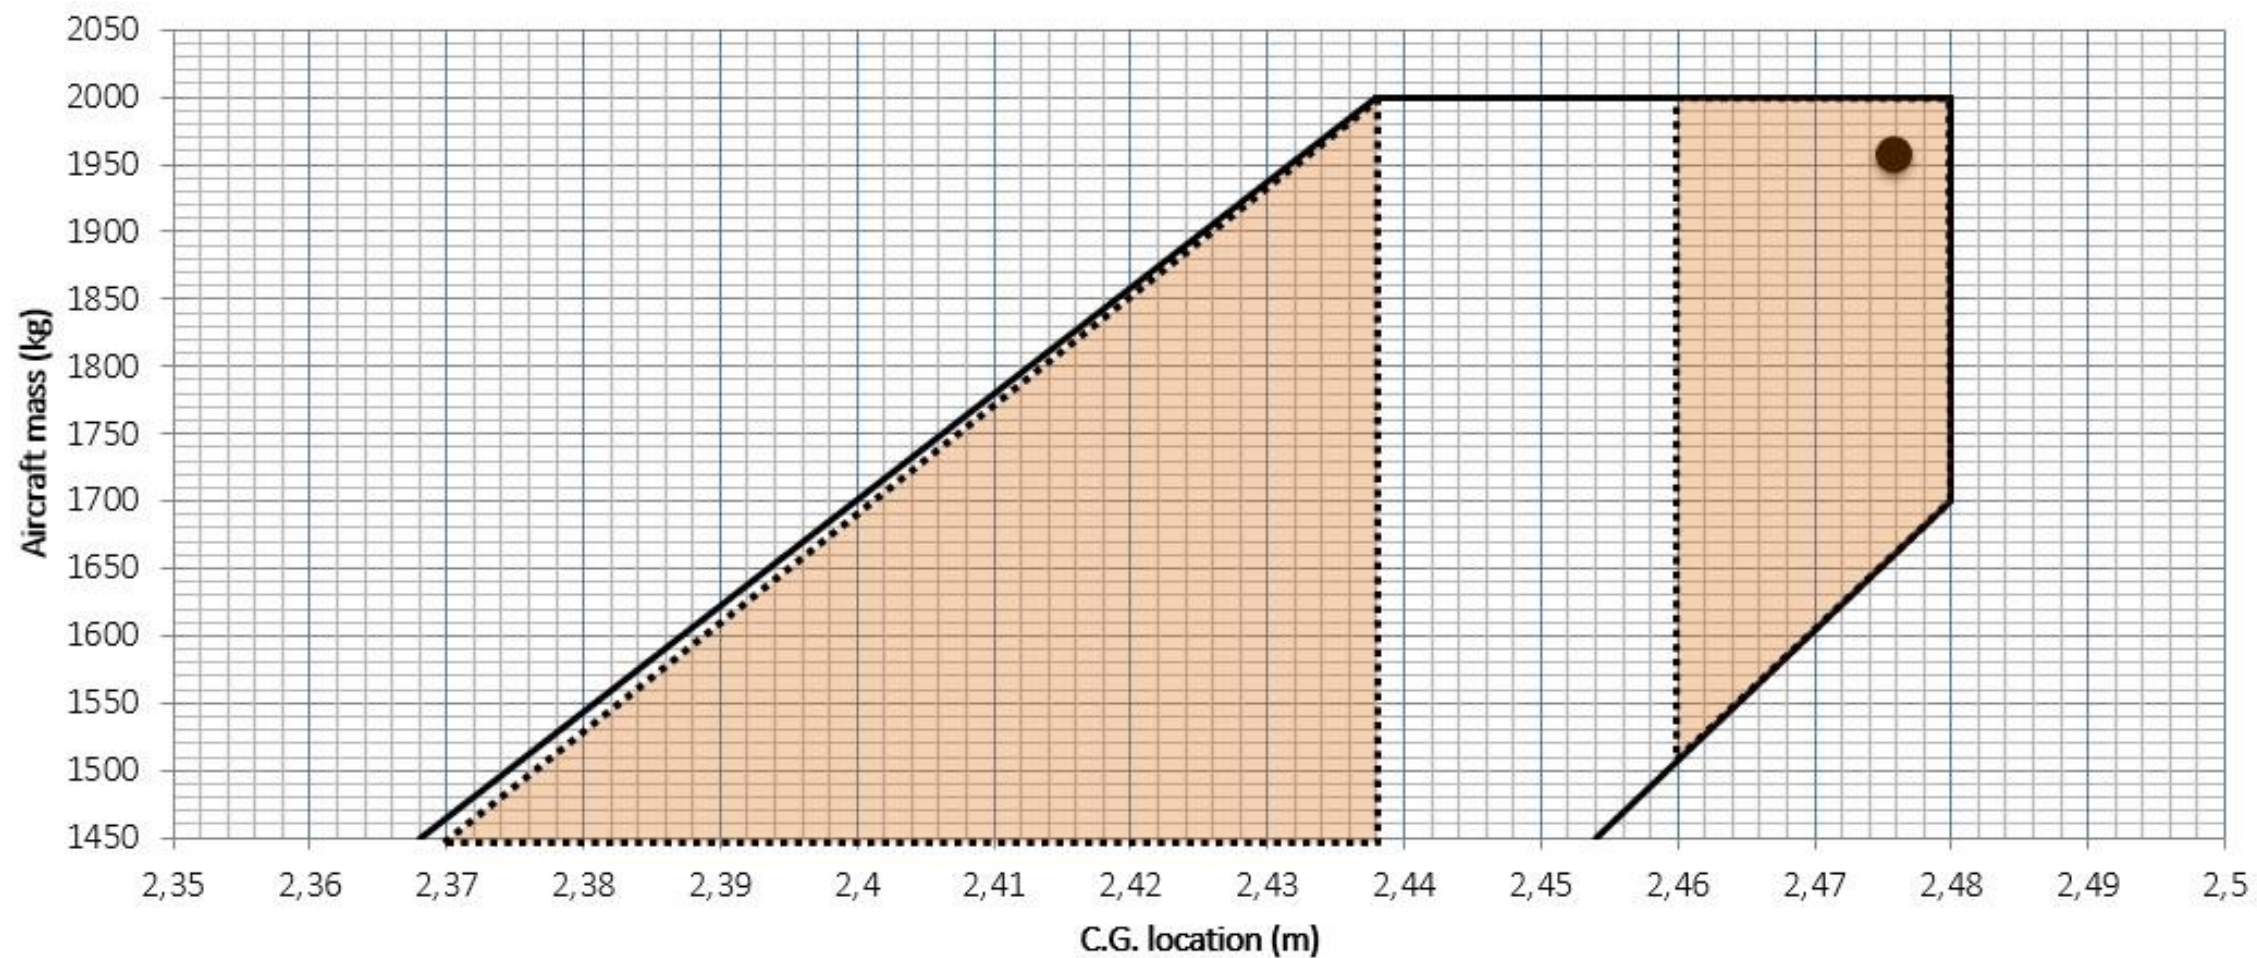
- The wreckage showed heavy damage and it has not been possible to determine what caused loss of control of the airplane based on examinations of the wreckage parts.
- No signs of unsafe maneuvering or reckless behavior.
- The Diamond DA 42 NG is sensitive regarding load distribution. The content of anti-icing fluid in the noes compartment tank greatly affects the balance. A single flight bag positioned in the passenger seat, or in the aft luggage compartment can make a great difference.
- There are no requirements for multi-engine airplanes in the normal category (CS-23) to be certified for spins.
- Demonstration of spin characteristics is only required for single-engine airplanes.
- Spins are generally trickier to handle with an aft CG.
