Integrity improvement of rotorcraft main gear box

REPORT NUMBER:	D1-1
REPORT CLASSIFICATION:	UNCLASSIFIED
DATE:	14 January 2022
KNOWLEDGE AREA(S):	Research, rotorcraft MGB, configuration and component design
DESCRIPTOR(S):	Potential weaknesses, single point of failure, failure flow analysis
CUSTOMER:	European Aviation Safety Agency
CONTRACT NUMBER:	EASA.2019.C15
OWNER:	European Aviation Safety Agency
DISTRIBUTION:	Limited
CLASSIFICATION OF TITLE:	UNCLASSIFIED
Author(s):	W. Riesen, S. Hilleke

EVALUATE AND DEFINE ROTOR AND ROTOR DRIVE SYSTEM DESIGN
OPTIONS TO PREVENT SINGLE POINTS OF CATASTROPHIC FAILURE

Review of the state-of-the-art rotorcraft gearbox configurations and component designs

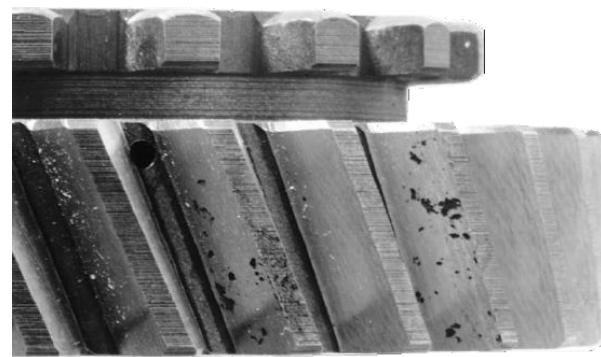
General corrosion is indicated by rust scours on the surface, which may be caused by the ingress of water, by condensation forming under unfavourable operating conditions, or by oil ageing in such quantities that the lubricant cannot provide protection for the steel surfaces, as well as by storage conditions. Figure 19 shows corrosion spots on a helical gear and on a raceway. Figure 20 show chemical attacked bearing raceway, Figure 21 gives an example on a light corrosion.

Figure 19: General corrosion [16]

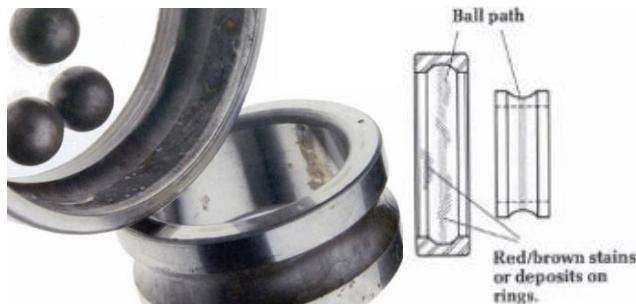
Figure 20: Corrosion results from a chemical attack on the metal by hostile fluids or atmospheres [14]

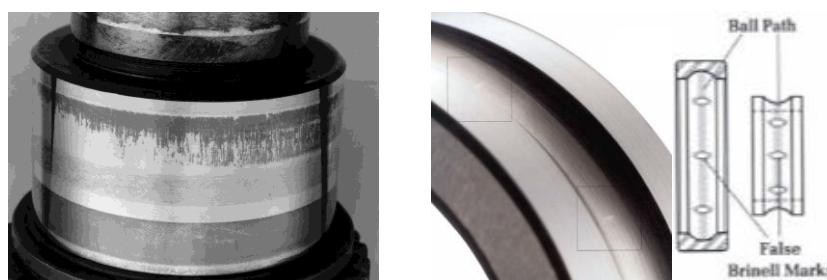
Figure 22 (left) shows friction corrosion produced by the micro movement of contacting metal surfaces, which transmit force without rolling motion and lead to local oxides of varied structures, microscopic metal particles, and decomposition products from oils and their additives, which accelerate the wear process.

False brinelling as shown on a bearing in Figure 22 (right) can be categorized as a type of friction corrosion, which indicates excessive external vibration.

Figure 22: Friction induced corrosion [16] and false brinell marks are bright and surrounded by debris [14]

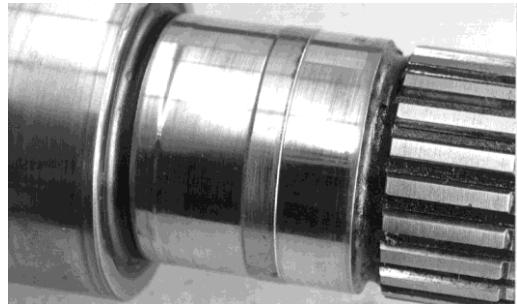
Figure 24 shows tribological oxidation, also referred to as infinitely brinelled surface, which occurs as a result of fretting corrosion in the shaft bearing races (gear/shaft) and takes the form of uniform radial wear (gear wear) by several vibrations.

Figure 24: Highly polished race surface by tribological oxidation [16]

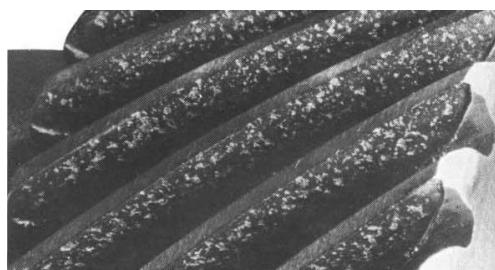
This is a deterioration of the surface due to chemical action, as shown in Figure 25, and is often caused by active ingredients in the lubricating oil such as acid, moisture and extreme-pressure additives. The oil breaks down so that corrosive chemicals present in the oil attack contacting surfaces. Often this affects the grain boundaries, causing fine pitting more or less uniformly over the tooth surfaces. At high temperatures, extreme-pressure additives sometimes from very active corrosive agents.

Figure 25: Example: Corrosive wear on gear tooth [13]

Lubricants can also become contaminated from absorption of foreign material from external sources. In such cases, the gear unit should be isolated from its environment. Because they are chemically active, lubricants with high anti-scoring, anti-wear additive content must be kept under careful observation to ensure that they are not attacking working surfaces, which should be managed by regular inspection of the gearbox.

At times, surfaces can be affected chemically during processing in the factory, e.g. when copper plate is stripped from the gear after carburizing or when nital-etch is used to detect grinding burns. Proper processing procedures must be set up and carefully followed. [13]

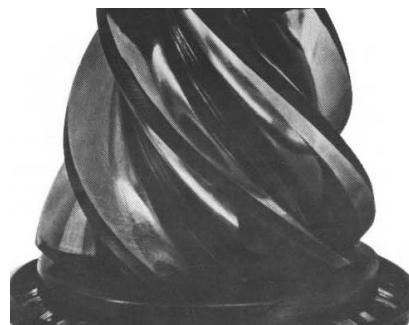
Polishing is a very slow wearing-in process in which the asperities of the contacting surfaces are gradually worn off until a very fine and smooth surface develops. This condition is usually caused by metal-to-metal contact during operation and generally occurs on slow-speed applications where the elastic-hydrodynamic lubrication film is not sufficiently thick and operation is near the boundary-lubrication range.

Figure 28: Example: Polishing wear [13]

Since it usually provides for good conformity of surfaces, often this condition need not be avoided unless the design life of the equipment is much longer than the predicted wear life due to polishing. After the gear is well polished, the surface can be protected by substituting a lubricant with a higher viscosity and by reducing the transmitted load operating speed to obtain a better elastic-hydrodynamic oil film. [13]

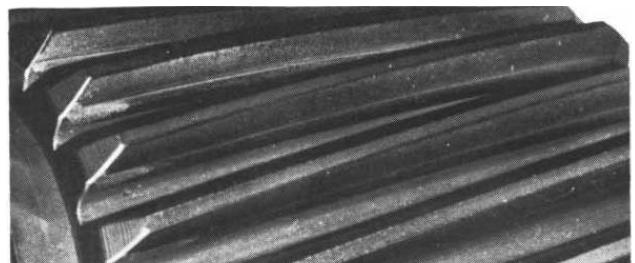
The type of wear classified as moderate takes place over a relatively long period. On gears the contact pattern indicates that metal has been removed in the addendum and dedendum area (Figure 29). In addition, the pitch line begins to show as an unbroken line.

Moderate wear is most commonly caused by an inadequate lubrication film or dirt in the system, with the film thickness being too thin for the load, which can be solved by specification of a lubricant with a greater film strength or one with a higher viscosity and general operation at a greater speed to build up the lubricating film, or by using a material with a higher wear resistance.

Figure 29: Example: Moderate Wear [13]

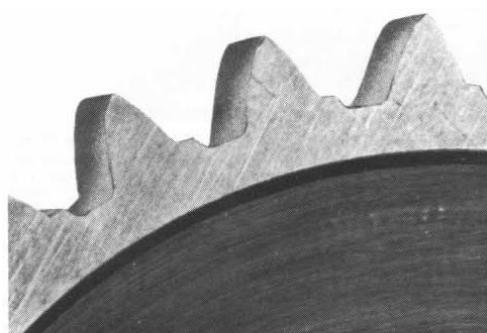
This is simply normal wear which has progressed to the point where a considerable amount of material has been removed from the surfaces, usually caused by the failure to notice early enough that wear is occurring (Figure 30). On gears, the pitch line is very prominent and shows signs of pitting. When enough material has been worn from the tooth surface, the involute profiles are destroyed and the gears begin to run roughly.

The situation is aggravated by the rough running, causing still greater wear. Eventually the surface is such that the gears are no longer fit for reliable service.

Figure 30: Example: Excessive Wear [13]

This condition might be avoided by using the same methods given for moderate wear. If the gear unit is splashed-fed, changing to a positive spray lubrication system with a filter will help keep wear particles out of the gear mesh and ensure that adequate lubricating oil is delivered to the working surfaces. [13]

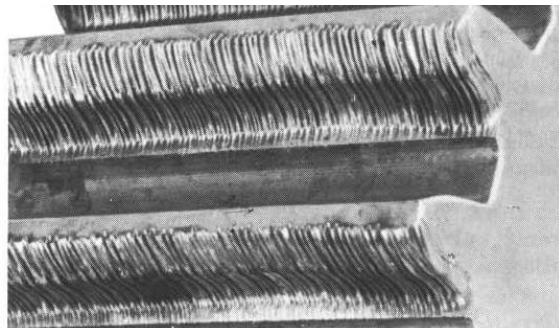
When abrasive wear has taken place, contact surfaces show signs of a lapped finish, radial scratch marks or grooves, or some other unmistakable indication that contact has occurred (Figure 31) caused by foreign material in the lubrication system. Apart from a clean system, a finer grade of filter can be implemented, if a filter is already being used, or as higher-viscosity lubricant that develop a thicker oil film which will pass fine particles without scratching for prevention of abrasive wear.

Figure 31: Example: Abrasive wear on a gear [13]

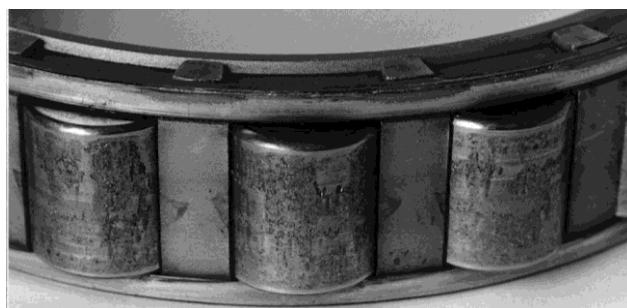
On the races of bearing components, grinding burrs undergo plastic deformation and some chip off. The metallic particles this process creates give rise to abrasive wear. Further consequences include the development of scoring and scratches and micro pitting. The wear process develops rapidly as the bearing play continues to increase. Finally, this leads to powder rubbing or peeling of the surface layers and severe subsequent damage caused by oil quality, e.g. particles, contamination, time and thermal ageing or high loading (Figure 32).

Figure 32: Peeling of the surface layers [16]

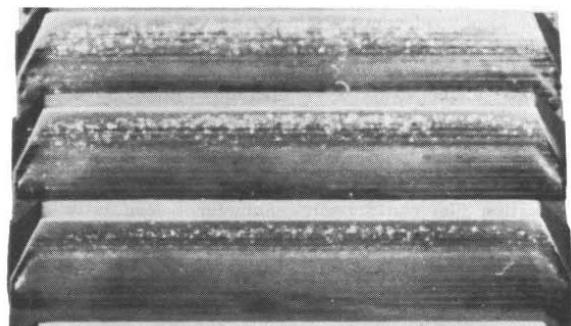
In the early stages of scoring frosting occurs, that is caused by heat in the mesh, which results in only marginal lubrication as shown in Figure 33. The heat of the mesh and the bulk temperature of the rotating gears combine to break down the lubrication film.

Often where frosting appears, subsequent operation of the unit will slowly polish away the frosted areas if all operating conditions remain constant. [13]

Figure 33: Example: Frosting [13]

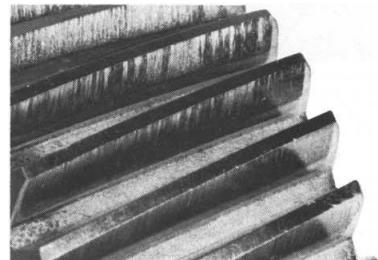
Following frosting a moderate scoring occur, a characteristic wear pattern becomes visible across the full face or only local as shown in Figure 34, often in patches and sometimes with indications of radial tear marks. In some cases, a solid lubricant placed on the contact surface helps prevent the scoring from progressing. Honing has also found increased use when guarding against scoring. [13]

Figure 34: Example: Light to moderate scoring [13]

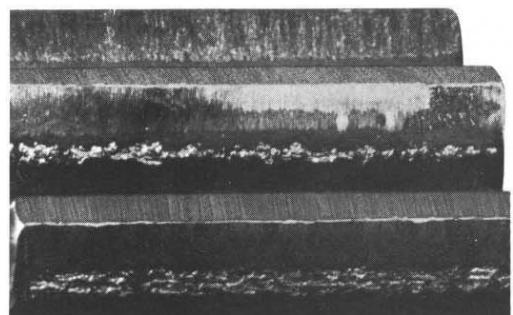
Definite indications of radial scratch and tear marks in the directions of sliding are called destructive scoring or scuffing. Often material has been displaced radially over the tips of the gears. In addition, there are indications that considerable material has been removed from above and below the pitch line and the pitch line itself stands out prominently. When the lubricant breaks down, the welding and tearing destroys the profile in minutes (Figure 35).

Figure 35: Example: Destructive Scoring [13]

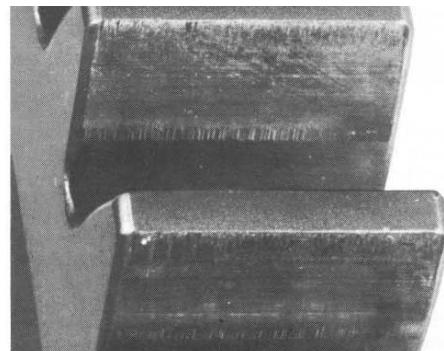
Another kind of scoring is visible by definite signs of metal removal on the deep-dedendum section of the gear and may often show destructive radial scratch marks, but undamaged other sections of the contacting face as shown Figure 36. The heavy loading at the tip or root of the mating pair, or the interference caused by a tight mesh, prematurely breaks down the lubricant film and causes rapid metal removal at the tips and roots and general abrasion of the teeth.

Figure 36: Example: Tip and root interference [13]

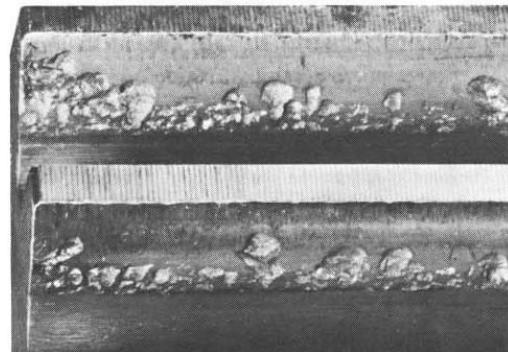
In destructive pitting, the surface pits are usually considerably larger in diameter than those associated with initial pitting. For instance, the dedendum section of the drive gear is often the first to experience serious pitting damage. As operation continues, however, pitting usually progresses to the point where a considerable portion of all surfaces have developed pitting craters of various shapes and sizes, as can be seen in Figure 38.

Destructive pitting usually results from surface overload, which cannot be alleviated by corrective (initial) pitting. Once enough stress cycles have been built up, pitting continues until the contact profile is completely destroyed, leading to extremely rough operation and considerable noise. Often a bending fatigue crack will originate from a pit, causing a premature breakage failure.

Figure 38: Example: Destructive pitting [13]

Destructive pitting can be avoided by maintaining the load on the material. In addition, hardness of the material can be increased so that the endurance limit will rise to a point where pitting does not take place.

On gears, pitting can sometimes be arrested by increasing the hardness level of only the driving member. [13]

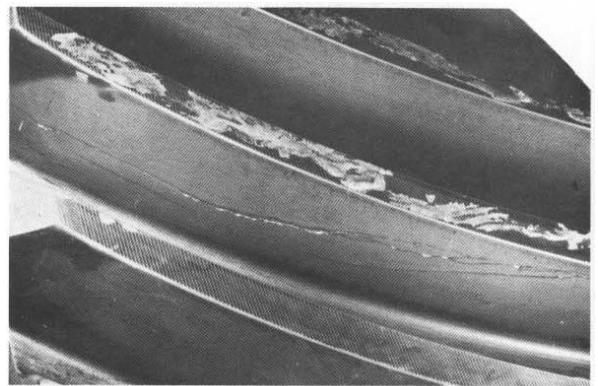
Although not considered a pitting failure, case crushing may appear similar in that damage has occurred on the contacting surface. It occurs on heavily loaded case-hardened parts, such as those which are case-carburized or nitrided. For example, failure often occurs on only one or two teeth of a pinion or gear. The other teeth appear to be undamaged. Often, longitudinal cracks appear on the surface and large, long pieces of the tooth surface break away. The general appearance suggests that the case material has chipped away in large flakes at a parting line just below the case-to-core junction.

Cracks originate at the subsurface when stresses exceed the strength of the subsurface material. The cracks propagate along the case-to-core boundary and to the surface of the gear tooth. When several cracks reach the tooth surface, large chunks of material are removed (Figure 39). Failures are caused by insufficient case depth or by very high residual stresses. Failures most often can be overcome by increasing the effective depth of the case material. A change in basic material can also be considered.

Figure 39: Example: Case crushing [13]

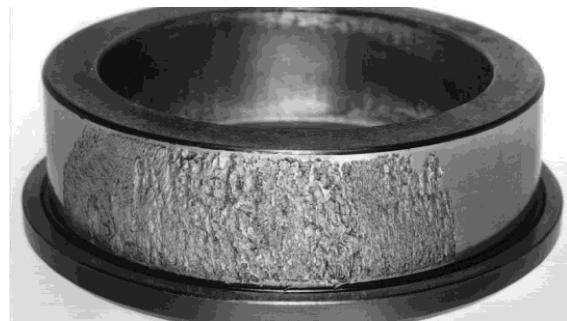
A phase after spalling is a peeled surface, as shown in Figure 40, produced by broken off pieces which may have been over rolled after pitting. This only occurs when lubrication is sufficient. Otherwise, fretting or seizure damage takes place.

Figure 40: Peeling [16]

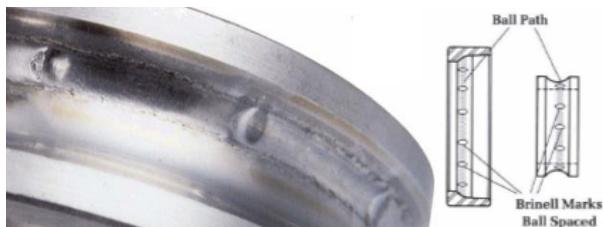
Brinelling occurs when loads exceed the elastic limit of the ring material. Brinell marks appear as indentations in the raceways, which increase bearing vibration. Severe brinell marks can cause premature fatigue failure as well as any static overload, for example due to the assembly or disassembly of the part as is shown in Figure 47.

Figure 47: Careful handling and installation practices can minimize or eliminate true brinelling problems [14]

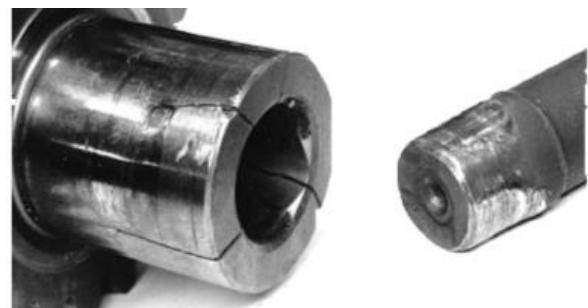
Polygon profiles have more favourable loading properties than other profiles, but also have the disadvantage that they are susceptible to damage from high surface pressures at the contact points between shaft and hub. If overloading occurs, tremendous spreading forces are exerted. Figure 52 shows a spalled countershaft hub caused by overloading of the torque level. Considerable quantities of deposited material can be seen on the shaft.

Figure 52: Polygon damage/hub breakage [16]

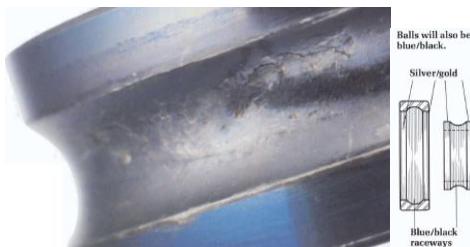
Ball bearings depend on the continuous presence of a very thin film of lubricant between the contact surfaces as well. If this is not the case, overheating and subsequent catastrophic failures may occur as shown by the discoloured example in Figure 54. The temperature rise can also degrade or destroy lubricant. Common influences are heavy electrical heat loads, inadequate heat paths, and insufficient cooling or lubrication when loads and speeds are excessive.

Figure 54: Lubricant failure will lead to excessive wear, overheating, and subsequent bearing failure [14]

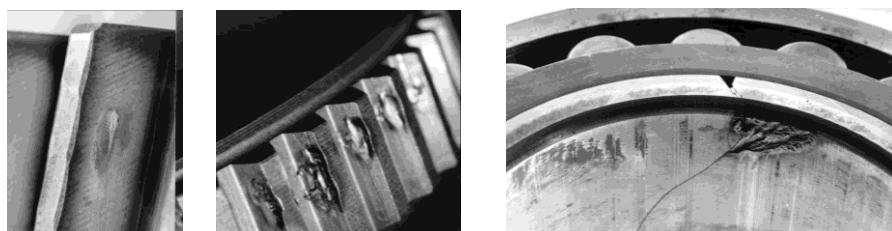
In most cases, the initial cause of the craters due to electrical power damage is usually obscured or erased by subsequent relative flank movement and cannot therefore be identified. Similar damage may also occur on splines, caused by distinct relative flank movement in conjunction with dry friction. If several similar faults with these characteristics occur in a gearbox/assembly, this is a sure sign of electrical power damage. Figure 55 shows electrical power damage on the flank of a spur gear (left), flank damage on a spline caused by electrical power and subsequent relative movement (middle), and small craters on the contact surfaces due to electrical power (right).

Figure 55: Electrical power damage [16]

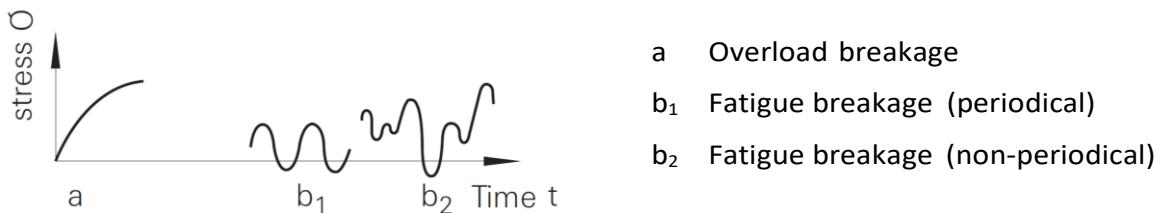
Overload breakage occurs when stress is applied and increased continuously until failure occurs, which typically happens at the point of applied stress reaching material's ultimate strength. This breakage pattern can be identified on most materials by means of the rough, fine to coarse-grained, irregular and partially striated failure surface.

The majority of fatigue breakages on machine components are due to stress concentrations at the failure points. Repeated excessive loadings at these stress concentration points can gradually lead to "fatigue" of the material, leading in turn to vibration-induced or fatigue breakage. In this instance, the load is reciprocating in nature, i.e. the stress alters periodically or non-periodically in accordance with size and direction over time. Cracking propagates with each new stress peak. Failure culminates in an overload breakage of the residual cross section. In contrast to overload breakage, a fatigue breakage can usually be identified by the flat, smooth, shiny breakage surface, frequently also covered with fine lines.

Figure 57: Chronological sequence of stress pattern under differing types of stress [16]

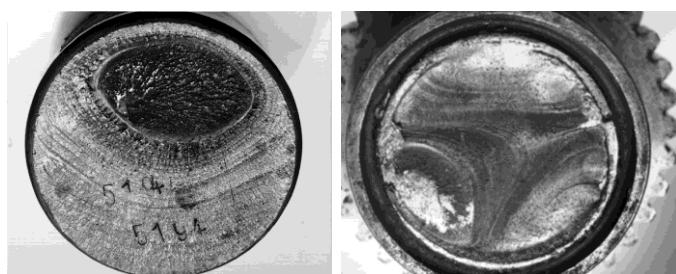
As visible in Figure 58, the surface of a bending broken part consists of two different zones. One has a finely structured velvety or powdery fatigue breakage surface while the other has a grainy, rough residual breakage surface. The fatigue breakage surface is located on the side with the highest load. The proportion of the fatigue breakage surface area to the entire breakage surface area is influenced by the load condition. A large fatigue breakage surface area points to an overall low load level, with individual peak loads causing the fracture. On the other hand, the fatigue breakage surface area is small if the overall load level is high.

Figure 58: Bending breakage and cyclic bending breakage [16]

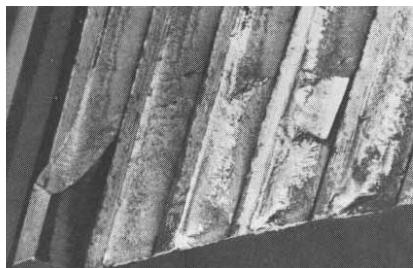
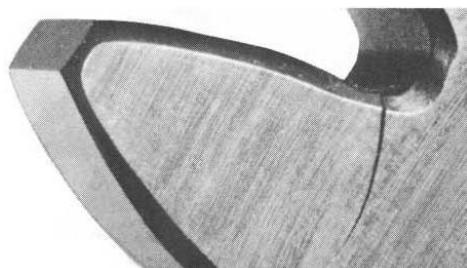
Figure 59 (left) shows a gear-tooth failure from bending fatigue, which generally results from an origin point in the root section of the gear tooth. The break shows signs of fretting and conventional smooth beach marks in the break area that may be caused by various impacts such as excessive loads, which result in stresses higher than the endurance limit of the material. Additionally, stress risers (notches in the root fillet, hob tears, inclusions, small heat-treat cracks, grinding burns and residual stresses) help aggravate this condition and subject a gear to higher root stress levels than would normally be predicted. This failure can be prevented by means of the design and the material, but also with manufacturing processes such as heat treatment to achieve

the best structure and to minimize detrimental residual stresses. An adjustment to the root fillet area is helpful as well, to prevent such cracks as shown in Figure 59 (right).

Figure 59: Example: Bending fatigue [13]

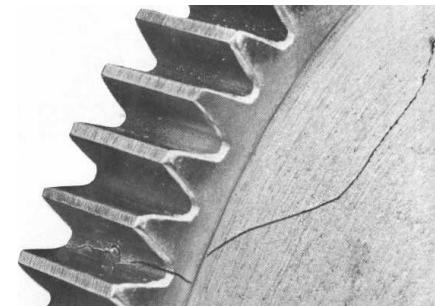
The rim of a gear usually fails between two adjacent teeth, and the crack propagates through the rim and into the web as shown in Figure 60, often caused by flexure stresses in the gear teeth and highly loaded thin rims and webs. Sometimes cracks appear in the web near the rim and web junction without disturbing the rim itself. Web cracks may be caused by stress risers, from holes in the web or web vibrations. If vibration is not the cause or the cause cannot be eliminated, both scenarios can be prevented by increasing its thickness in order to eliminate the stress level.

Figure 60: Example: Rim and web failure [13]

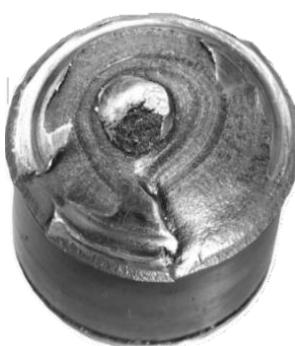
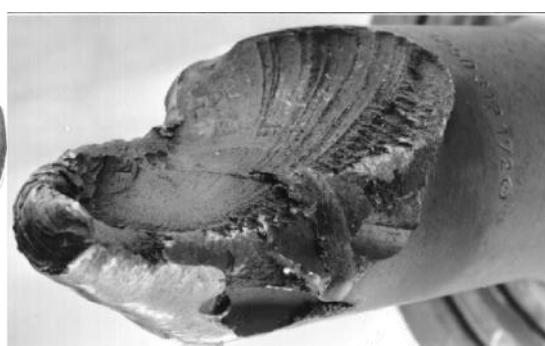
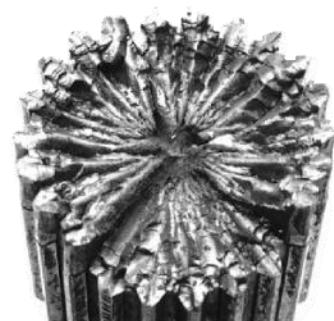
Torsional bending fatigue breakages, which are caused by high loading conditions such as failure of other components in the transmission or driveline, accident, operating faults, and functional errors. The breakage works towards the center of the shaft cross-section. Eventually, the breakage proceeds to such an extent that the remaining sound cross-section can no longer withstand the torque to be transmitted and fails as shown in Figure 61.

Figure 61: Bending breakage through torsion [16]

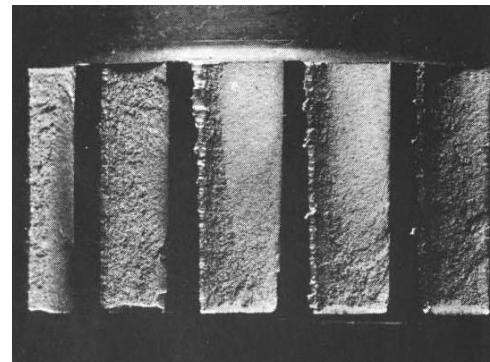
An overload fracture results in a stringy, fibrous break showing evidence of having been pulled or torn apart. In harder materials, the break has a finer stringy appearance but still shows evidence of being pulled apart abruptly. An example of tooth breakage caused by overload which exceeds the tensile strength of the gear material is shown in Figure 63 and may result from a bearing seizure, failure of driven equipment, foreign material passing through the mesh, or a sudden misalignment from a failed or wiped gear bearing.

Figure 63: Example: Overload breakage [13]

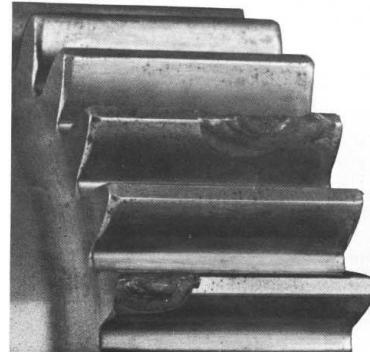
Gear-tooth breakage is usually associated with the root-fillet section of the gear tooth. Failures of this kind are often caused by deficiencies in the gear tooth, which result in a high stress concentration at a particular area that cause local fractures as shown in Figure 67.

Figure 67: Example: Tooth tip Breakage [13]

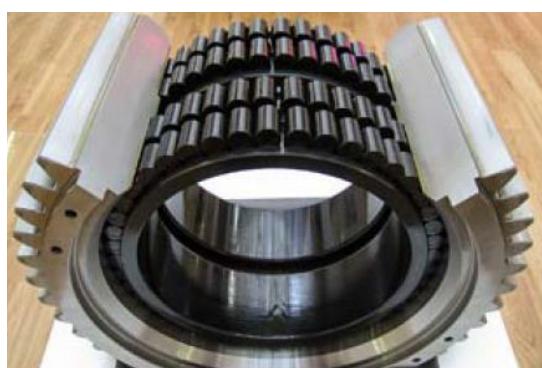
The second failure mode to underline for these planet bearings is micro spalling (Figure 81, case c), which essentially occurs due to poor lubrication conditions in application. As a solution for this and several other failure modes, SKF developed a Black Oxide treatment (Figure 80), which shall reduce premature failure due to cracks/white etching cracks.

Figure 82: Planet multi rows CRB with SKF Black Oxide treatment [17]

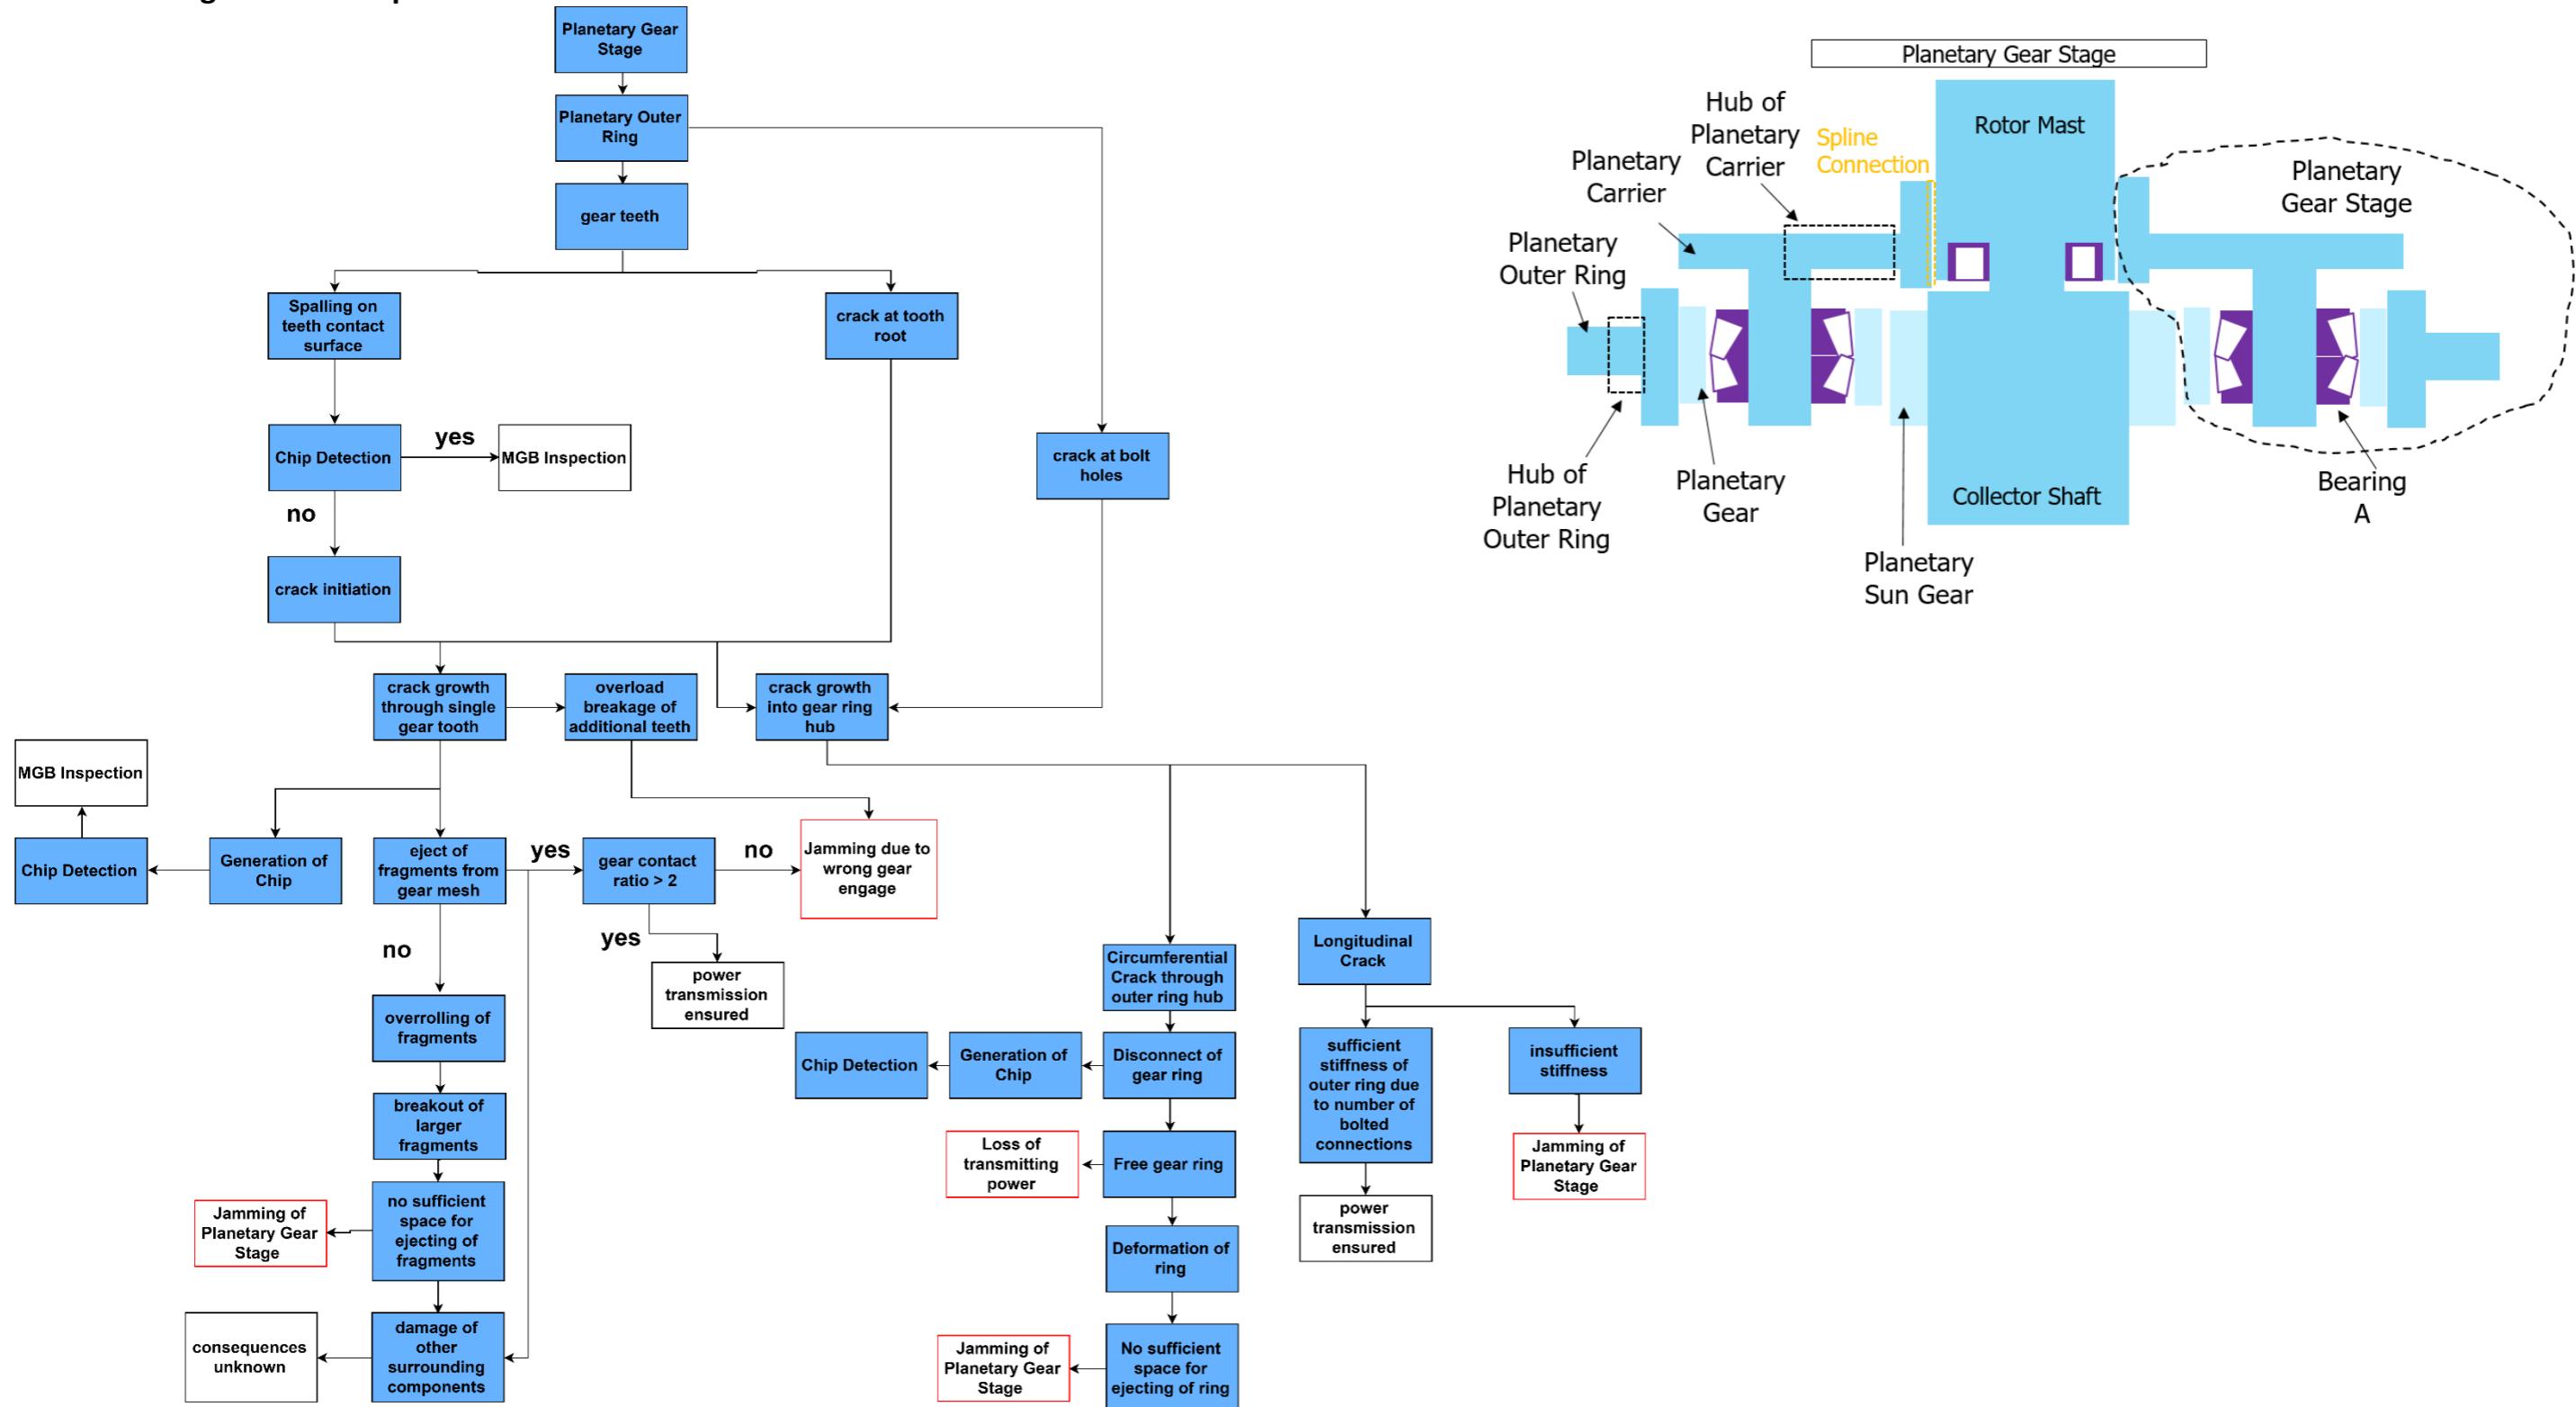
Pos.	Figure	Configuration	Subpart	Weakness	Crack/Wear growth	Breakage/Crack	Additional contributions
1	Figure 98	Epicyclic; 2 Engines with reduction gearboxes	Planetary gear stage outer ring	Loss of transmitting power	Crack growth from tooth root or teeth contact surface into gear ring hub	Circumferential crack through outer ring hub	
2	Figure 98	Epicyclic; 2 Engines with reduction gearboxes	Planetary gear stage outer ring	Jamming of planetary gear stage	Crack growth from tooth root or teeth contact surface into gear ring hub	Circumferential crack through outer ring hub	Deformation of ring No sufficient space for ejection of ring
3	Figure 98	Epicyclic; 2 Engines with reduction gearboxes	Planetary gear stage outer ring	Jamming of planetary gear stage	Crack growth from tooth root or teeth contact surface into gear ring hub	Longitudinal crack	Insufficient stiffness
4	Figure 98	Epicyclic; 2 Engines with reduction gearboxes	Planetary gear stage outer ring	Jamming of planetary gear stage	Crack growth from tooth root or teeth contact surface through single gear tooth	Breakout of larger fragments	Ejection of fragments from gear mesh not possible

5	Figure 98	Epicyclic; 2 Engines with reduction gearboxes	Planetary gear stage outer ring	Jamming due to wrong gear engagement	Crack growth from tooth root or teeth contact surface through single gear tooth/teeth	Breakage of planetary outer gear teeth	Overload due to missing tooth/teeth Contact ratio < 2
6	Figure 99	Epicyclic; 2 Engines with reduction gearboxes	Planetary gear stage carrier	Jamming of planetary gear stage	Crack growth from planetary gear shafts/support	Breakage of gear shaft	Separation of gear shaft
7	Figure 99	Epicyclic; 2 Engines with reduction gearboxes	Planetary gear stage carrier	Loss of transmitting power to rotor mast	Total wear at spline connection	n/a	No release of fragments due to closed design
8	Figure 99	Epicyclic; 2 Engines with reduction gearboxes	Planetary gear stage carrier	Jamming of planetary gear stage	Crack growth from spline connection into hub	Circumferential crack	No sufficient space for ejection Free gear stage fragments

Figure 98: Bell 525 – Planetary Gear Stage

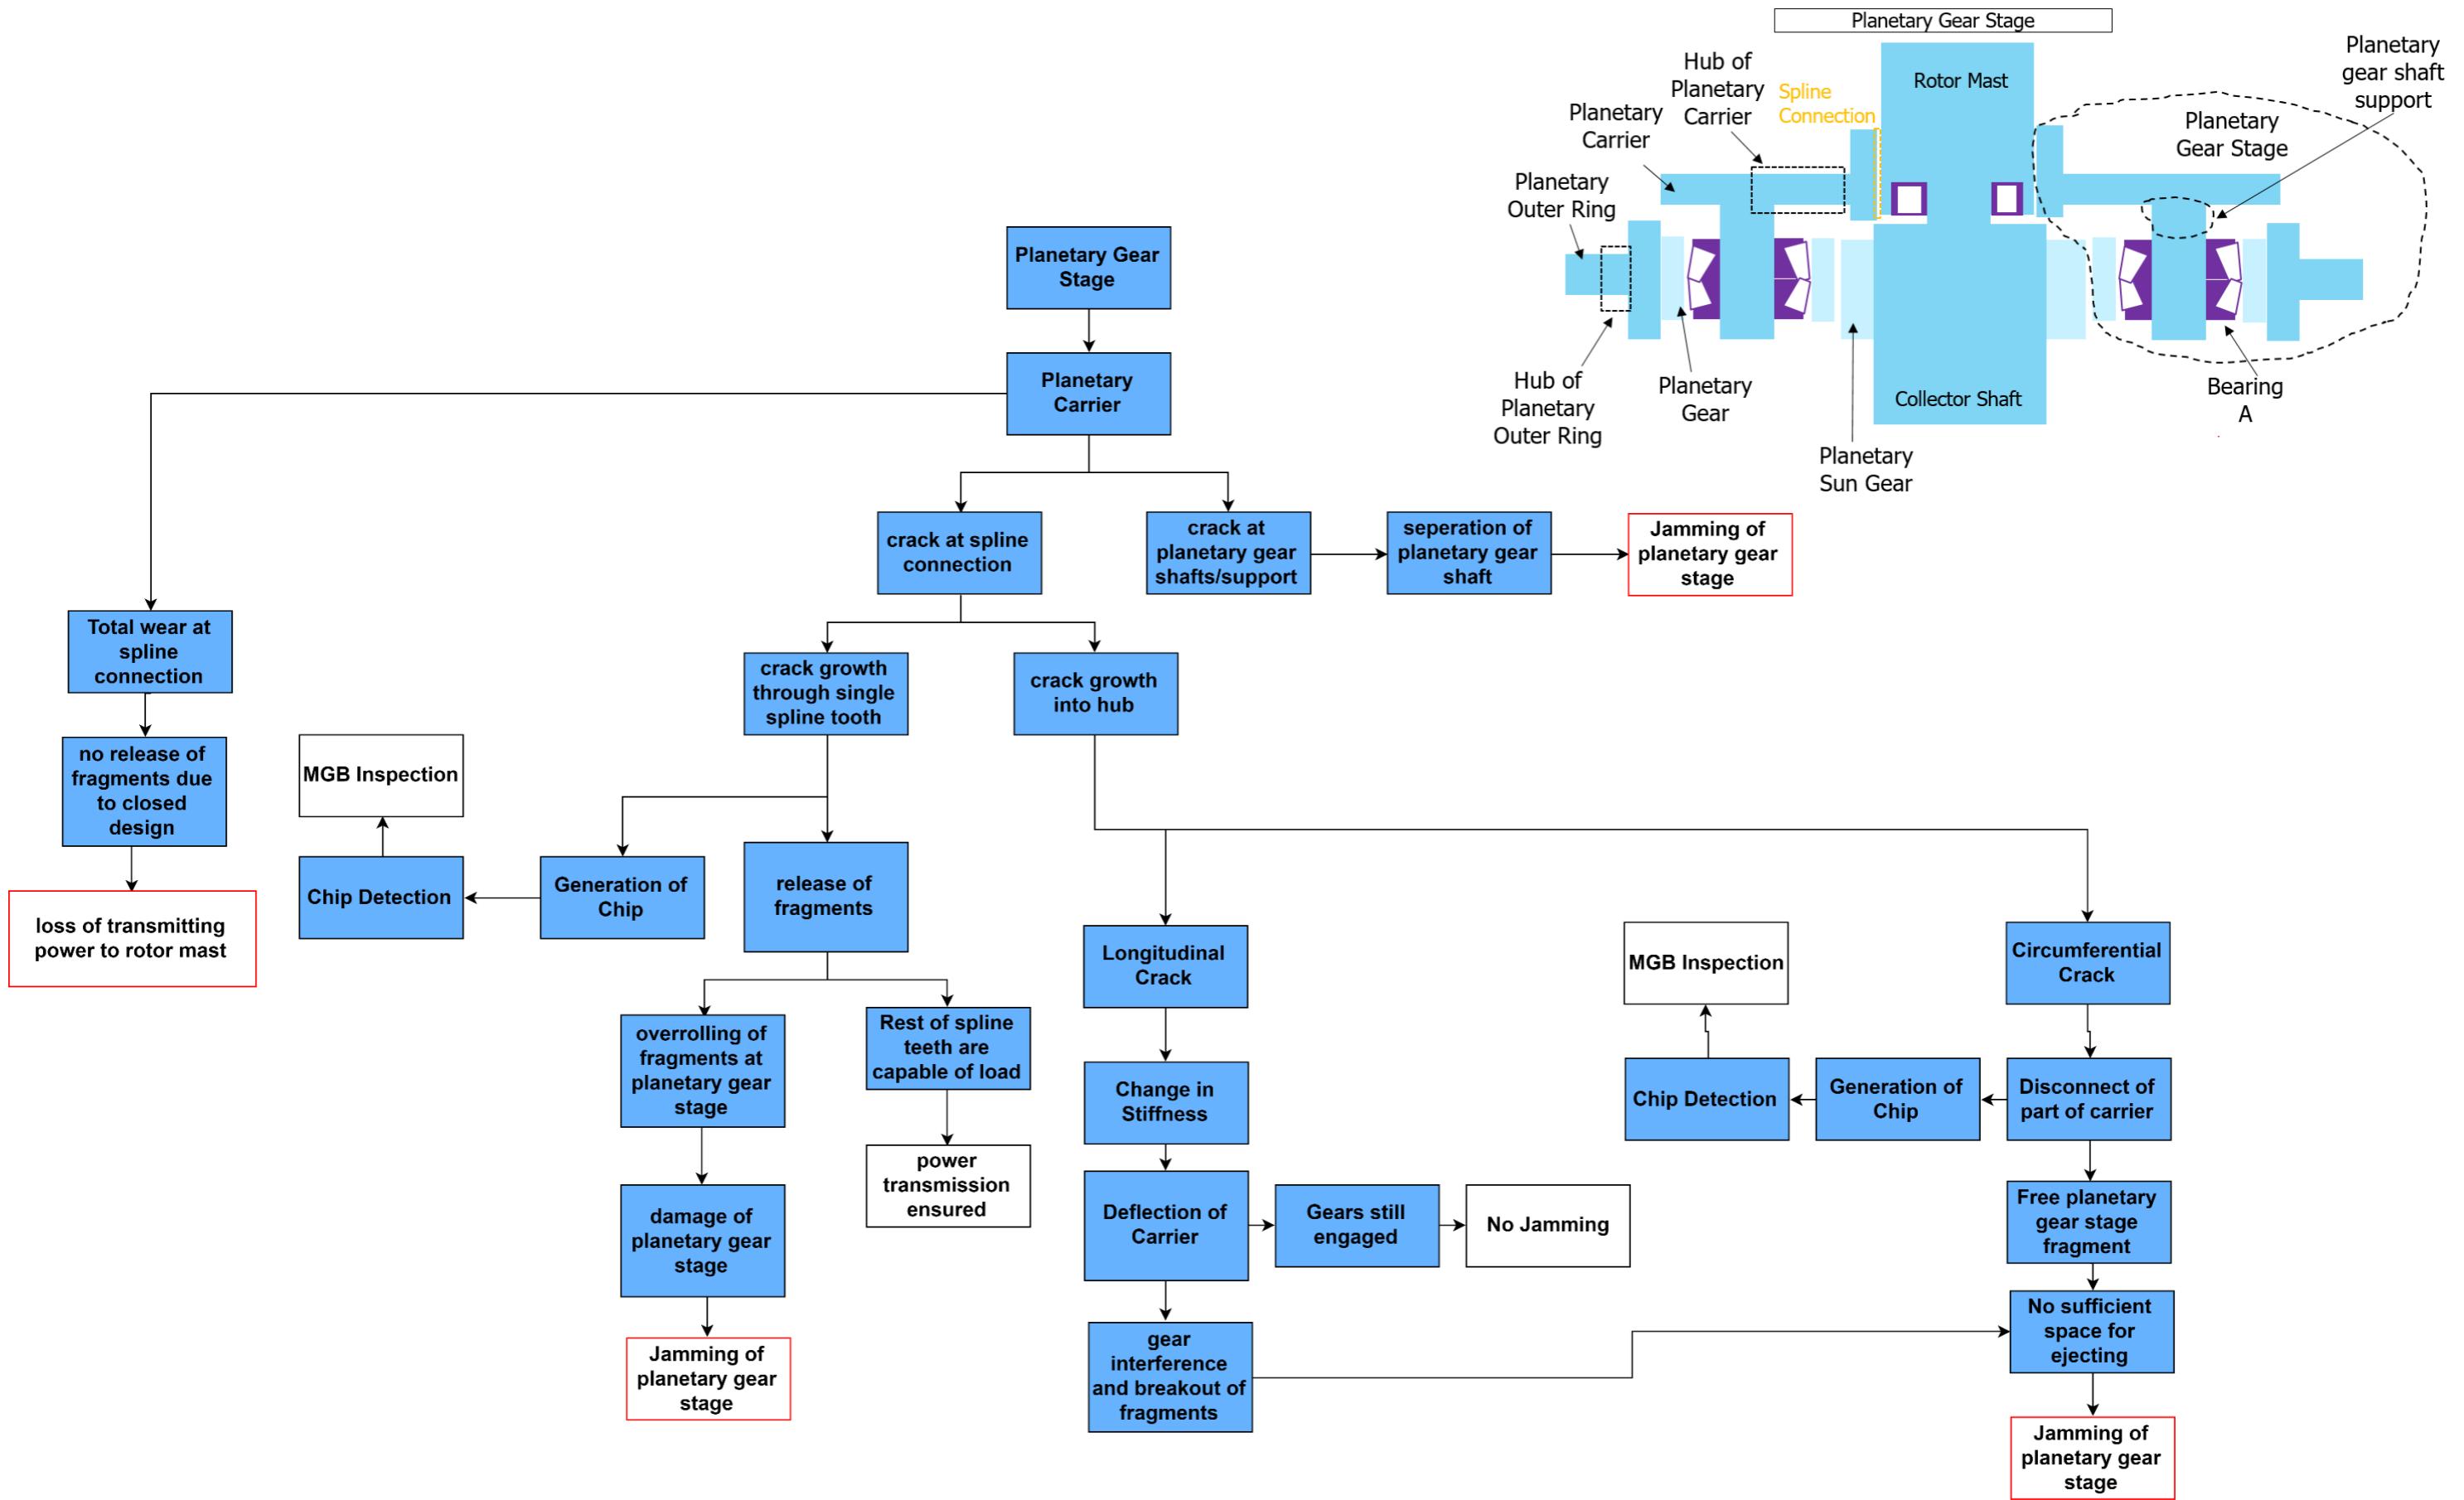
Pos.	Figure	Configuration	Subpart	Weakness	Crack/Wear growth	Breakage/Crack	Additional contributions	
9	Figure 99	Epicyclic; 2 Engines with reduction gearboxes	Planetary gear stage carrier	Jamming of planetary gear stage	Crack growth from spline connection into hub	Longitudinal crack	No sufficient space for ejection	Change of stiffness and gear deflection
10	Figure 99	Epicyclic; 2 Engines with reduction gearboxes	Planetary gear stage carrier	Jamming of planetary gear stage	Crack growth from spline connection through single spline tooth	Breakout of larger fragments	Overrolling of released fragments at gear stage	Damage of gear stage
11	Figure 100	Epicyclic; 2 Engines with reduction gearboxes	Planetary gear stage gear	Jamming of planetary gear stage	Crack growth from tooth root or teeth contact surface through single or multiple gear tooth	Breakage of planetary gear tooth/teeth	No sufficient space for ejecting of fragments	Damage of other surrounding components

Figure 99: Bell 525 – Planetary Gear Stage
