Integrity improvement of rotorcraft main gear box

REPORT NUMBER:	D1-1
REPORT CLASSIFICATION:	UNCLASSIFIED
DATE:	14 January 2022
KNOWLEDGE AREA(S):	Research, rotorcraft MGB, configuration and component design
DESCRIPTOR(S):	Potential weaknesses, single point of failure, failure flow analysis
CUSTOMER:	European Aviation Safety Agency
CONTRACT NUMBER:	EASA.2019.C15
OWNER:	European Aviation Safety Agency
DISTRIBUTION:	Limited
CLASSIFICATION OF TITLE:	UNCLASSIFIED
Author(s):	W. Riesen, S. Hilleke

EVALUATE AND DEFINE ROTOR AND ROTOR DRIVE SYSTEM DESIGN
OPTIONS TO PREVENT SINGLE POINTS OF CATASTROPHIC FAILURE

Review of the state-of-the-art rotorcraft gearbox configurations and component designs

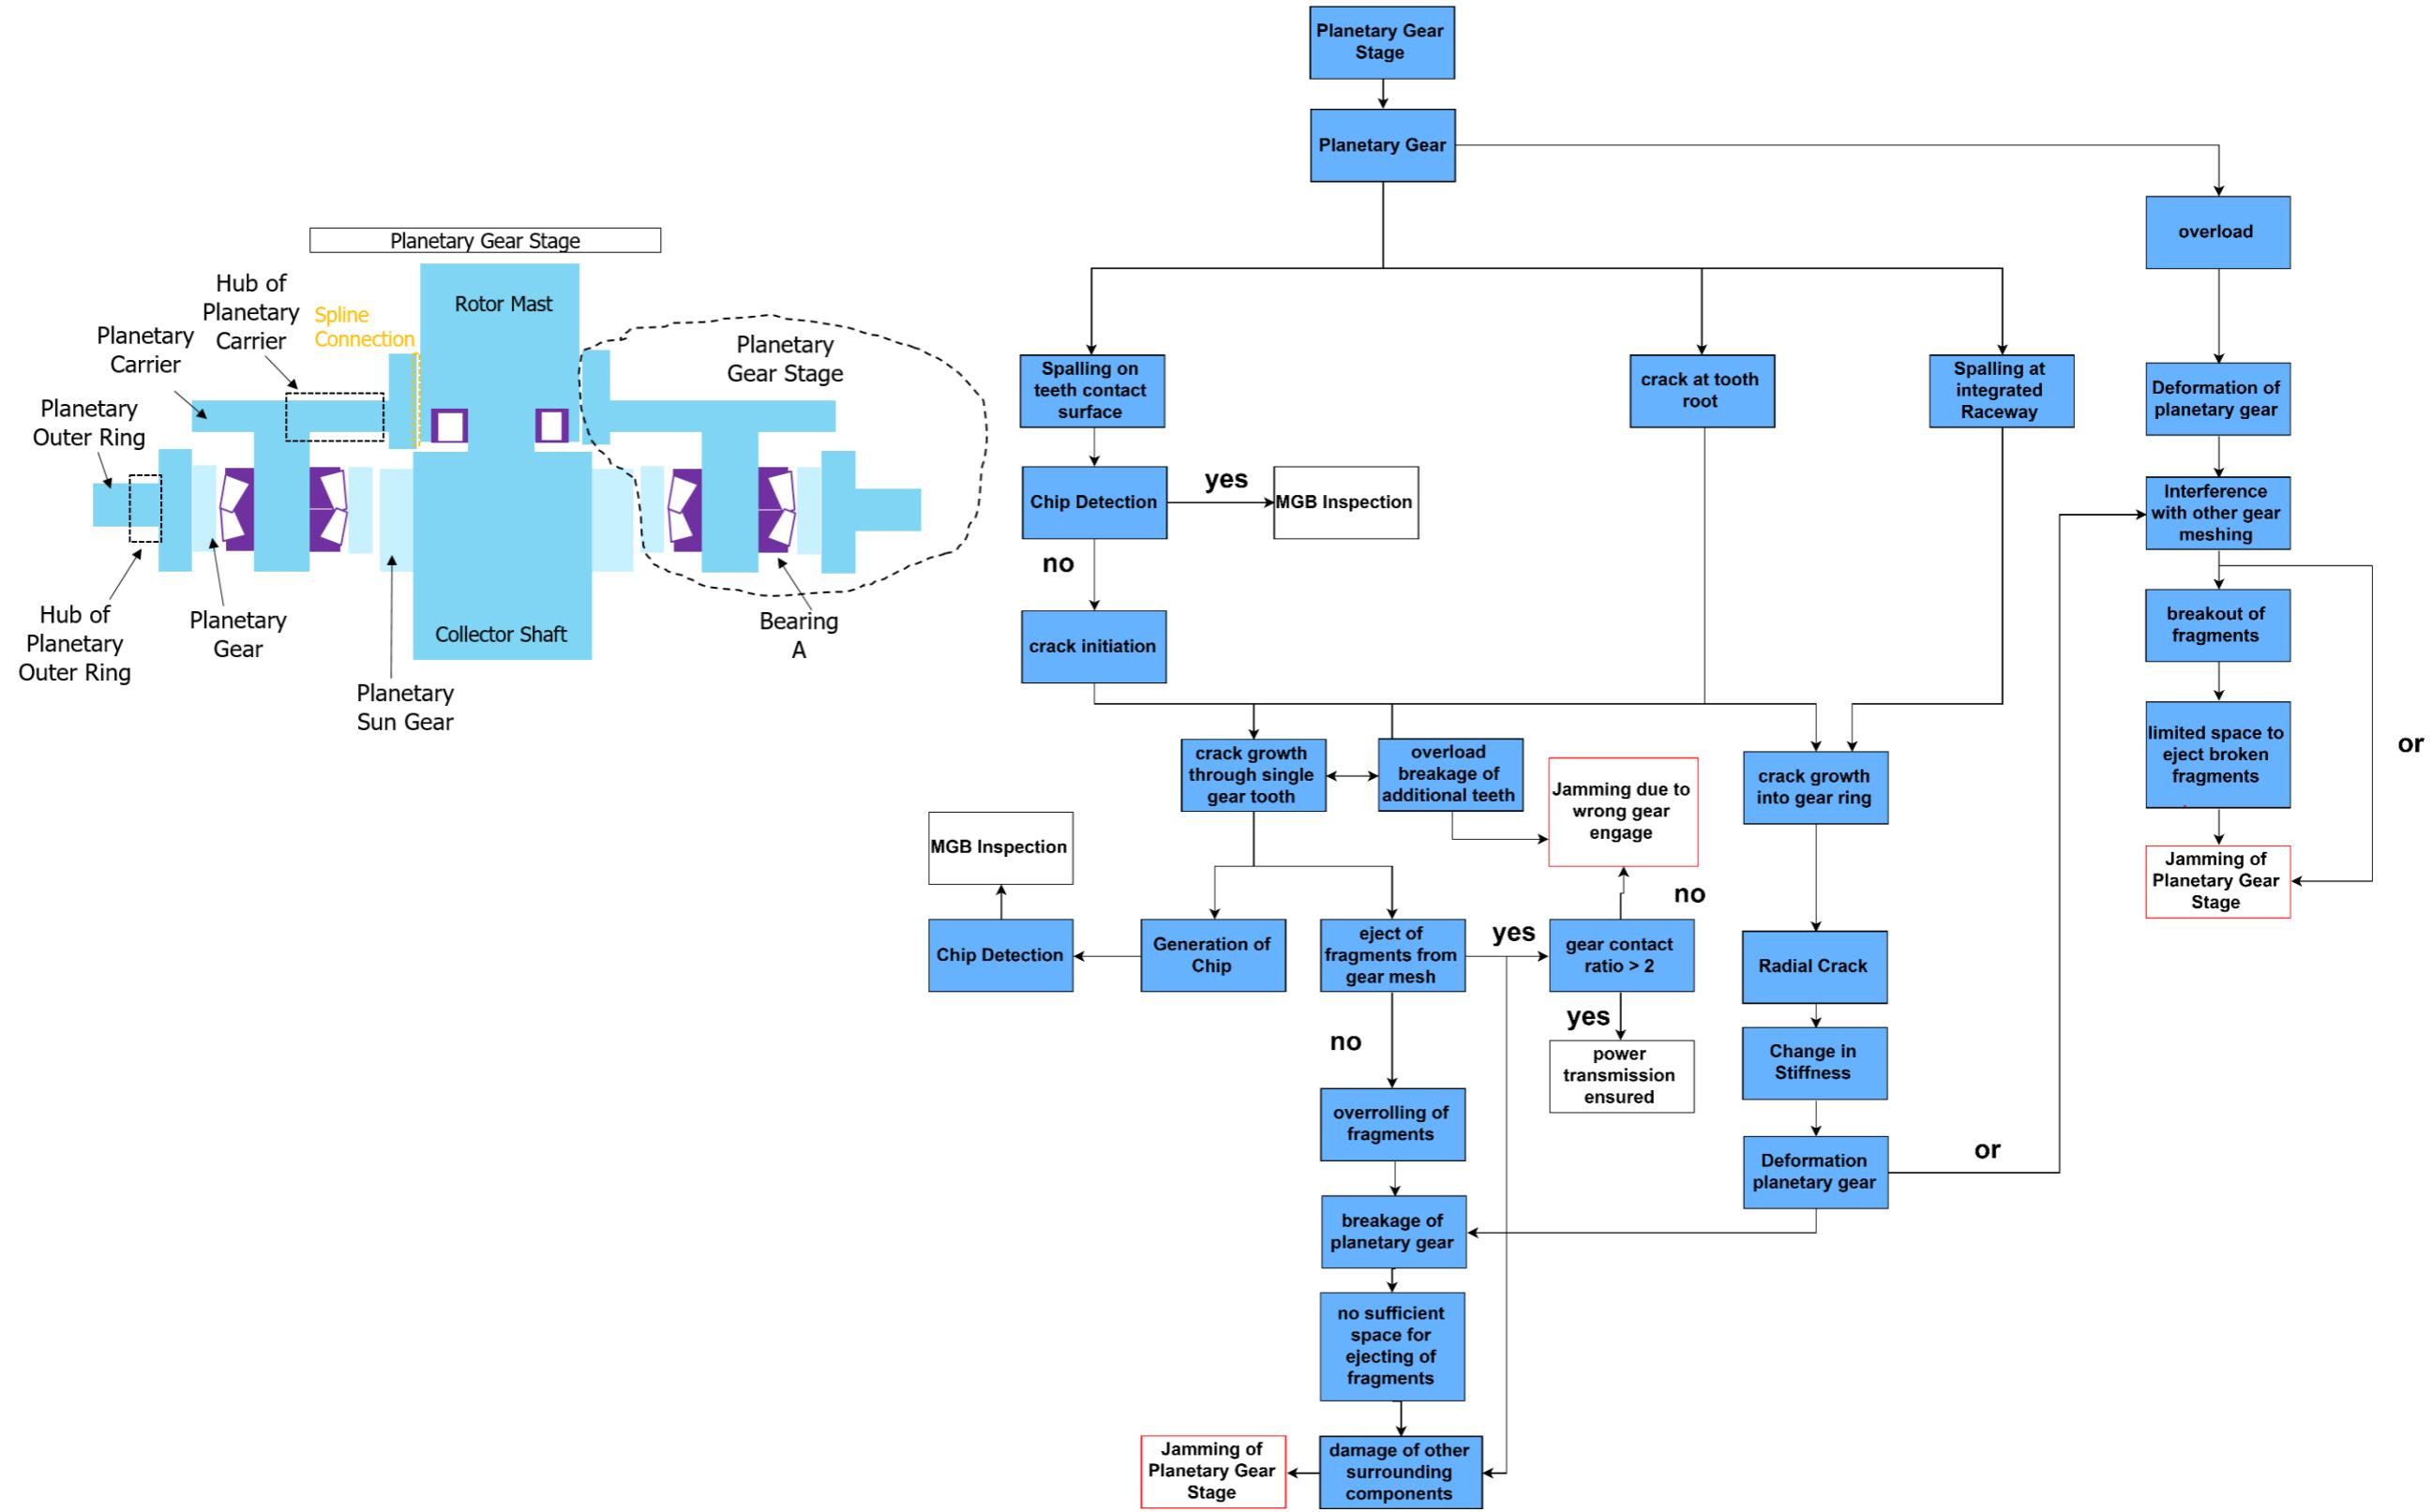
12	Figure 100	Epicyclic; 2 Engines with reduction gearboxes	Planetary gear stage gear	Jamming due to wrong gear engagement	Crack growth from tooth root or teeth contact surface through single or multiple gear tooth	Breakage of planetary gear tooth/teeth	Overload due to missing tooth	Contact ratio < 2
13	Figure 100	Epicyclic; 2 Engines with reduction gearboxes	Planetary gear stage gear	Jamming of planetary gear stage	Crack growth from tooth root, teeth contact surface or integrated raceway into gear ring	Radial crack	Change in stiffness and deformation of gear	Gear mesh interference and limited space for ejection of fragments
14	Figure 100	Epicyclic; 2 Engines with reduction gearboxes	Planetary gear stage gear	Jamming of planetary gear stage	Crack growth from tooth root, teeth contact surface or integrated raceway into gear ring	Radial crack	Change in stiffness and deformation of gear	Damage of other surrounding components limited space for ejection of fragments

15	Figure 100	Epicyclic; 2 Engines with reduction gearboxes	Planetary gear stage gear	Jamming of planetary gear stage	Overload of gear	Deformation/breakage of planetary gear	Interference with other gear meshing	Limited space for ejection of fragments
16	Figure 101	Epicyclic; 2 Engines with reduction gearboxes	Collector wheel	Loss of transmitting power to rotor mast	Crack growth from spline connection into upper or bottom area of the wheel	Circumferential crack	Wheel still fixed in position

Figure 100: Bell 525 – Planetary Gear Stage

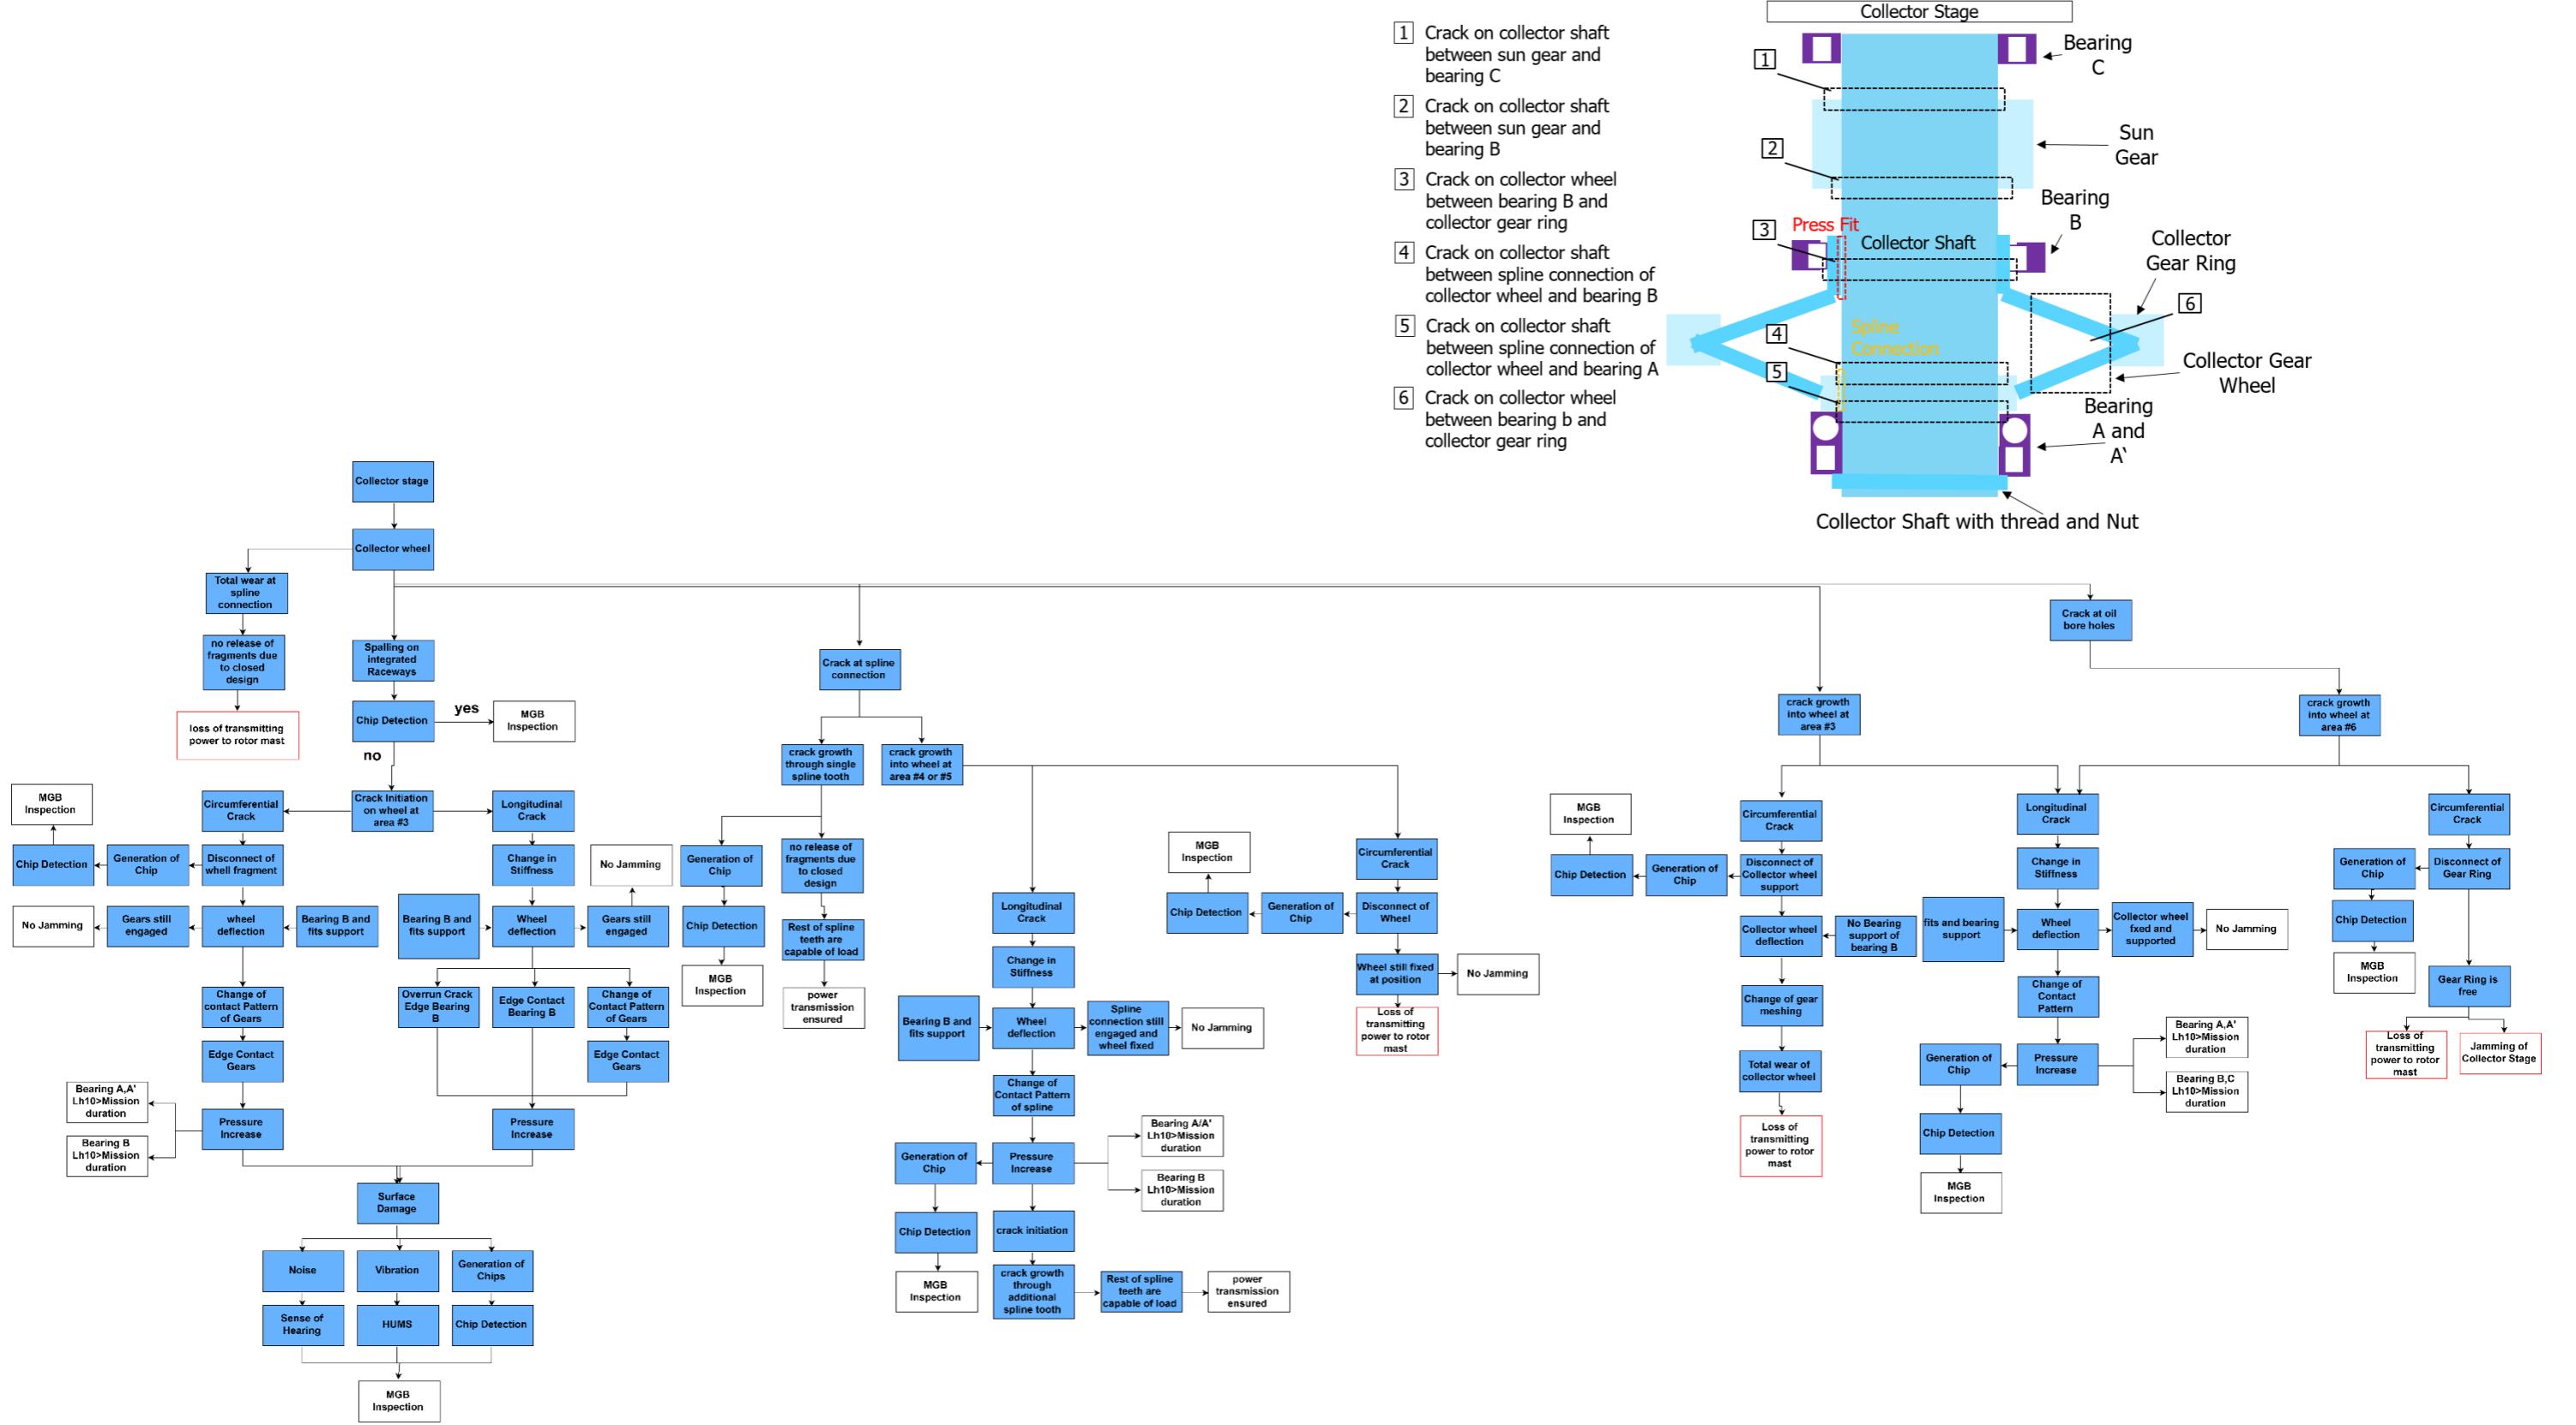
Pos.	Figure	Configuration	Subpart	Weakness	Crack/Wear growth	Breakage/Crack	Additional contributions
17	Figure 101	Epicyclic; 2 Engines with reduction gearboxes	Collector wheel	Loss of transmitting power to rotor mast	Crack growth from spline connection into lower area of the wheel	Circumferential crack	Deflection and change of mesh Total wear
18	Figure 101	Epicyclic; 2 Engines with reduction gearboxes	Collector wheel	Loss of transmitting power to rotor mast	Crack growth from oil bore holes into shaft	Circumferential crack	Gear ring is free after disconnection
19	Figure 101	Epicyclic; 2 Engines with reduction gearboxes	Collector wheel	Jamming of collector stage	Crack growth from oil bore holes into shaft	Circumferential crack	Gear ring is free after disconnection
20	Figure 101	Epicyclic; 2 Engines with reduction gearboxes	Collector wheel	Loss of transmitting power to rotor mast	Total wear at spline connection	n/a	No release of fragments due to closed design

Figure 101: Bell 525 – Collector Wheel

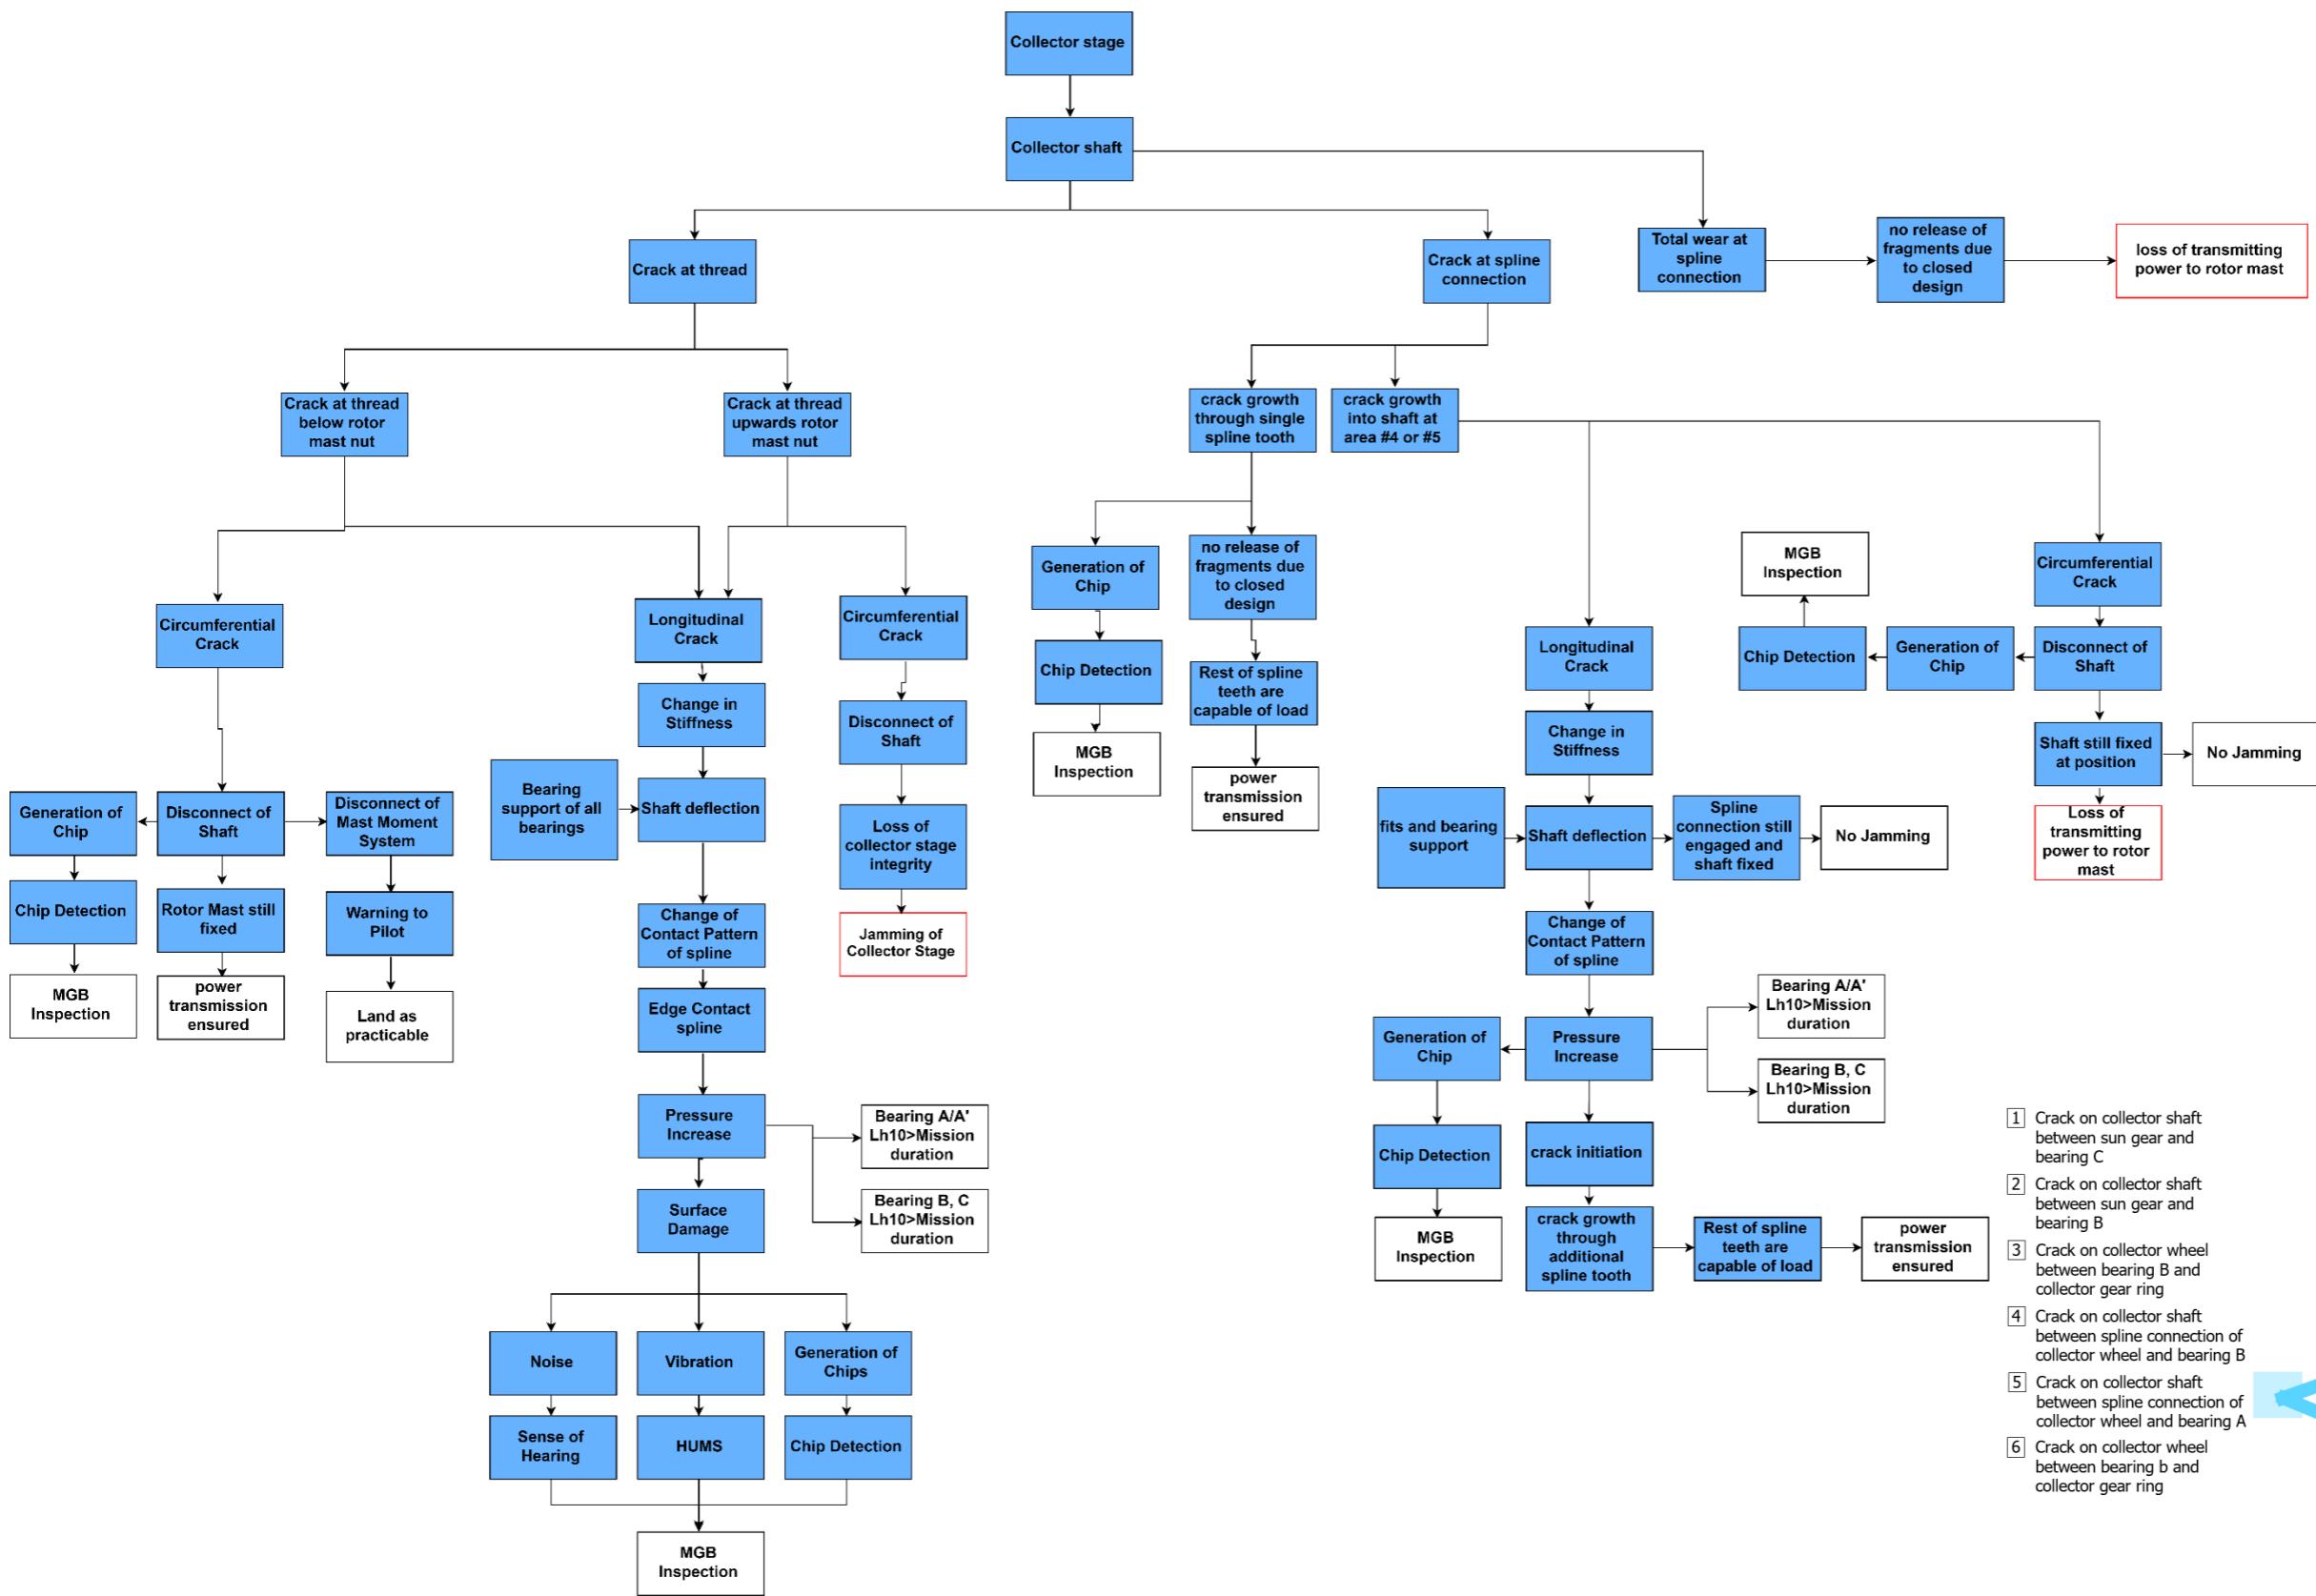
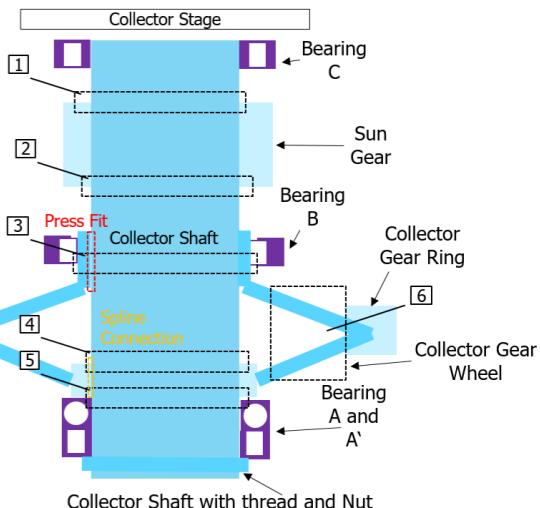
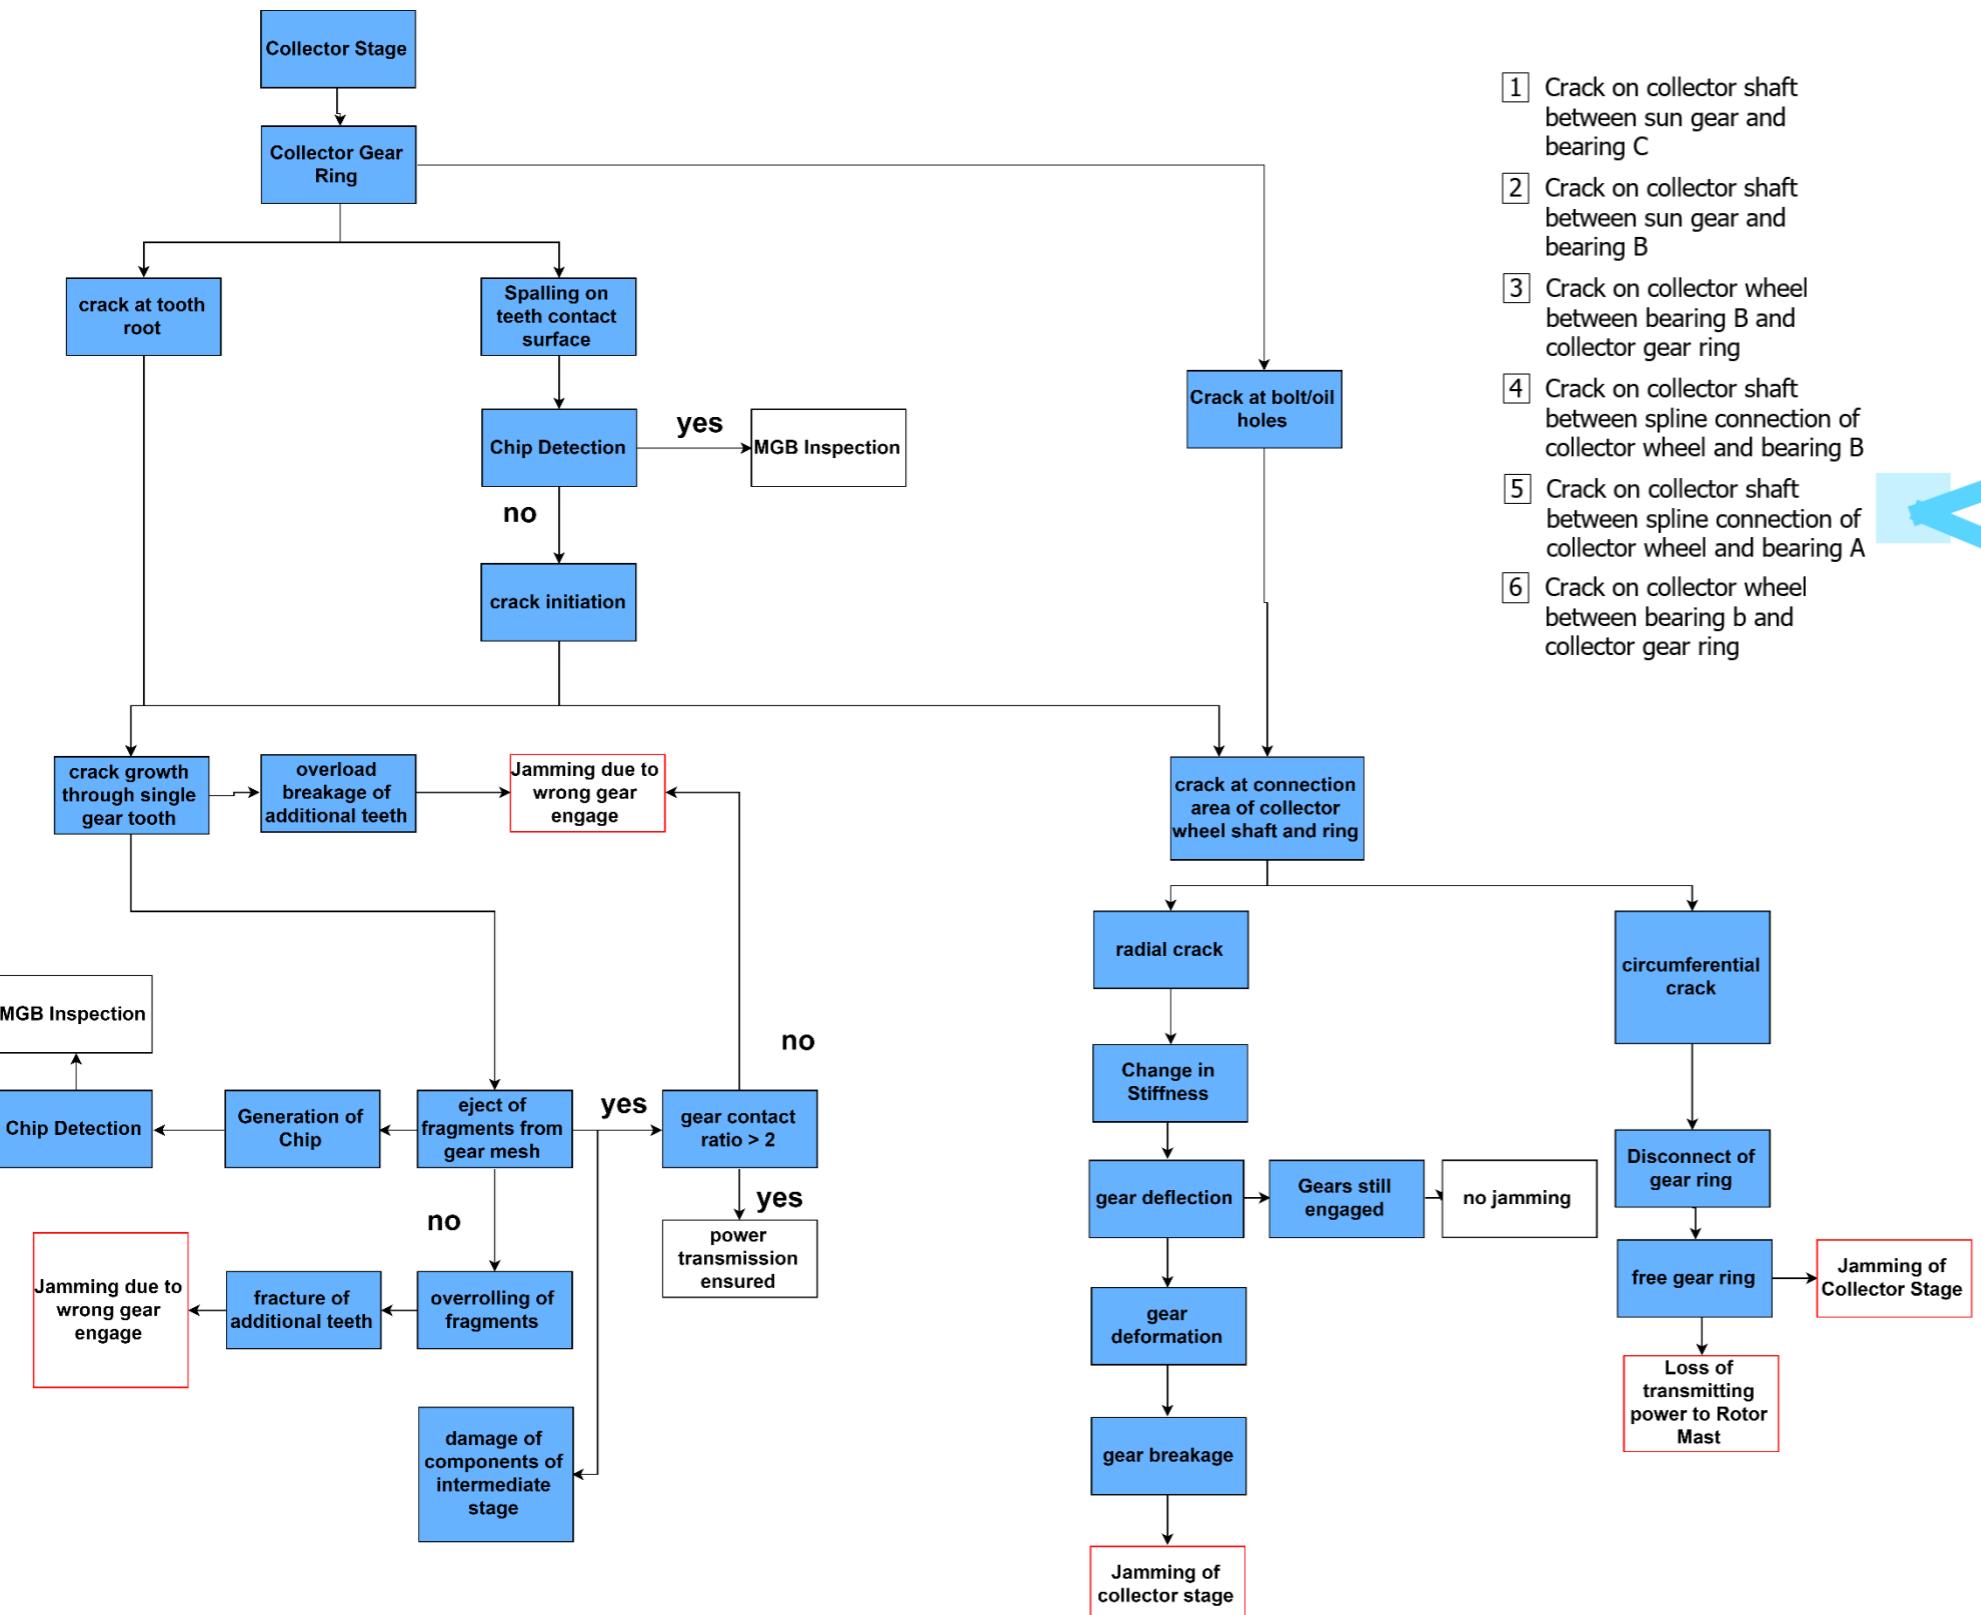
Figure 102: Bell 525 – Collector Shaft

- 1 Crack on collector shaft between sun gear and bearing C
- 2 Crack on collector shaft between sun gear and bearing B
- 3 Crack on collector wheel between bearing B and collector gear ring
- 4 Crack on collector shaft between spline connection of collector wheel and bearing B
- 5 Crack on collector shaft between spline connection of collector wheel and bearing A
- 6 Crack on collector wheel between bearing b and collector gear ring

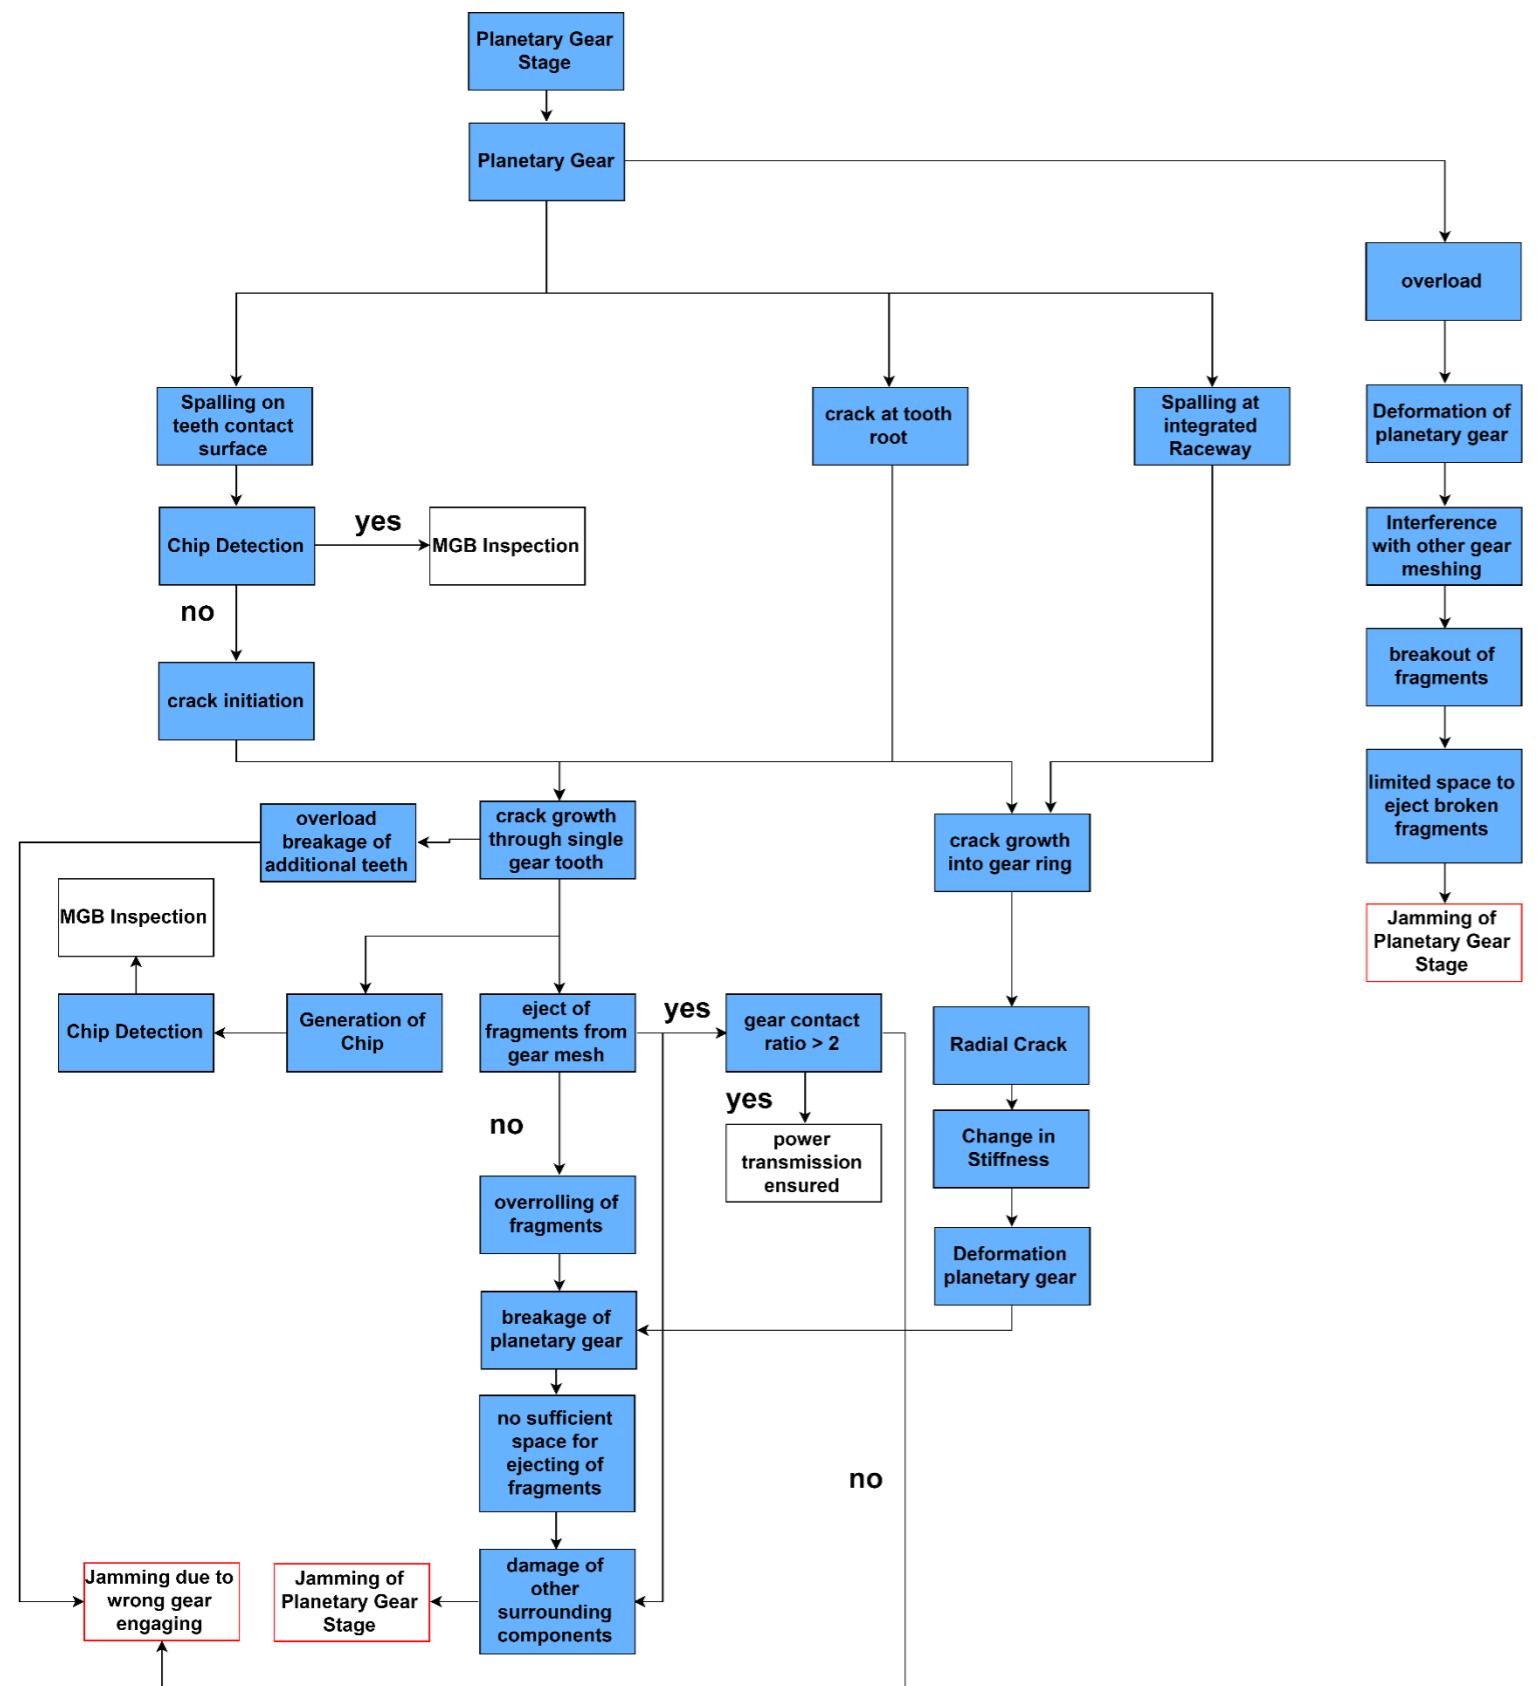
Figure 135: BO105 – Planetary Gear Stage

1 Crack on planetary carrier downwards of spline connection

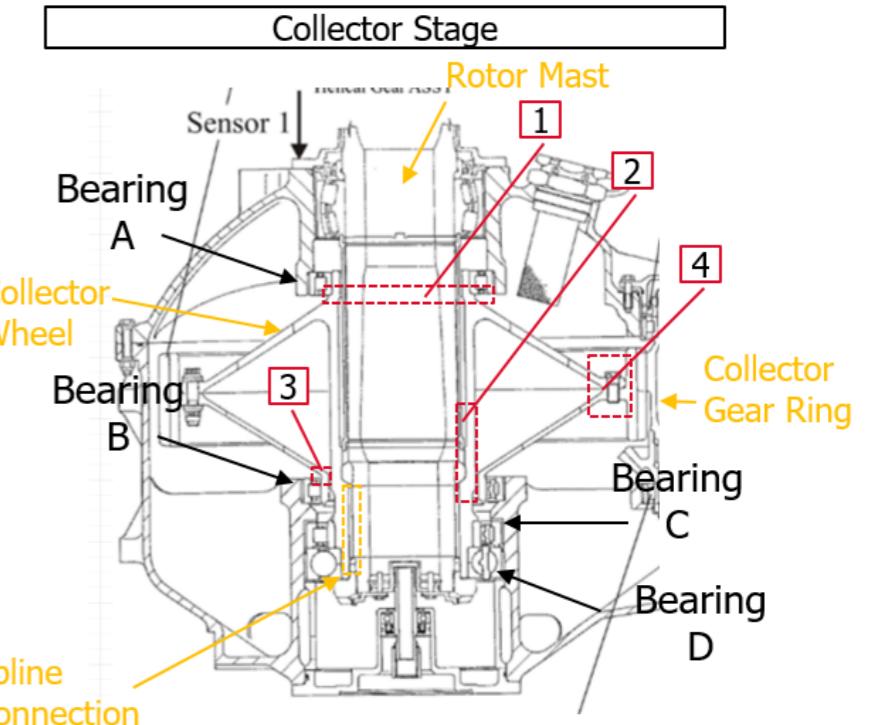
Figure 137: BK117 – Collector Shaft Ring

- [1] Crack on collector wheel downwards of raceway of bearing A
- [2] Crack on collector shaft upwards of spline connection
- [3] Crack on collector wheel upwards of raceway of bearing B
- [4] Crack on arms/connection of collector wheel to collector gear ring

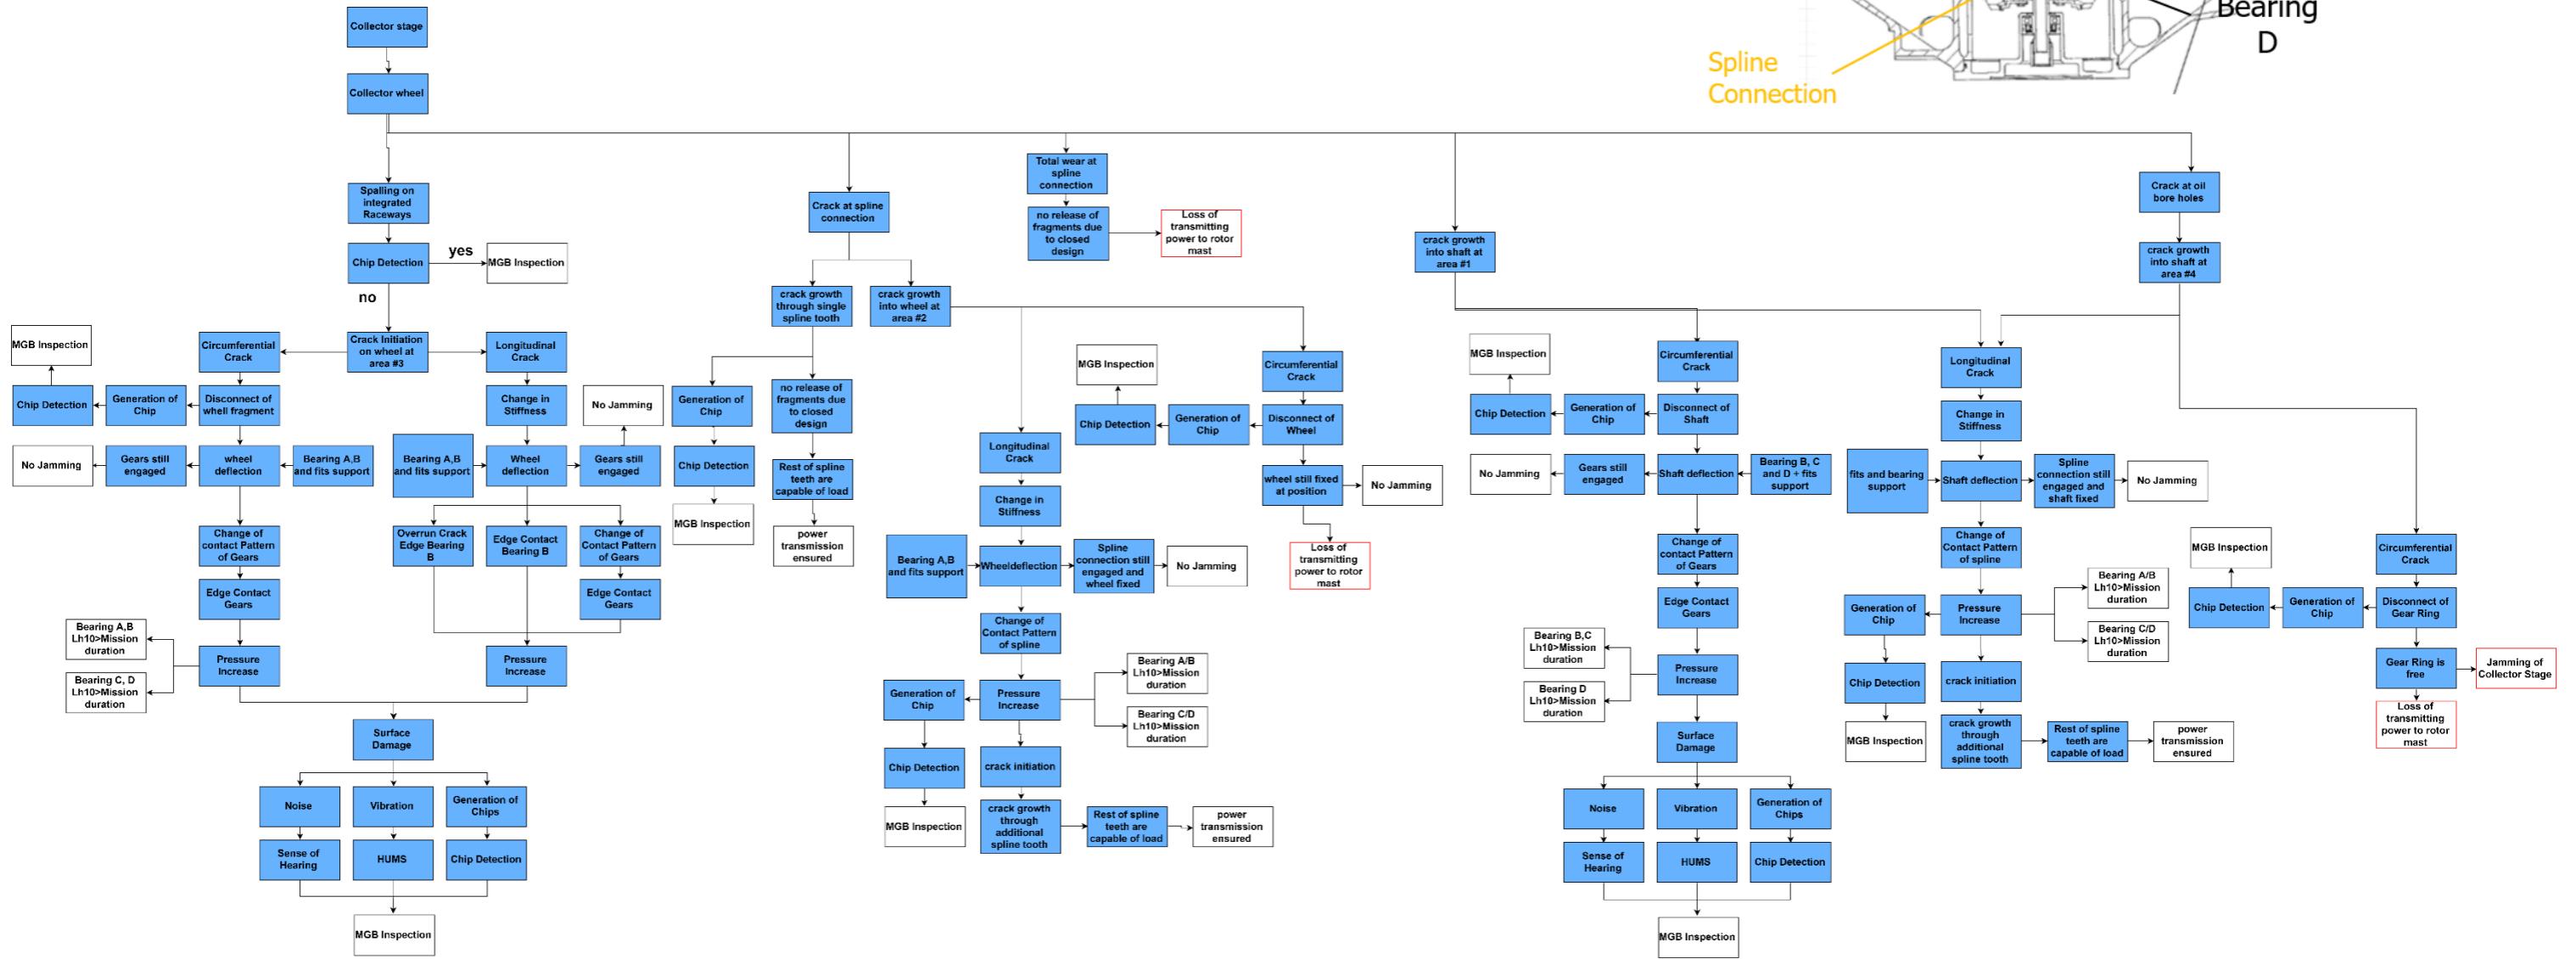
Figure 138: BK117 – Collector Wheel

143	Figure 138	Collector; 2 Engines Fenestron Tail Rotor	Collector wheel	Loss of transmitting power	Crack growth from spline connection into wheel	Circumferential crack

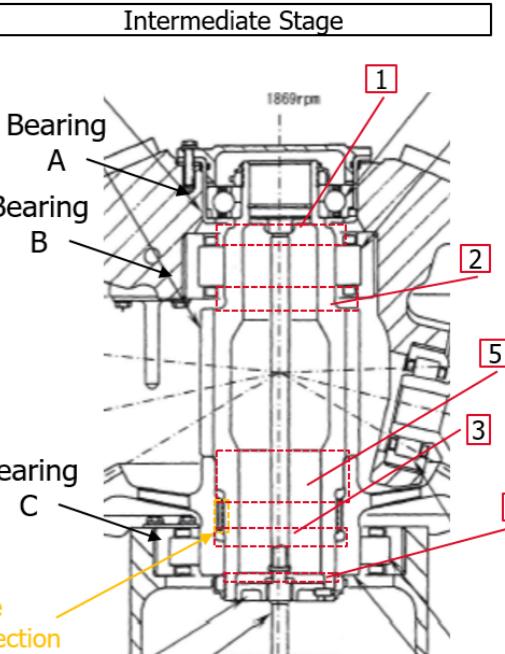
Figure 142: BK117 – Intermediate Shaft

① Crack on intermediate shaft between bearing A and B

② Crack on intermediate shaft between bearing B and spur gear

④ Crack on intermediate shaft at spline connection of oil pump drive

⑤ Crack on intermediate shaft between spur gear and spline connection of bevel gear
