Integrity improvement of rotorcraft main gear box

REPORT NUMBER:	D1-1
REPORT CLASSIFICATION:	UNCLASSIFIED
DATE:	14 January 2022
KNOWLEDGE AREA(S):	Research, rotorcraft MGB, configuration and component design
DESCRIPTOR(S):	Potential weaknesses, single point of failure, failure flow analysis
CUSTOMER:	European Aviation Safety Agency
CONTRACT NUMBER:	EASA.2019.C15
OWNER:	European Aviation Safety Agency
DISTRIBUTION:	Limited
CLASSIFICATION OF TITLE:	UNCLASSIFIED
Author(s):	W. Riesen, S. Hilleke

EVALUATE AND DEFINE ROTOR AND ROTOR DRIVE SYSTEM DESIGN
OPTIONS TO PREVENT SINGLE POINTS OF CATASTROPHIC FAILURE

Review of the state-of-the-art rotorcraft gearbox configurations and component designs

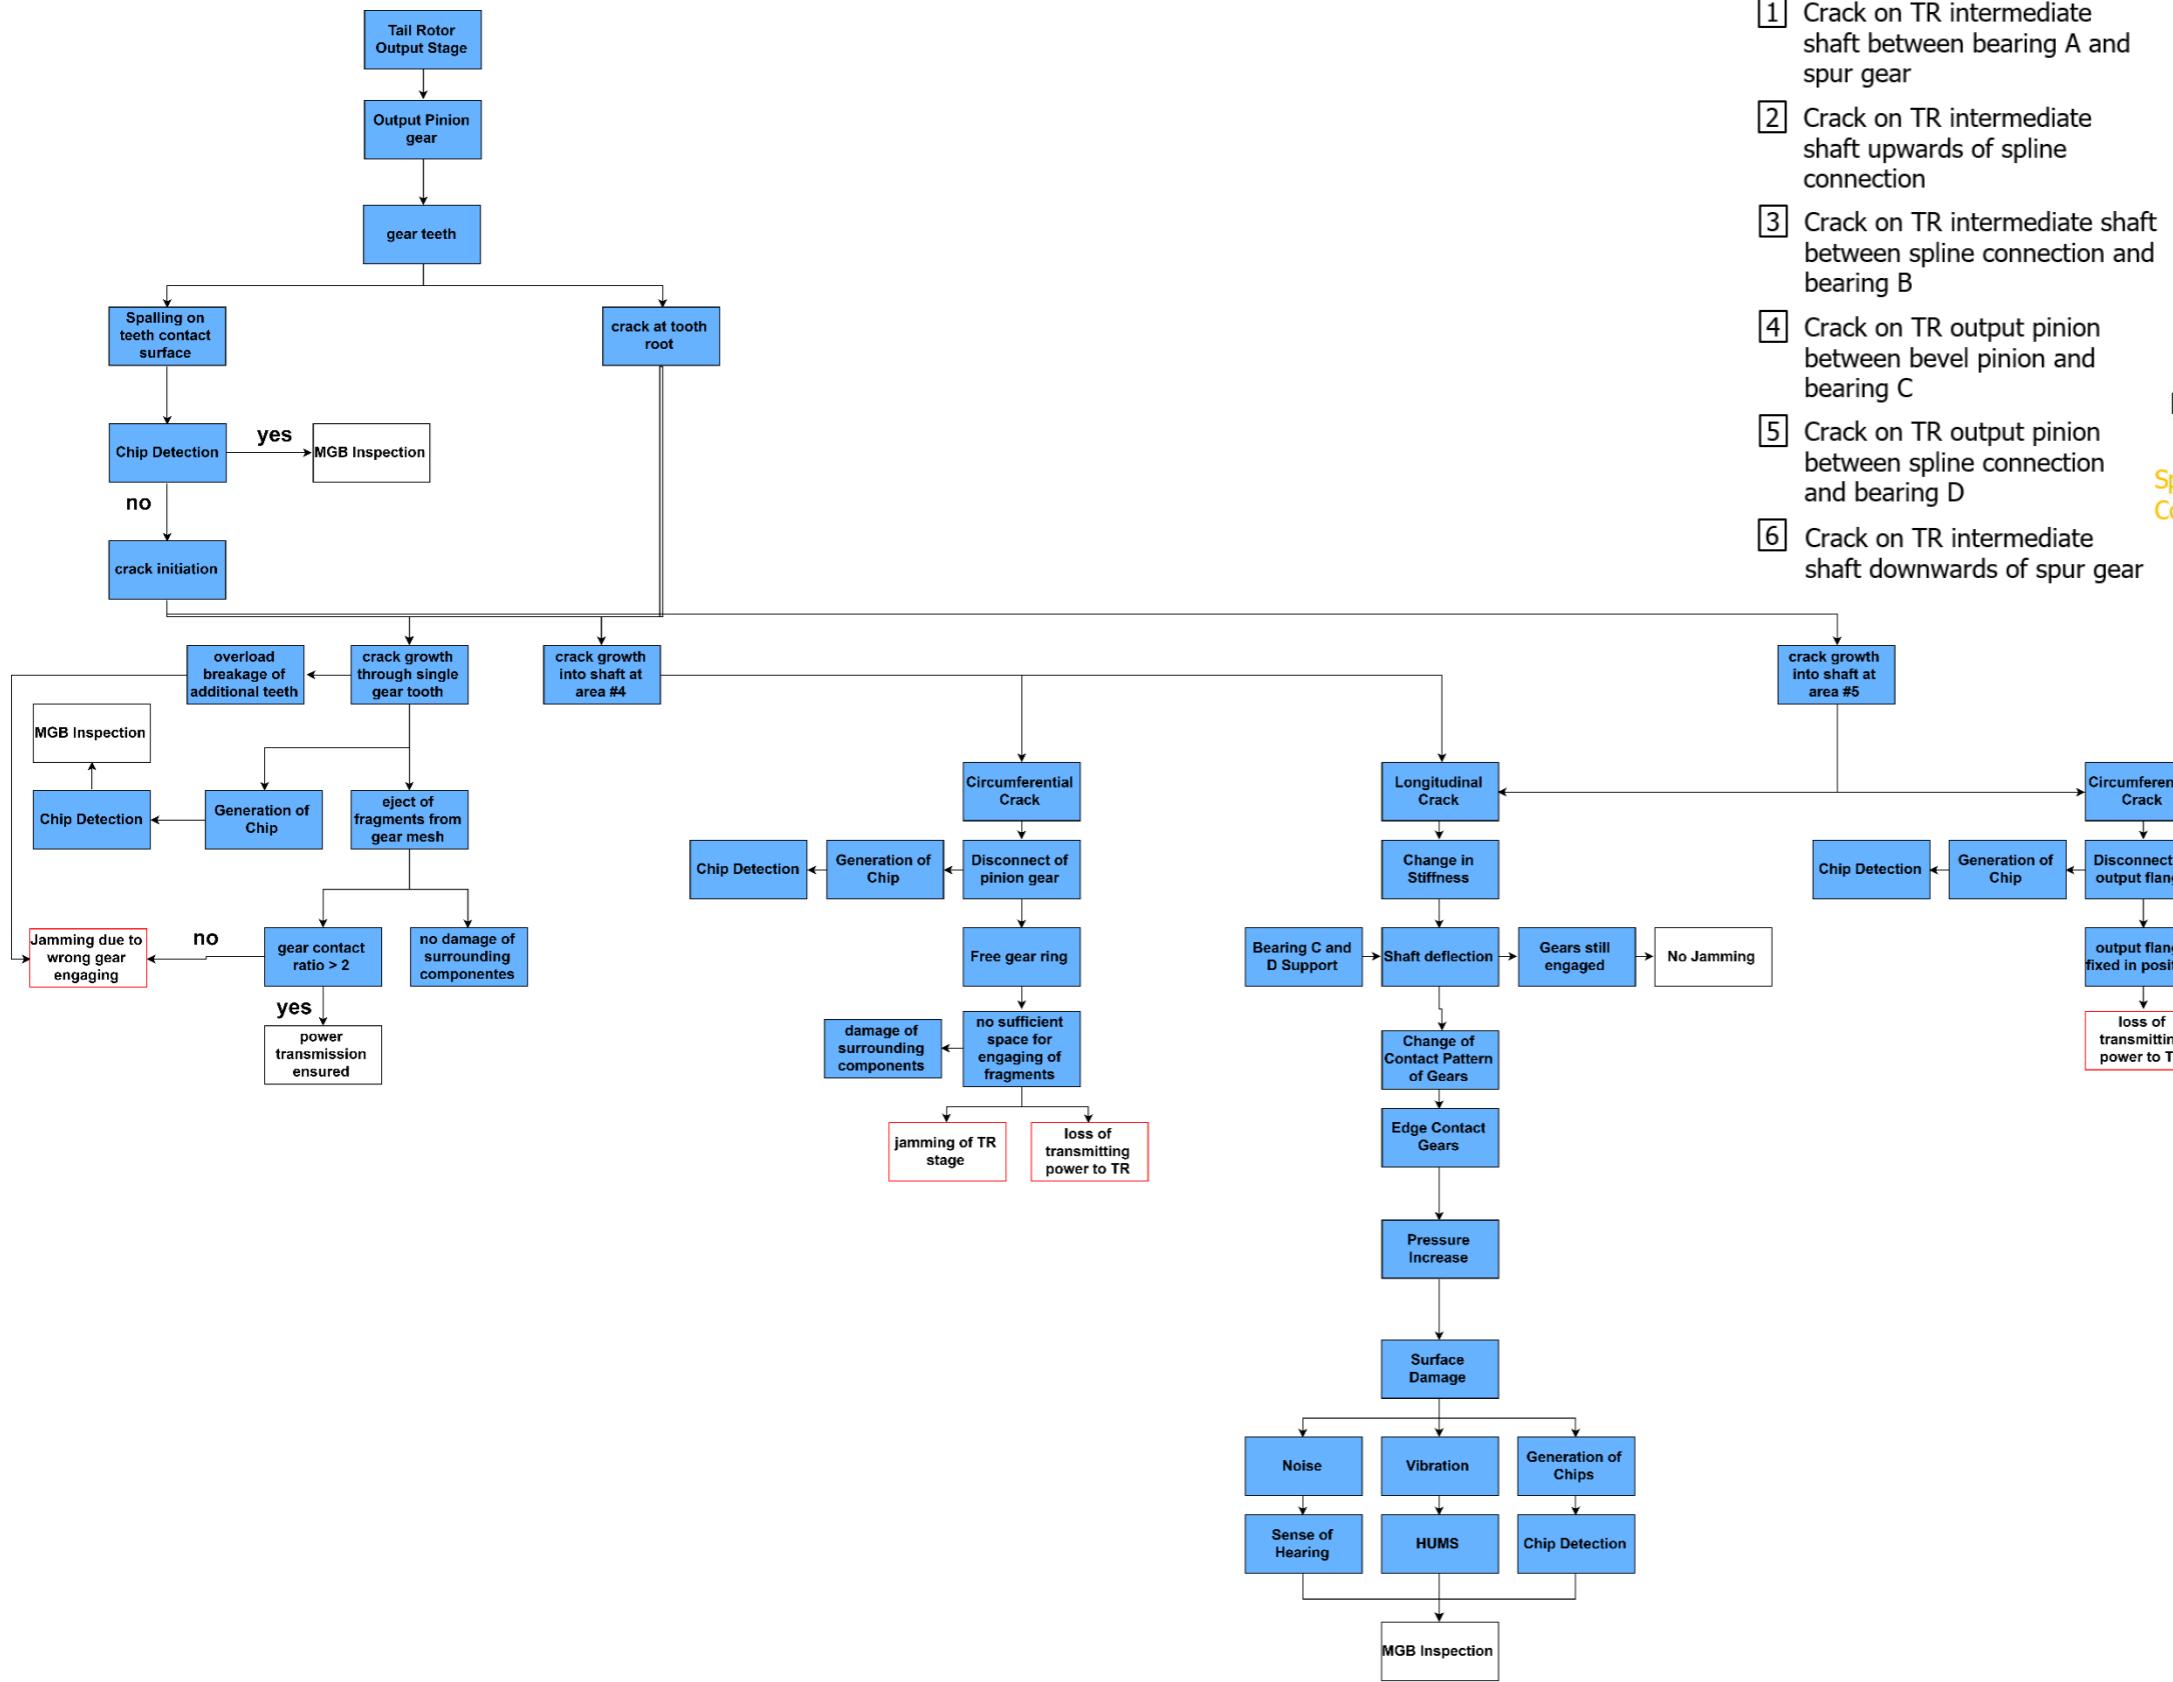
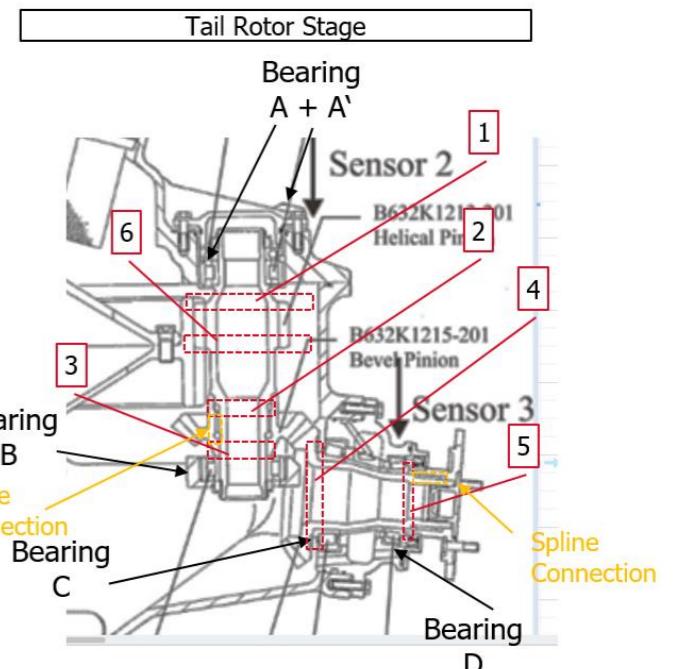
Figure 148: BK117 – Tail Rotor Output Pinion

177	Figure 148	Collector; 2 Engines Fenestron Tail Rotor	Tail rotor output pinion	Loss of transmitting power to tail rotor	Crack growth from tooth root or teeth contact surface into shaft between input spline and bearing	Circumferential crack	Output flange fixed in position
178	Figure 150	Collector; 3 Engines Split torque variant	Input pinion	Jamming due to wrong gear engaging	Crack growth from tooth root, teeth contact surface through single tooth or multiple teeth	Fracture of additional teeth	Ejection of fragments from gear mesh not possible
179	Figure 150	Collector; 3 Engines Split torque variant	Input pinion	Jamming due to wrong gear engaging	Crack growth from tooth root, teeth contact surface through single tooth or multiple teeth	Breakage of pinion tooth/teeth	Overload due to missing tooth contact ratio < 2
180	Figure 151	Collector; 3 Engines Split torque variant	Reduction stage shaft	Jamming of one of the 1 st reduction stages	Crack growth between upper integrated raceway and bevel gear	Circumferential crack	Shaft deflection No sufficient bearing support

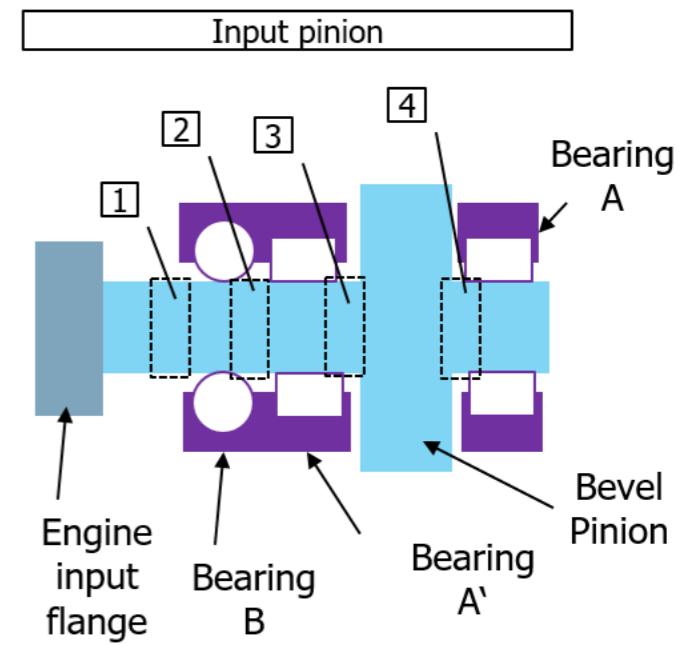
Figure 150: CH53-K – Input Pinion

- [1] Crack on input pinion between engine input flange and bearing B
- [2] Crack on input pinion between bearing B and A'
- [3] Crack on input pinion between bearing A' and bevel pinion
- [4] Crack on input pinion between bevel pinion and bearing A

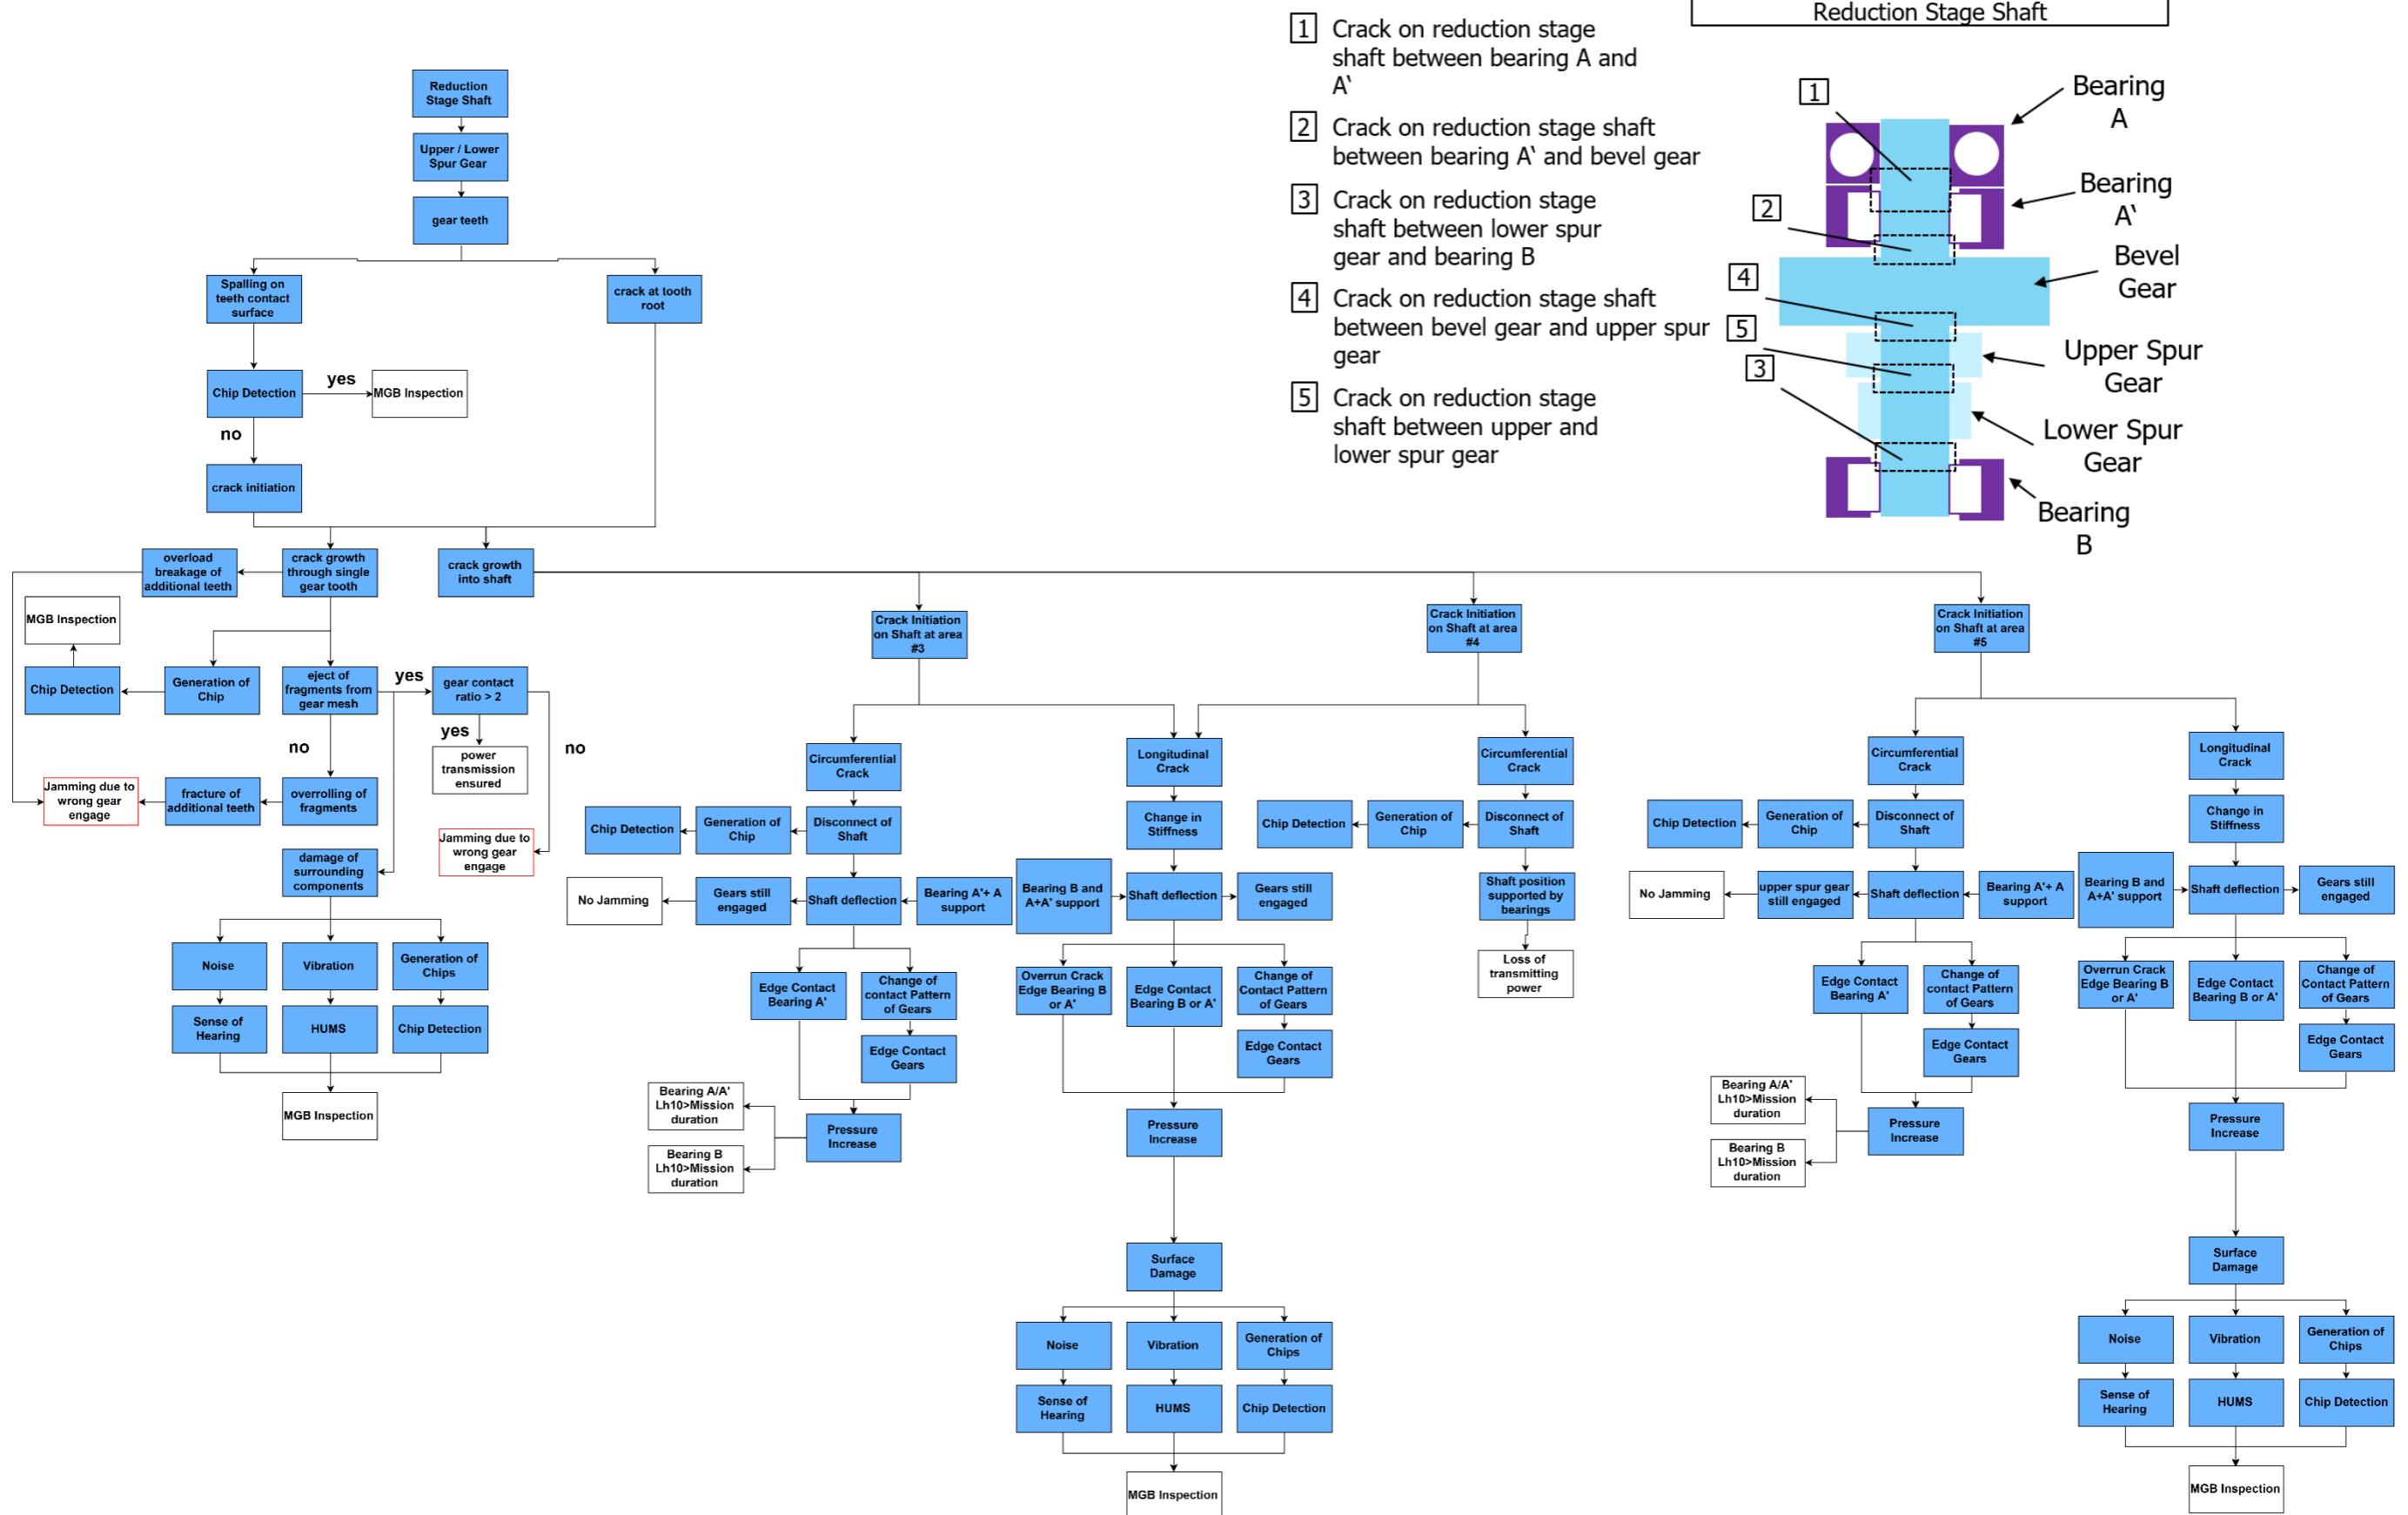
Figure 152: CH53-K – Reduction Stage Shaft

181	Figure 152	Collector; 3 Engines Split torque variant	Reduction stage upper / lower spur gear	Jamming due to wrong gear engaging	Crack growth from tooth root, teeth contact surface through single tooth or multiple teeth	Fracture of additional teeth	Ejection of fragments from gear mesh not possible
182	Figure 152	Collector; 3 Engines Split torque variant	Reduction stage upper / lower spur gear	Jamming due to wrong gear engaging	Crack growth from tooth root, teeth contact surface through single tooth or multiple teeth	Breakage of spur gear tooth/teeth	Overload due to missing tooth contact ratio < 2

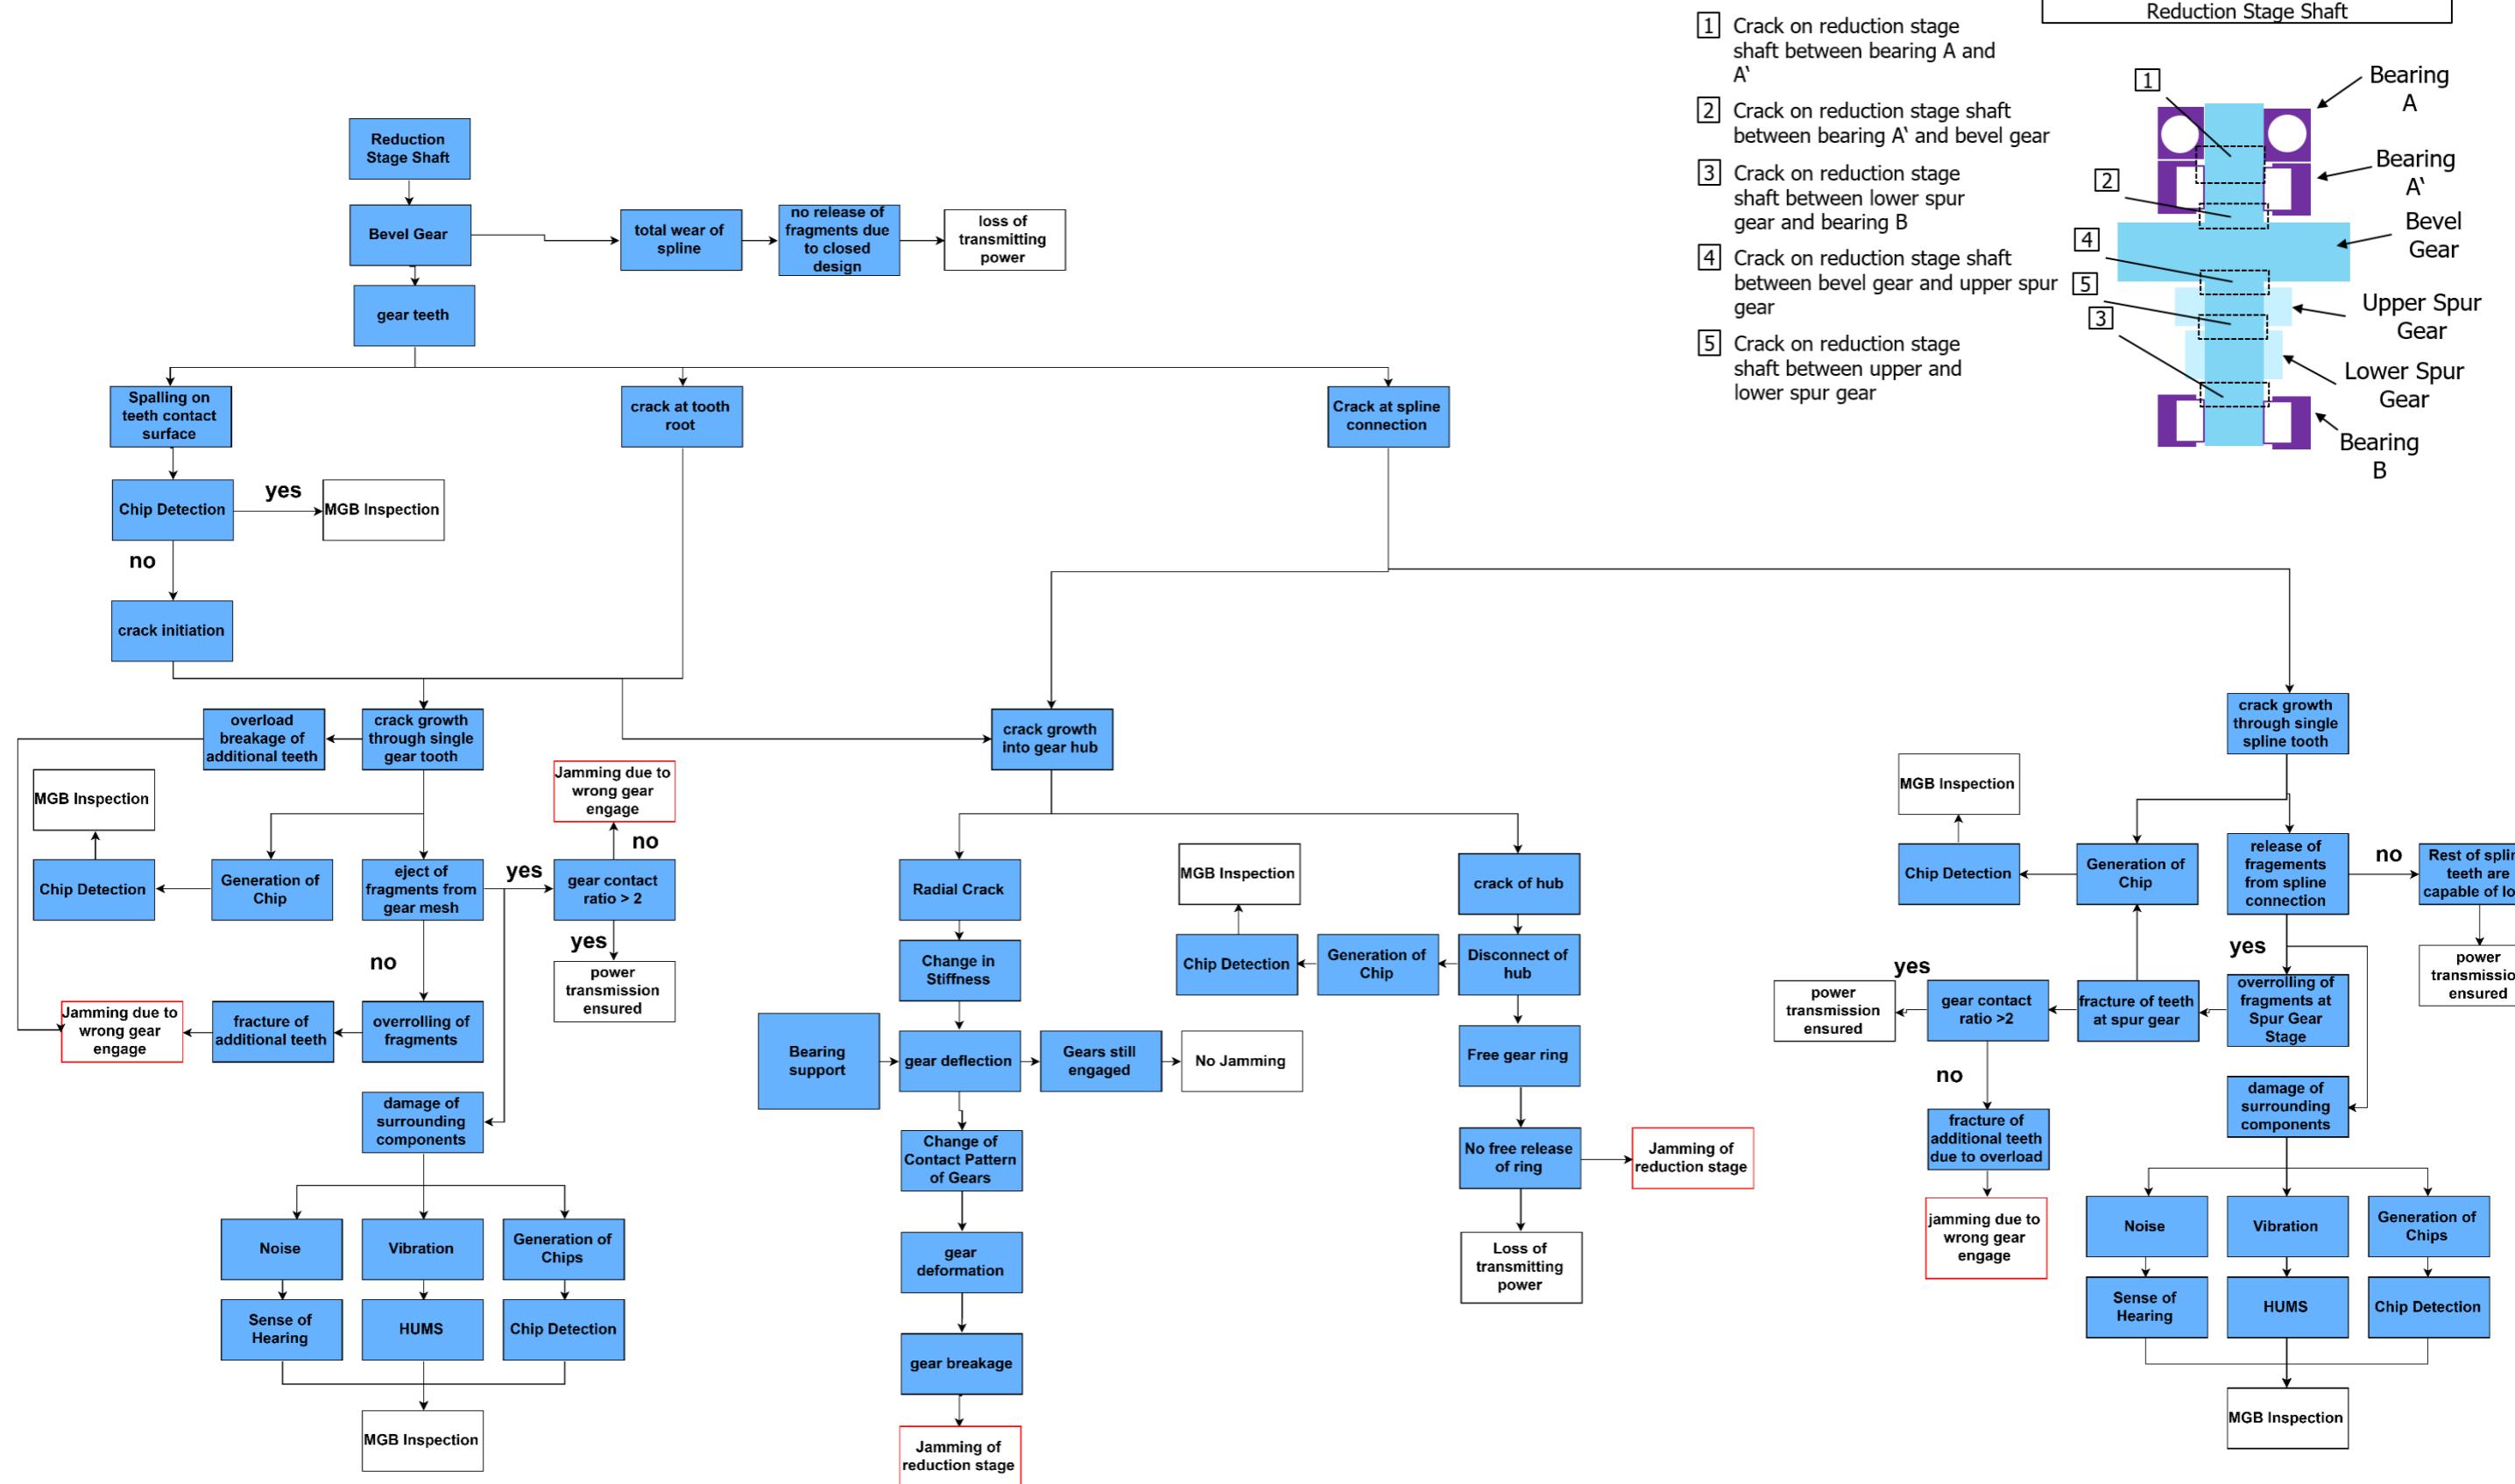
Figure 153: CH53-K – Reduction Stage Shaft

Pos.	Figure	Configuration	Subpart	Weakness	Crack/Wear growth	Breakage/Crack	Additional contributions
183	Figure 153	Collector; 3 Engines Split torque variant	Reduction stage shaft bevel gear	Jamming due to wrong gear engaging	Crack growth from tooth root, teeth contact surface through single tooth or multiple teeth	Fracture of additional teeth	Ejection of fragments from gear mesh not possible
184	Figure 153	Collector; 3 Engines Split torque variant	Reduction stage shaft bevel gear	Jamming due to wrong gear engaging	Crack growth from tooth root, teeth contact surface through single tooth or multiple teeth	Breakage of bevel gear tooth/teeth	Overload due to missing tooth contact ratio < 2
185	Figure 153	Collector; 3 Engines Split torque variant	Reduction stage shaft bevel gear	Jamming of reduction stage	Crack growth from tooth root, teeth contact surface or spline connection into gear hub	Crack of hub	Free ring gear No release of ring

186	Figure 153	Collector; 3 Engines Split torque variant	Reduction stage shaft bevel gear	Jamming of reduction stage	Crack growth from tooth root, teeth contact surface or spline connection into gear hub	Radial crack	Change in stiffness and deflection of gear Gear deformation and breakage
187	Figure 153	Collector; 3 Engines Split torque variant	Reduction stage shaft bevel gear	Jamming due to wrong gear engaging	Crack growth from tooth root, teeth contact surface or spline connection through spline tooth	Fracture of additional teeth	Overload due to missing tooth contact ratio < 2 due to teeth fracture at bull gear
188	Figure 154	Collector; 3 Engines Split torque variant	Quill shaft	Jamming due to wrong gear engaging	Crack growth from spline connection through single spline tooth	Fracture of additional teeth	Overload due to missing tooth contact ratio < 2 due to teeth fracture at bull gear
189	Figure 155	Collector; 3 Engines Split torque variant	Reduction stage large/small spur gear	Jamming of 2nd reduction stage	Crack growth from spur gear through single spline tooth	Fracture of additional teeth	Overload due to missing tooth contact ratio < 2 due to teeth fracture at bull gear

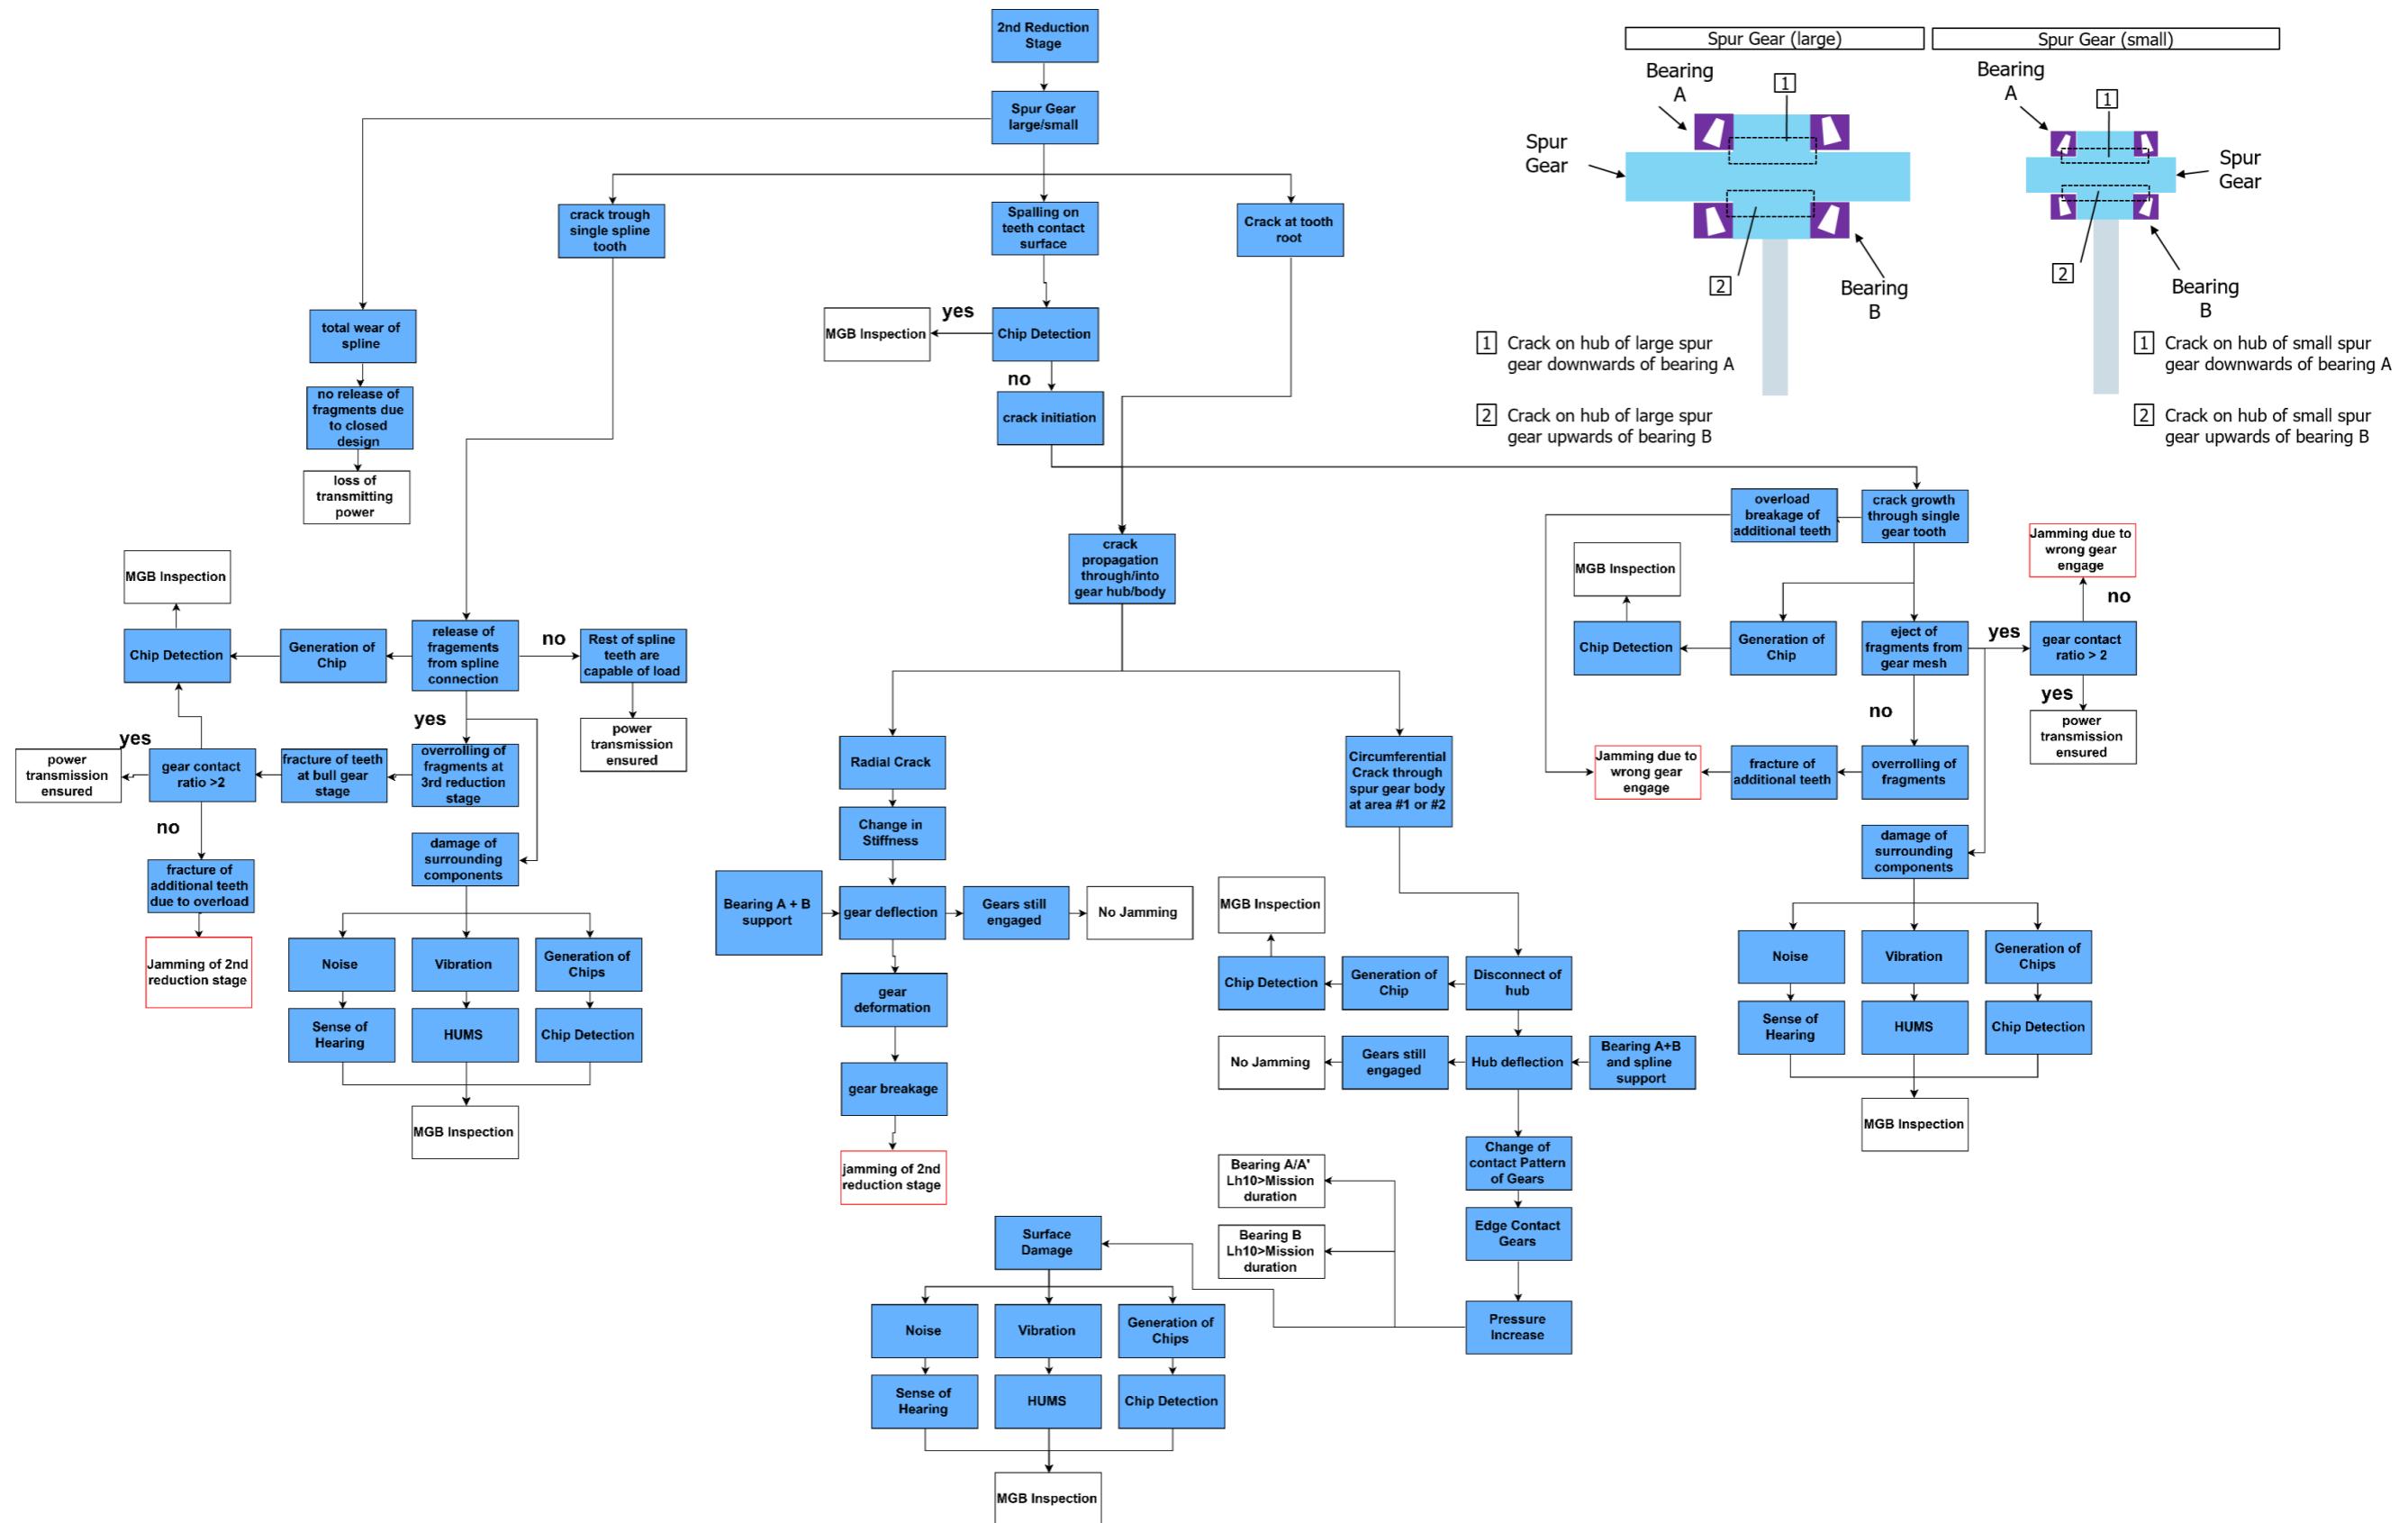
Figure 155: CH53-K – Spur Gear small/large

190	Figure 155	Collector; 3 Engines Split torque variant	Reduction stage large/small spur gear	Jamming of 2nd reduction stage	Crack growth from tooth root or contact surface through gear hub/body	Radial crack	Change in stiffness and deflection of gear Gear deformation and breakage
191	Figure 155	Collector; 3 Engines Split torque variant	Reduction stage large/small spur gear	Jamming due to wrong gear engaging	Crack growth from tooth root or contact surface through single gear tooth	Fracture of additional teeth	Ejection of fragments from gear mesh not possible
192	Figure 155	Collector; 3 Engines Split torque variant	Reduction stage large/small spur gear	Jamming due to wrong gear engaging	Crack growth from tooth root or contact surface through single gear tooth	Breakage of spur gear tooth/teeth	Overload due to missing tooth contact ratio < 2

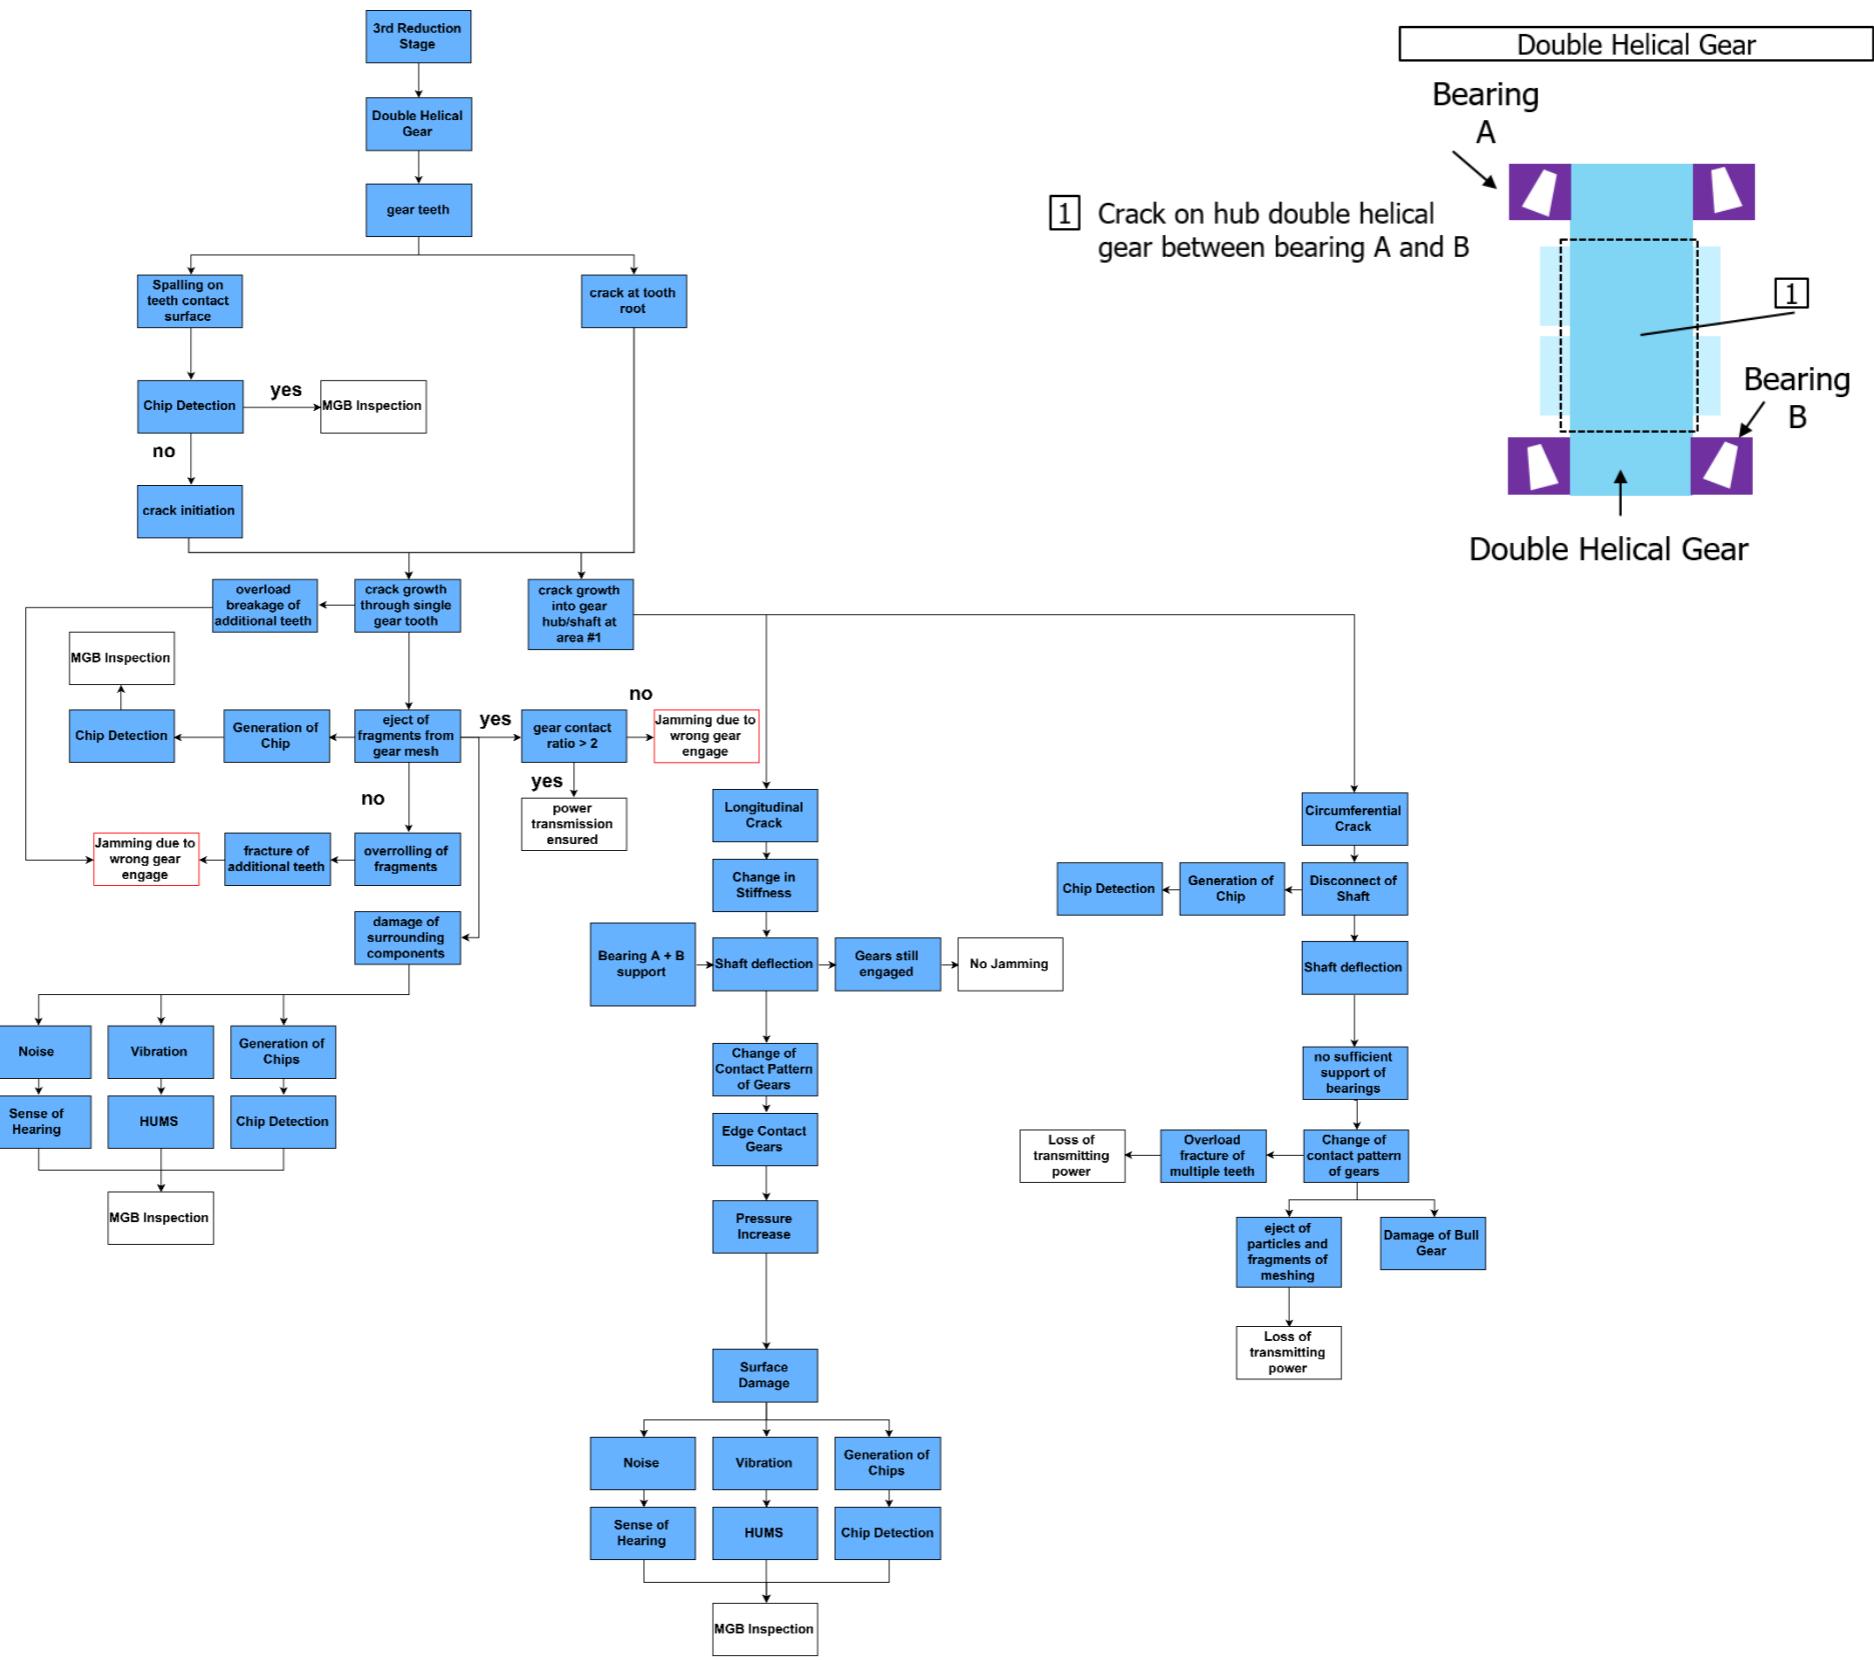
Figure 156: CH53-K – Double Helical Gear

Pos.	Figure	Configuration	Subpart	Weakness	Crack/Wear growth	Breakage/Crack	Additional contributions
193	Figure 156	Collector; 3 Engines Split torque variant	Double helical gear	Jamming of 3rd reduction stage	Crack growth from tooth root or teeth contact surface through single tooth or multiple teeth	Fracture of additional teeth	Ejection of fragments from gear mesh not possible
194	Figure 156	Collector; 3 Engines Split torque variant	Double helical gear	Jamming of 3rd reduction stage	Crack growth from tooth root or teeth contact surface through single tooth or multiple teeth	Breakage of helical gear tooth/teeth	Overload due to missing tooth
195	Figure 157	Collector; 3 Engines Split torque variant	Helical bull gear	Jamming due to wrong gear engaging	Crack growth from tooth root, tooth contact surface or spline connection through gear tooth	Fracture of additional teeth	Ejection of fragments from gear mesh not possible
