Integrity improvement of rotorcraft main gear box

REPORT NUMBER:	D1-1
REPORT CLASSIFICATION:	UNCLASSIFIED
DATE:	14 January 2022
KNOWLEDGE AREA(S):	Research, rotorcraft MGB, configuration and component design
DESCRIPTOR(S):	Potential weaknesses, single point of failure, failure flow analysis
CUSTOMER:	European Aviation Safety Agency
CONTRACT NUMBER:	EASA.2019.C15
OWNER:	European Aviation Safety Agency
DISTRIBUTION:	Limited
CLASSIFICATION OF TITLE:	UNCLASSIFIED
Author(s):	W. Riesen, S. Hilleke

EVALUATE AND DEFINE ROTOR AND ROTOR DRIVE SYSTEM DESIGN
OPTIONS TO PREVENT SINGLE POINTS OF CATASTROPHIC FAILURE

Review of the state-of-the-art rotorcraft gearbox configurations and component designs

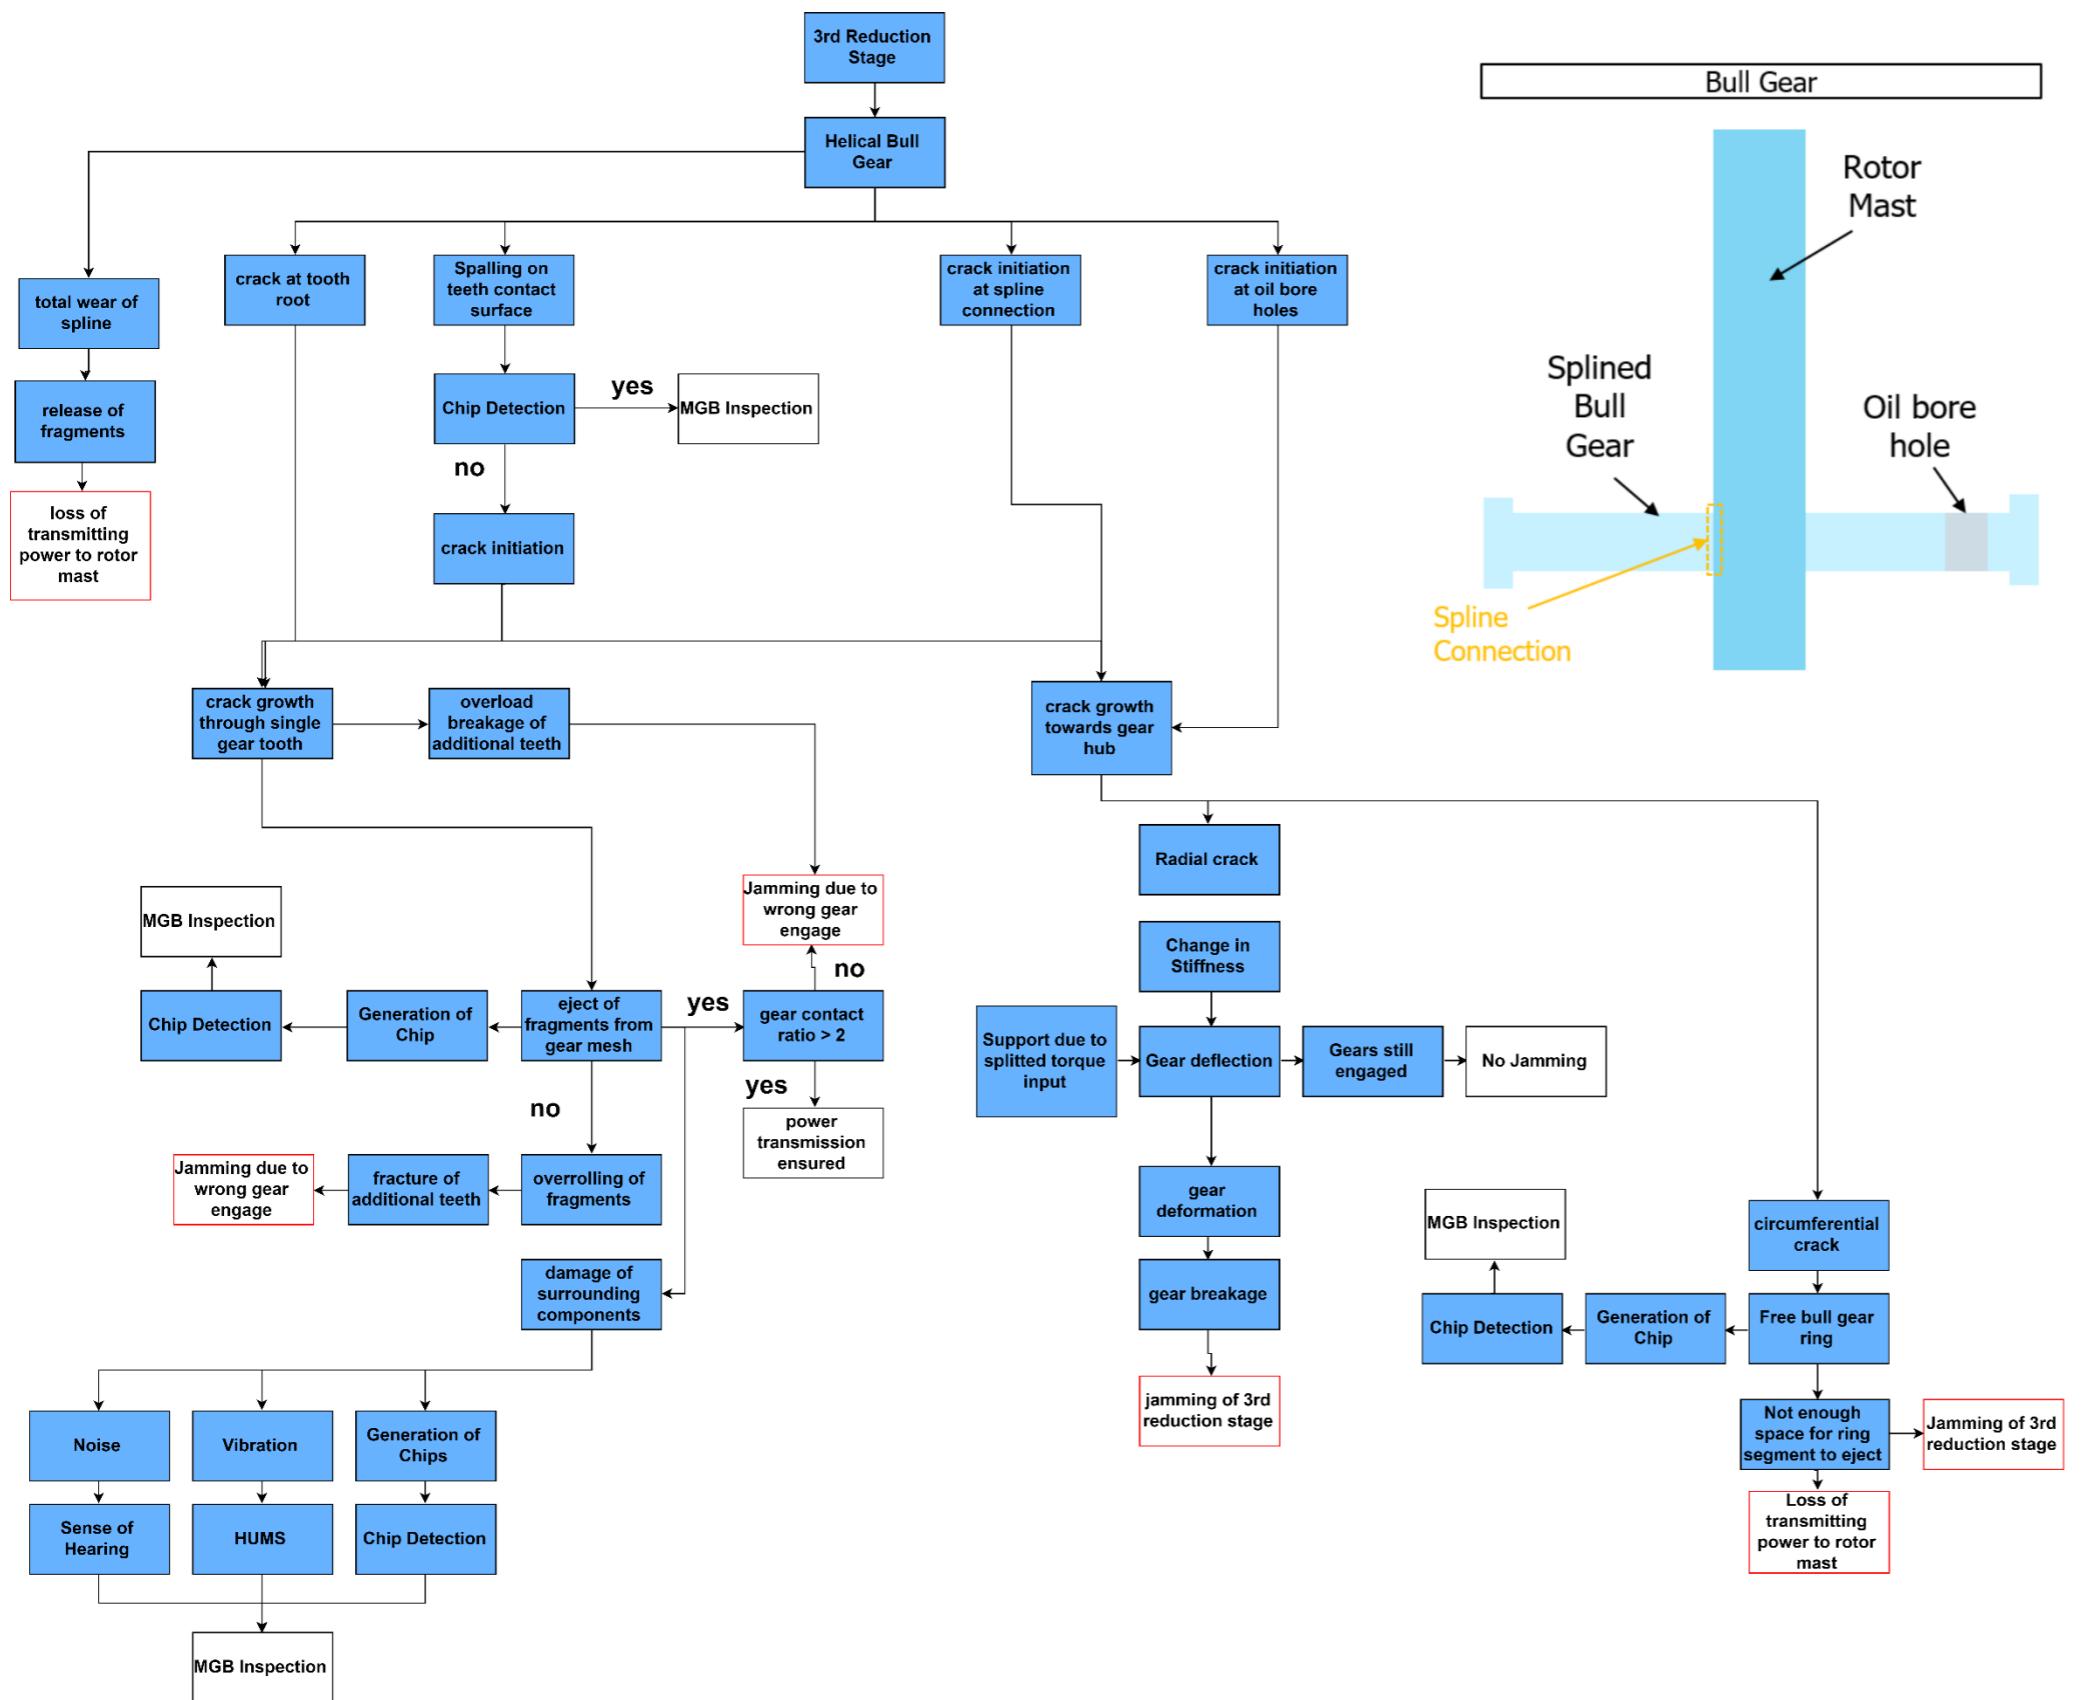
Figure 157: CH53-K – Helical Bull Gear

196	Figure 157	Collector; 3 Engines Split torque variant	Helical bull gear	Jamming due to wrong gear engaging	Crack growth from tooth root, tooth contact surface or spline connection through gear tooth	Breakage of bull gear tooth/teeth	Overload due to missing tooth
197	Figure 157	Collector; 3 Engines Split torque variant	Helical bull gear	Jamming of 3rd reduction stage	Crack growth from tooth root, tooth contact surface, spline or oil bore holes toward gear hub	Radial crack	Change in stiffness and deflection of gear
198	Figure 157	Collector; 3 Engines Split torque variant	Helical bull gear	Loss of transmitting power to rotor mast	Crack growth from tooth root, tooth contact surface, spline or oil bore holes toward gear hub	Circumferential crack	Free bull gear ring
199	Figure 157	Collector; 3 Engines Split torque variant	Helical bull gear	Jamming of 3rd reduction stage	Crack growth from tooth root, tooth contact surface, spline or oil bore holes toward gear hub	Circumferential crack	Free bull gear ring

200	Figure 157	Collector; 3 Engines Split torque variant	Helical bull gear	Loss of transmitting power to rotor mast	Total wear at spline connection	n/a	No release of fragments due to closed design
201	Figure 158	Collector; 3 Engines Split torque variant	Rotor mast	Loss of transmitting power	Crack growth from integrated raceway into rotor mast	Circumferential crack	
202	Figure 158	Collector; 3 Engines Split torque variant	Rotor mast	Loss of transmitting power	Crack growth from integrated raceway into rotor mast	Longitudinal crack	Change in stiffness and shaft deformation
							Change of crack growth direction

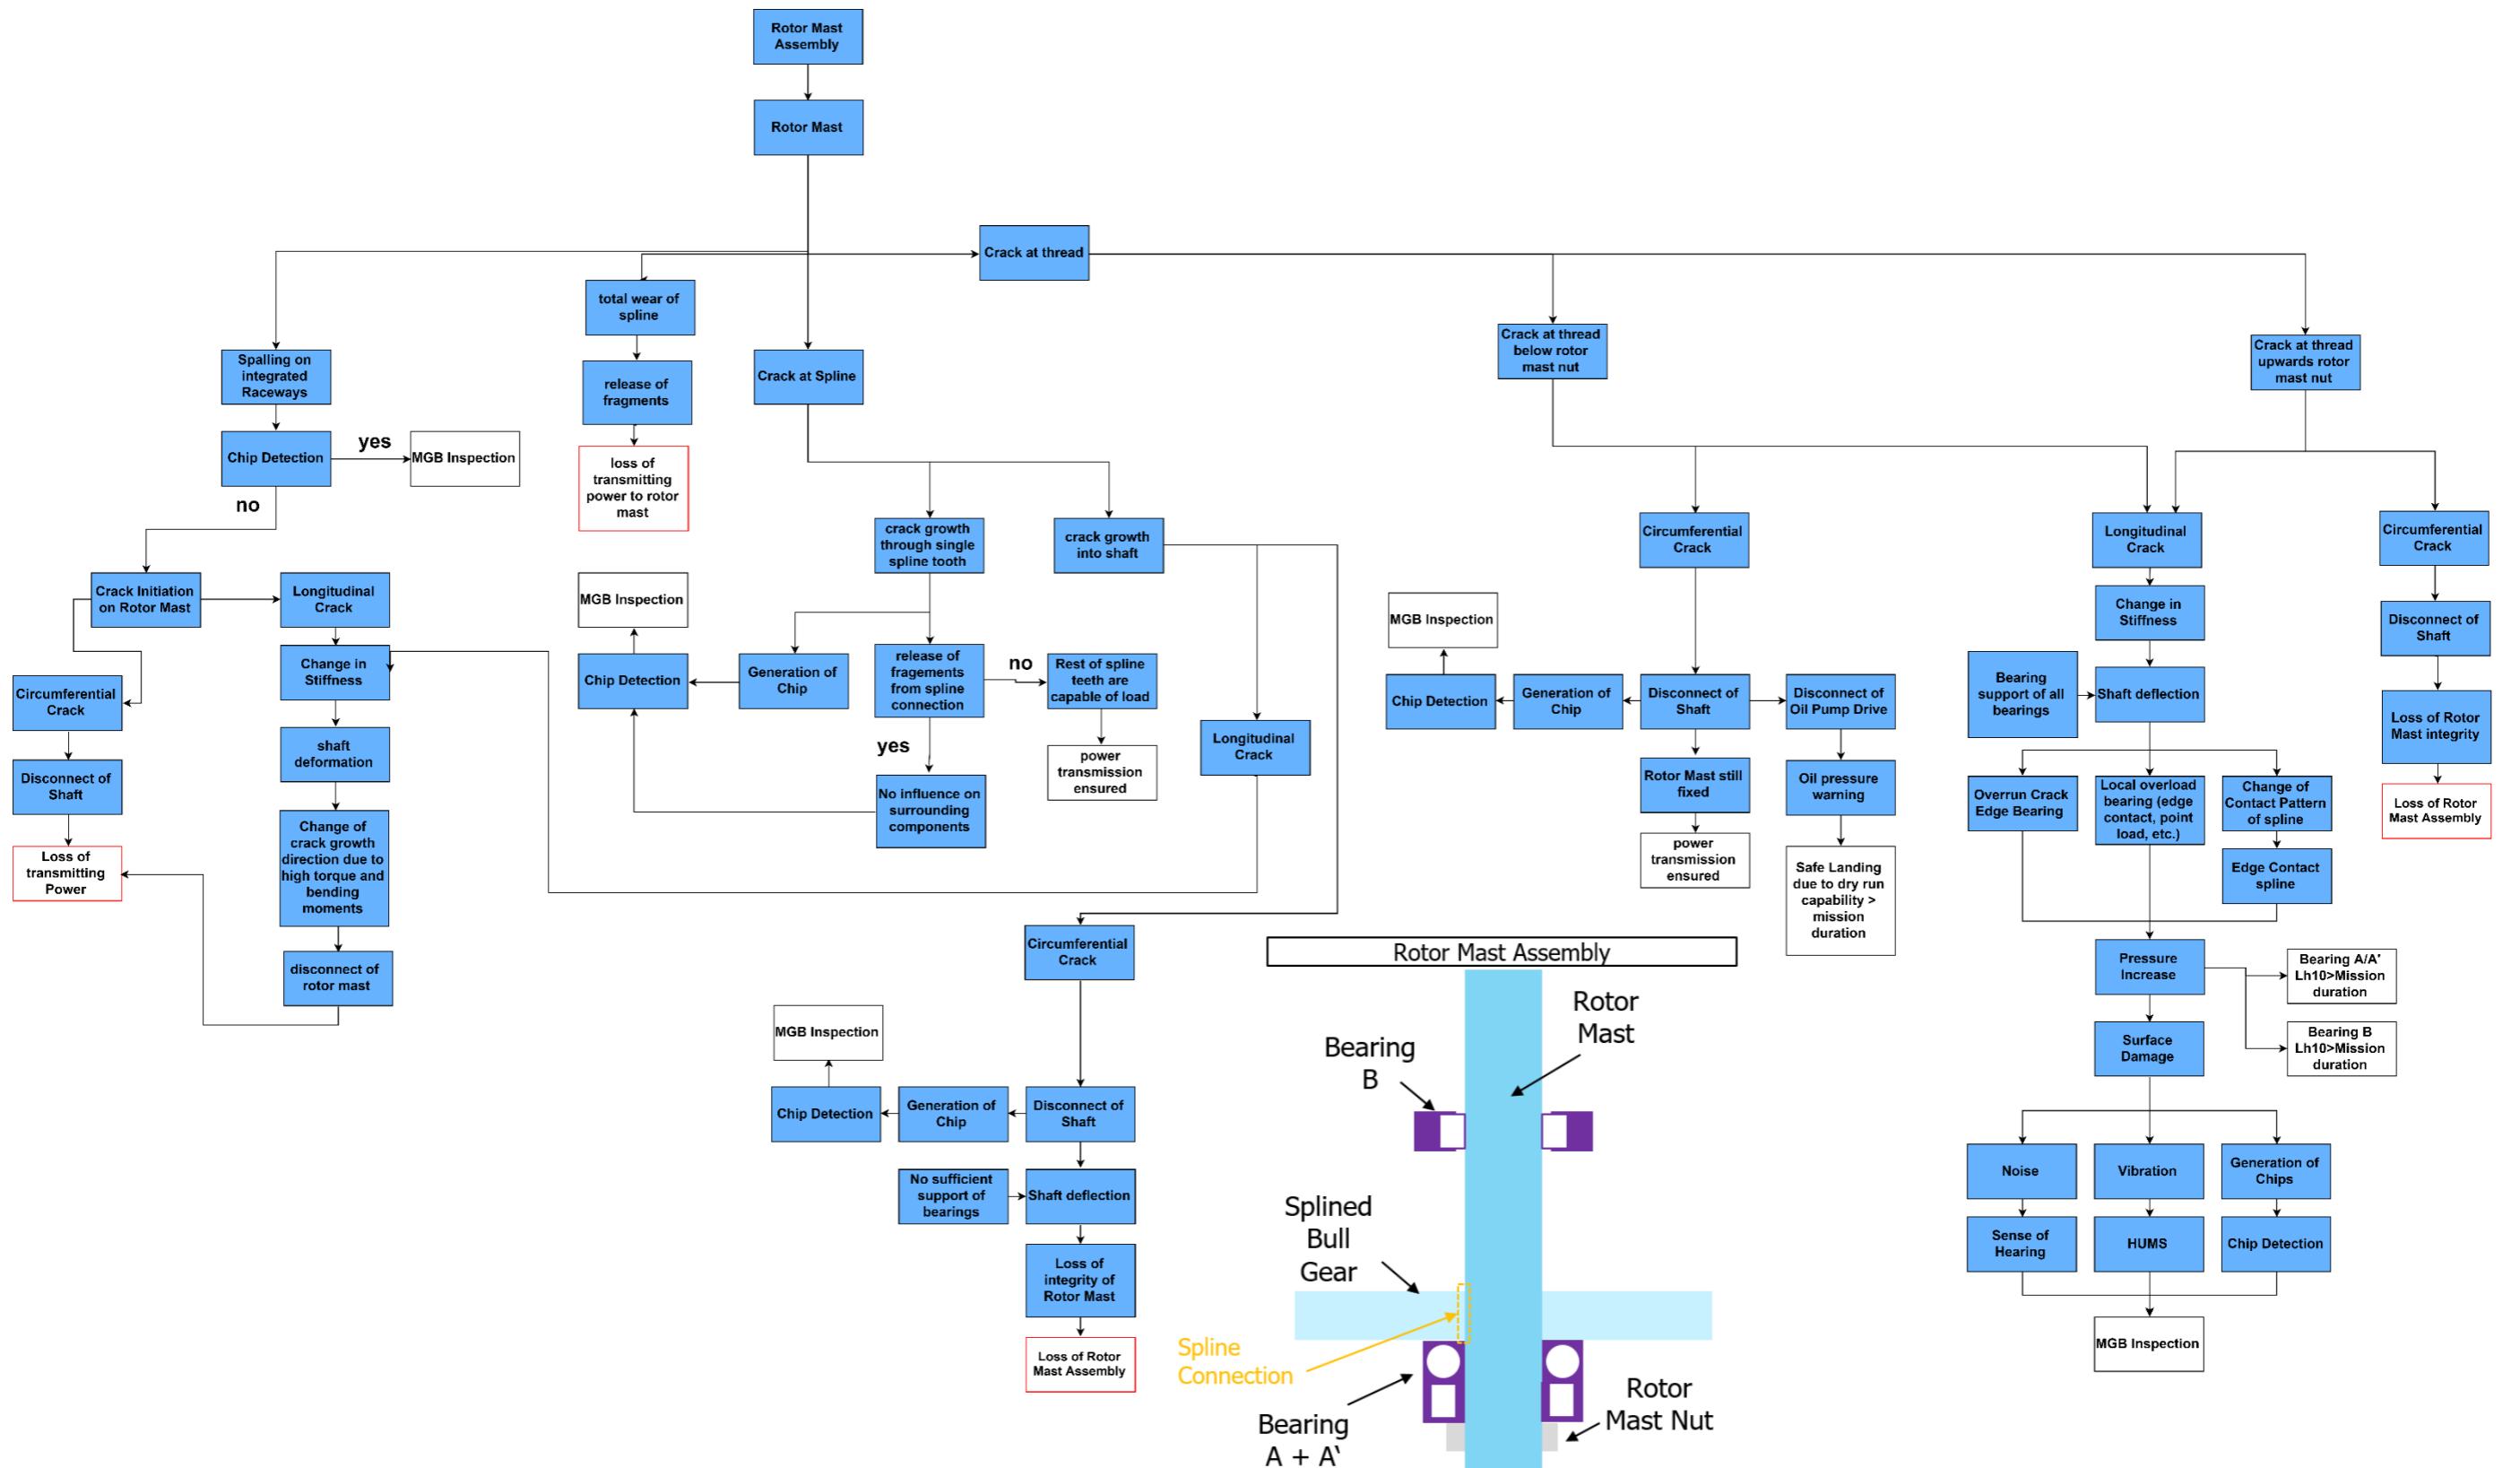
Figure 158: CH53-K – Rotor Mast Assembly

Pos.	Figure	Configuration	Subpart	Weakness	Crack/Wear growth	Breakage/Crack	Additional contributions
203	Figure 158	Collector; 3 Engines Split torque variant	Rotor mast	Loss of rotor mast assembly	Crack growth from spline into shaft	Circumferential crack	Shaft deflection Change in stiffness and shaft deformation
204	Figure 158	Collector; 3 Engines Split torque variant	Rotor mast	Loss of rotor mast assembly	Crack growth from spline into shaft	Longitudinal crack	Change of crack growth direction
205	Figure 158	Collector; 3 Engines Split torque variant	Rotor mast	Loss of rotor mast assembly	Crack growth from thread upwards rotor mast nut	Circumferential crack	Loss of integrity of rotor mast
206	Figure 158	Collector; 3 Engines Split torque variant	Rotor mast	Loss transmitting power to rotor mast	Total wear at spline connection	n/a	No release of fragments due to closed design
