Research Project EASA.2012/2

MASH - Metallurgical Assessment of Standard Hardware

European Aviation Safety Agency - Metallurgical Assessment of Standard Hardware, EASA reference E2.2012.C.02.

ES/13/49

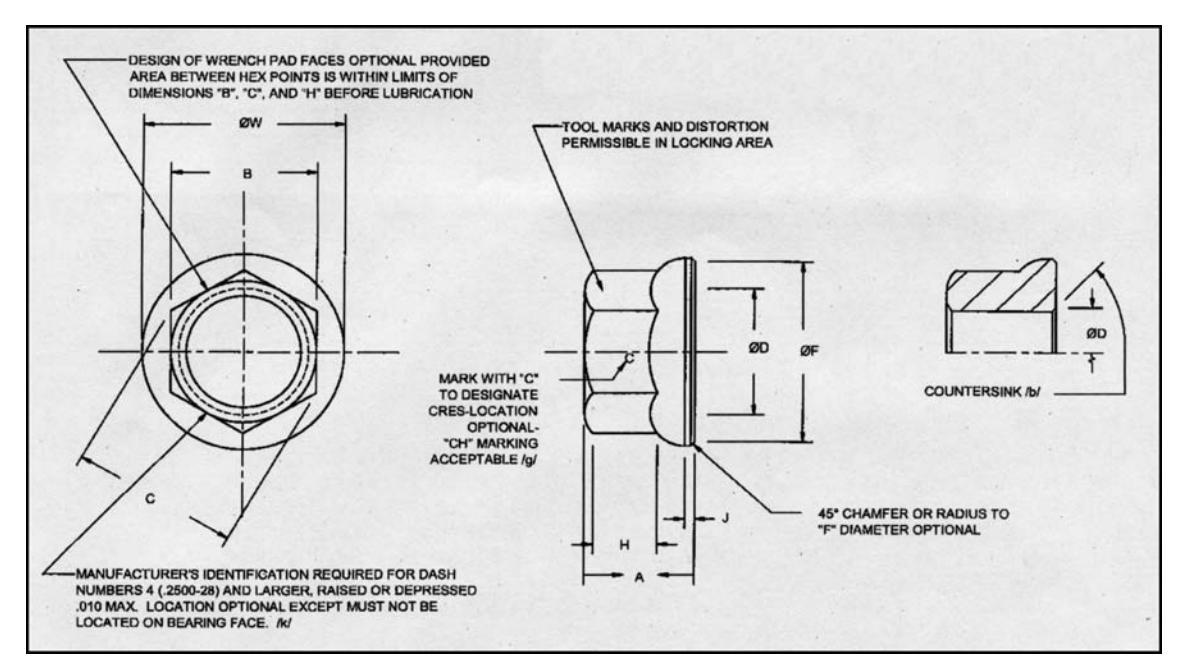
Figure 3. Diagram of standard hardware from NAS1291 rev.13.

It can be seen from the red highlighted results that four of the submitted samples fail the dimensional requirements and another two only satisfy these requirements, with respect to the maximum value of diameter D (i.e. the inner diameter of the annular bearing surface), if measurement error is taken into account. It should be noted however, that despite this discrepancy the actual contact bearing areas of all the six samples are well within the wide range of contact bearing areas which can be calculated from the specified dimensions, see the area limits given in the final column of Table 1. The calculated annular bearing contact surface area in all cases (right hand column) was greater than the absolute minimum value that would have been permitted by the specified dimensions, i.e. 5.56mm², see Figure 4 below

Whilst it is acknowledged that these results take the six samples out of conformance with the specification, it is not thought that these minimal failings would have had any significant effect on the performance of the nuts or would have played any contributory role in producing the type of longitudinal cracking reported in other examples of these nuts. The results are a possible indication of a lack of quality control which is rigorous enough to detect such failings.
