***International Maintenance Review Board Policy Board (IMRBPB)***

***IP Number: 135***

**Title:** Zonal Analysis for Zones with different levels of Access.

**Submitter:** EASA, MRB Section

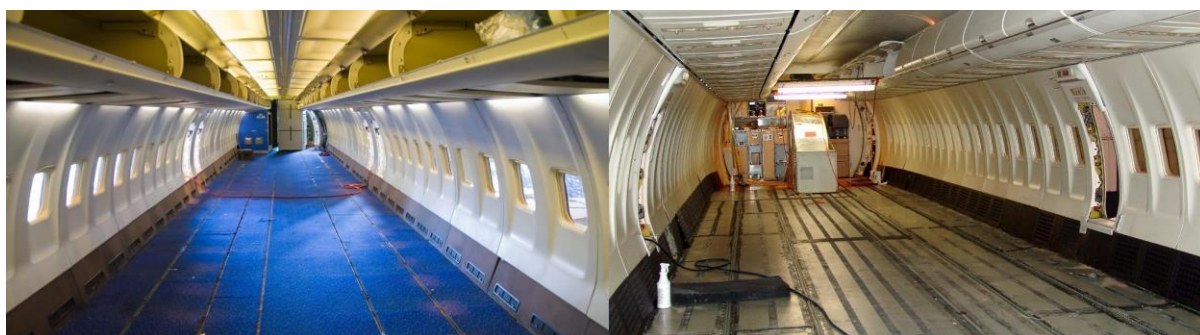
#### **Example 2: Cabin zones with seats and galleys/lavatories removed**

Many items are available for a GVI after removal of the passenger seats and floor covering.

- Corrosion or accidental damage to the seat rails or galley/toilet attachment points
- Loose or broken dado panels and vent grills
- Loose or damaged passenger service units, luggage bins or sidewall lining
- Loose or damaged floor panels, damaged or missing floor sealing

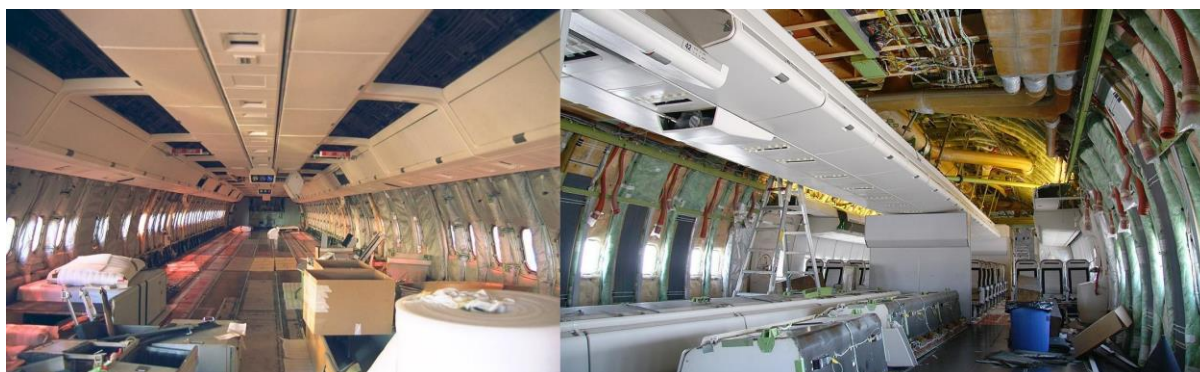
#### **Example 3: Cabin zones with interior and lining partly removed**

Many piping, ducting, wiring, other structures, insulation blankets etc. is available for a GVI after removal of the floor covering, sidewall linings, ceiling panels and some of the bins.

Typical examples for Zonal findings at this level of access:

- Corroded, cracked or accidentally damaged structures (mainly other structures and support items)
- Contamination of cabin interior items (bins, lining etc.)
- Damaged, leaking, chafing, loose piping and ducting
- Damaged, loose, corroded, chafing flight control cables, worn cable guides

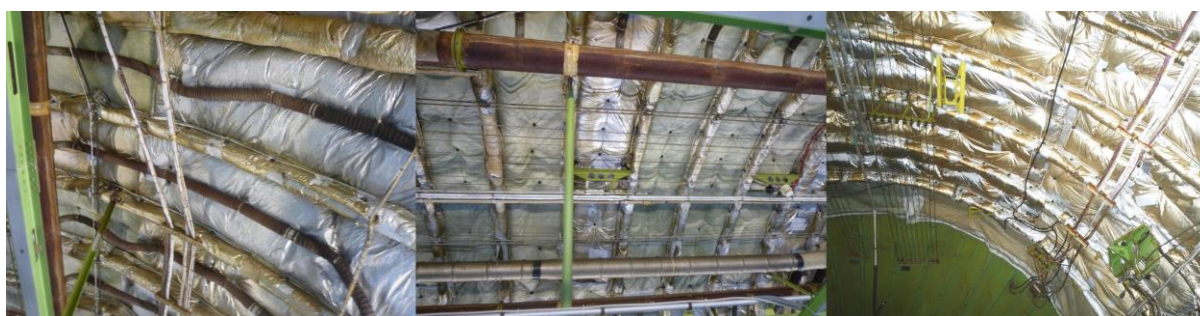
#### **Example 4: Cabin zone with interior and lining fully removed**

Piping, ducting, wiring, other structures, insulation blankets etc. visible for a Zonal inspection

- Damaged, loose or contaminated, discoloured insulation blankets indicating overheating, leakage, spill events
- Damaged, leaking, chafing, loose piping and ducting
- Damaged, loose, corroded, chafing flight control cables, worn cable guides
