European Aviation Safety Agency	Date: 9 March 2016
Runway Excursions (RE) analysis 2011 - 2015	
SM1. Safety Intelligence and Performance	SM1.1 Safety Analysis Section

Annex A: Safety data collection for RMT.0296 - Review of aeroplane performance requirements for CAT operations

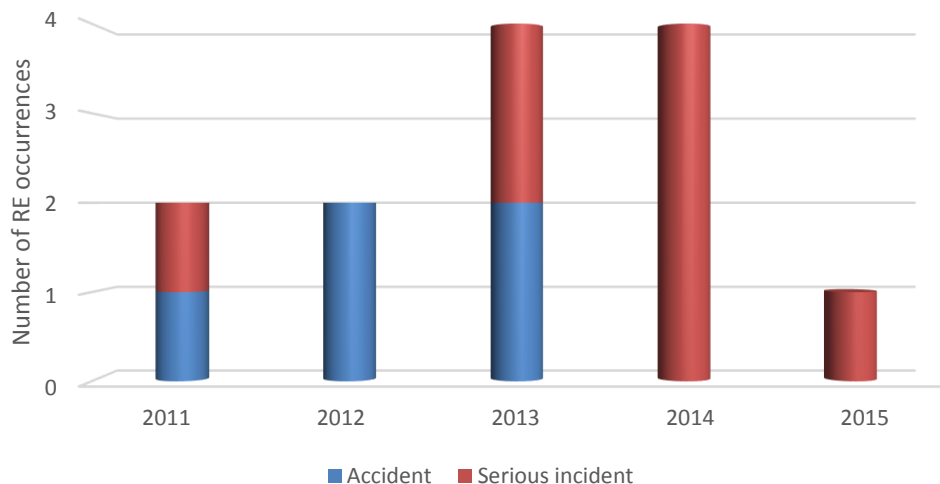
Figure 1. Distribution by year and class of the occurrence

The set of study is composed of 13 occurrences, each of them involving one aircraft. All accidents and serious incidents occurred in the period of 5 years between 01/01/2011 and 31/12/2015. Figure 1 summarises the distribution of occurrences along this period and its split between accident and serious incident (ICAO Annex 13 definitions). Due to the ongoing investigation of accidents and serious incidents, the true figure is possible to be slightly higher as complete investigations are not yet available for all events happened in 2015.

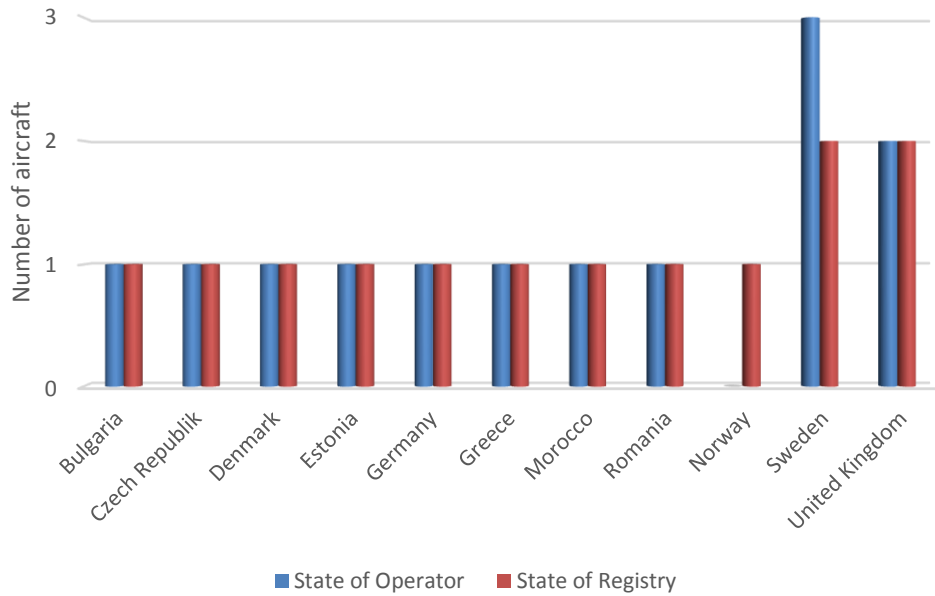
Figure 2. Distribution by state of operator and state of registry

There are 11 different States of Registry represented in the study set: Bulgaria, Czech Republic, Denmark, Estonia, Germany, Greece, Morocco, Norway, Romania, Sweden and United Kingdom (see Figure 2). States of the operator are the same as the states of registry for all aircraft except one, which was registered in Norway and operated by a Swedish operator.

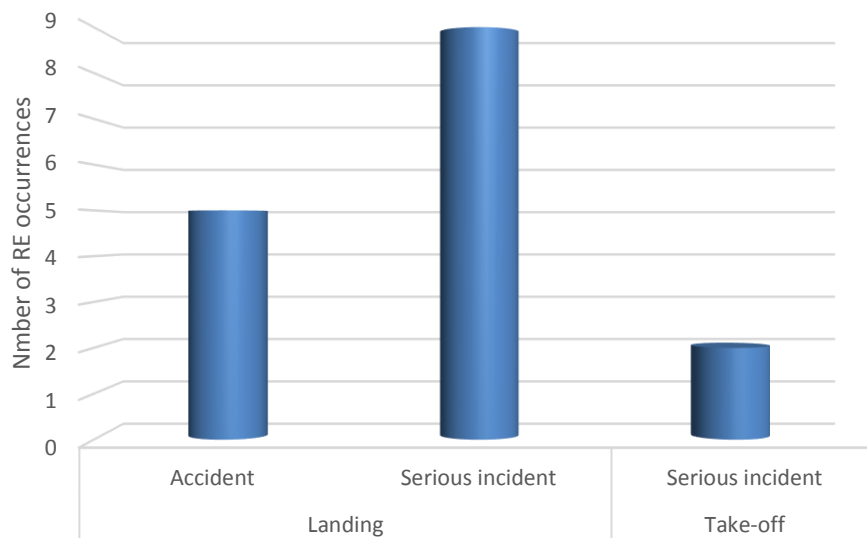
Figure 3. Distribution by phase of flight and occurrence class

As shown in Figure 3, the vast majority of occurrences happened during landing, with 5 of them classified as accidents and 9 as serious incidents.

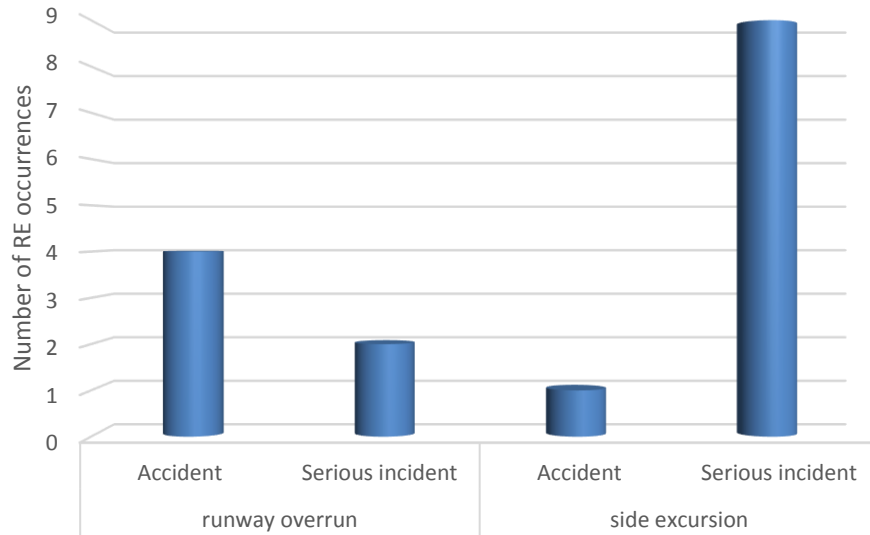
Figure 4. Distribution by type of runway excursion and occurrence class

From the Figure 4 it is clear that runway overruns were less frequent, however they caused higher level of damages and/or injuries than runway side excursions.

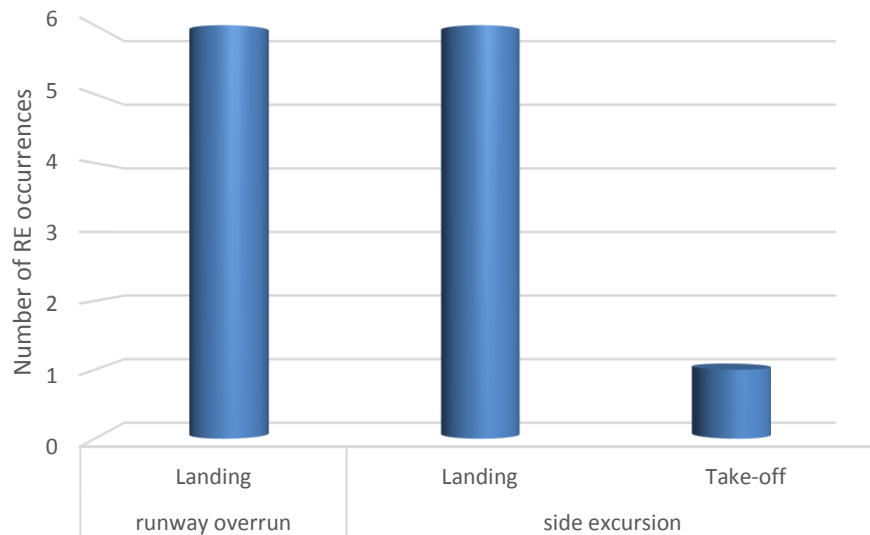
Figure 5. Distribution by type of runway excursion and phase of flight

Figure 5 depicts the number of occurrences with a distinction between types of runway excursion, as well as between those that happened on landing and those that happened during take-off. The number of runway overruns and side excursions occurred during landing is balanced. In the study set there was no instance of a runway overrun during take-off.

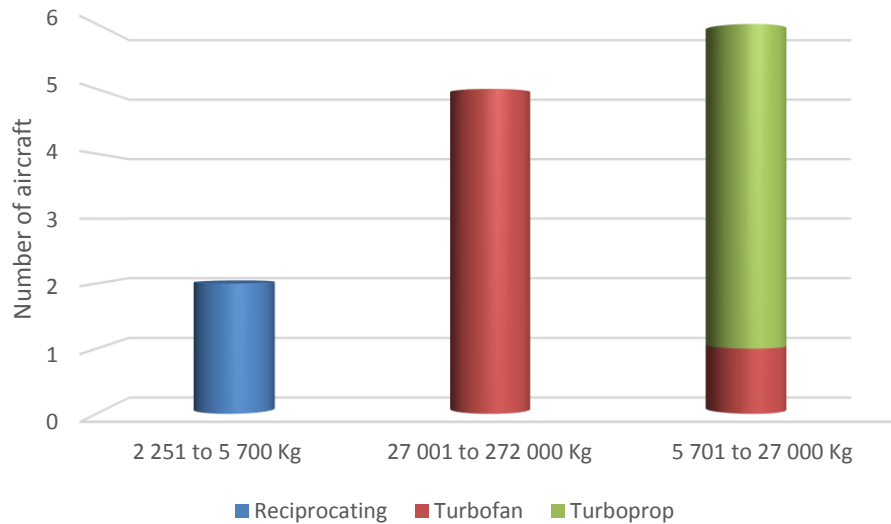
Figure 6. Distribution by aircraft mass and propulsion type

Figure 6 presents the distribution by propulsion type depending on the aircraft mass group. Among the aircraft lighter than 5 700 kg all were equipped with reciprocating engines, while the heavier aircraft have turbofan or turboprop engines.

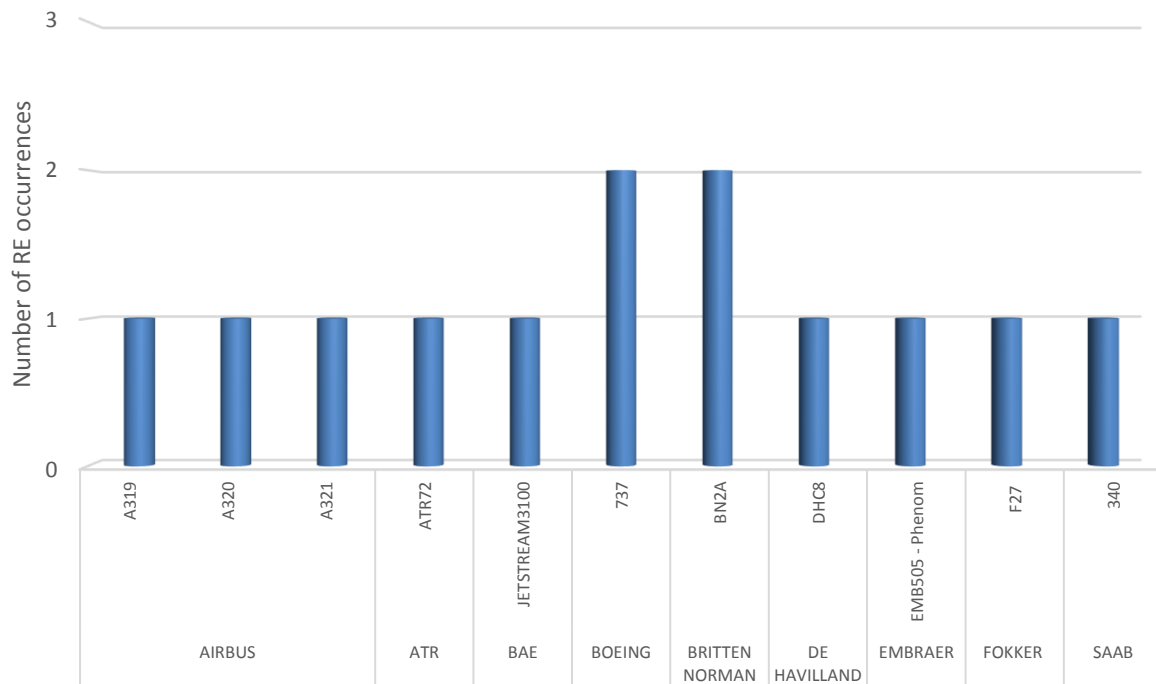
Figure 7. Distribution by manufacturer and model of the aircraft

There are 9 manufactures and 11 different models of aircraft represented in the study set (see Figure 7).
