European Aviation Safety Agency
Executive Directorate
Safety Analysis and Research Department

**EASA safety analysis report for
RMT.0327/0328 based on data retrieved from
EASA copy of ICAO ADREP database**

This safety analysis report is prepared in support of the European Aviation Safety Agency's (EASA) rulemaking task RMT.0327 (OPS.058(a)) and RMT.0328 (OPS.058(b)). The rulemaking task is a transfer of Joint Aviation Authorities' (JAA) cabin safety tasks in regard to air operator requirements for:

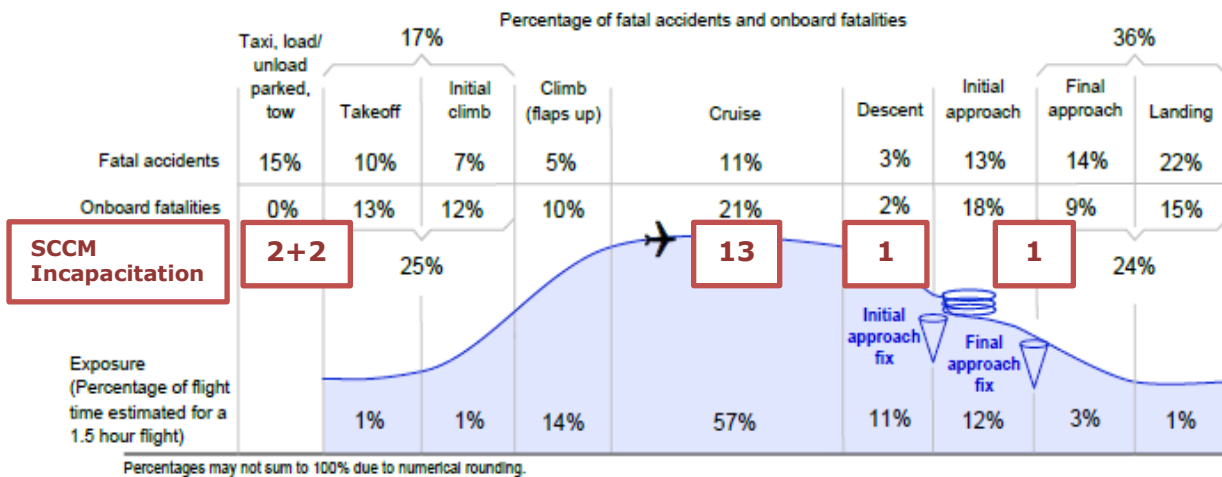
Figure 2 represents a fatal accident and on-board fatalities by phase of flight (worldwide commercial jet fleet – 2001 through 2010) graph obtained from Boeing Statistical Summary of Commercial Jet Airplane Accidents (Worldwide operations 1959-2010)⁸. This graph is supplemented by the figures (in red) of SCCM incapacitation occurrences analysis.

Figure 2 Fatal accidents and on-board fatalities (worldwide commercial jet fleet – 2001 through 2010) and SCCM incapacitations (1996 through 2009) by phase of flight

Figure 2 of this safety analysis report shows that 17 % of commercial jet fatal accidents can be associated to take-off and initial climb, and 36 % of fatal accidents happen during final approach and landing. These two flight phases are the most demanding from flight crew's perspective; one of the SCCM incapacitation has occurred during one of the critical flight phases. It must be noted that the retrieval of the data was not focused on finding occurrences, which would include events where SCCM has become incapacitated because of a crash impact, since such events do not fit within the scope of the EASA rulemaking task RMT.0327 (OPS.058 (a)) and RMT.0328 (OPS.058 (b)). Figure 2 depicts that 4 events have occurred during taxi and parking, 14 occurrences have happened en route, and one during approach. Parking, taxi and en route allow a timely replacement of incapacitated SCCM with another SCCM or with the next most suitably qualified cabin crew member.
