European Union Aviation Safety Agency
Notice of Proposed Amendment 2020-05

Tyre pressure monitoring

RMT.0586

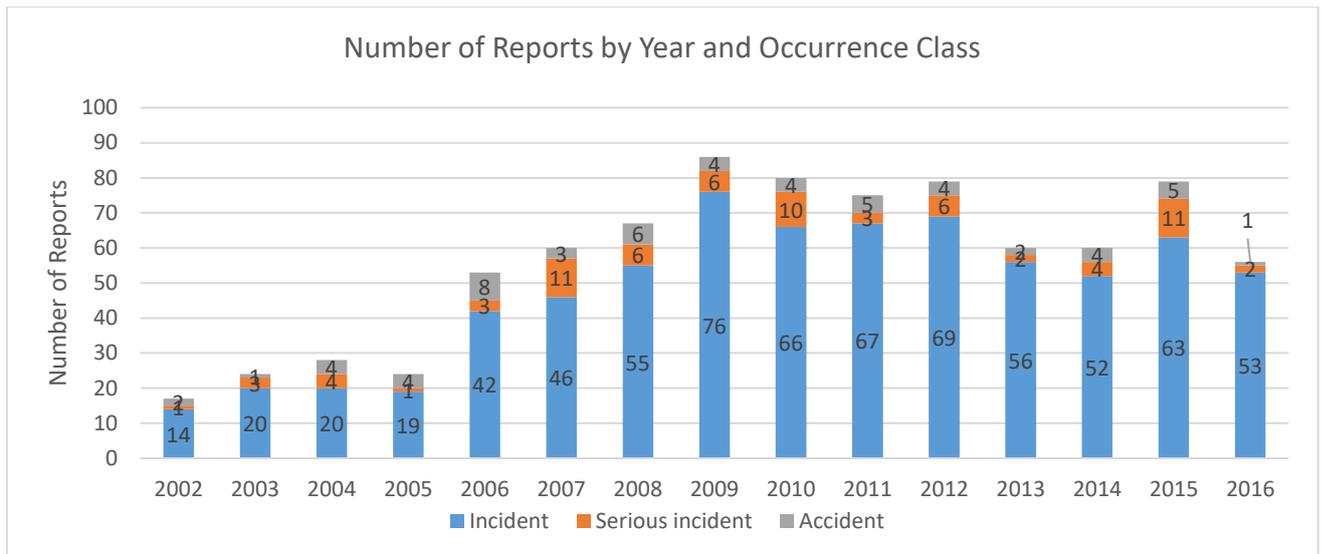
Figure 1: Overall number of reported tyre and wheel failure occurrences per year

A total of 848 occurrences were found, which are classified as follows: 57 accidents, 73 serious incidents and 718 incidents.

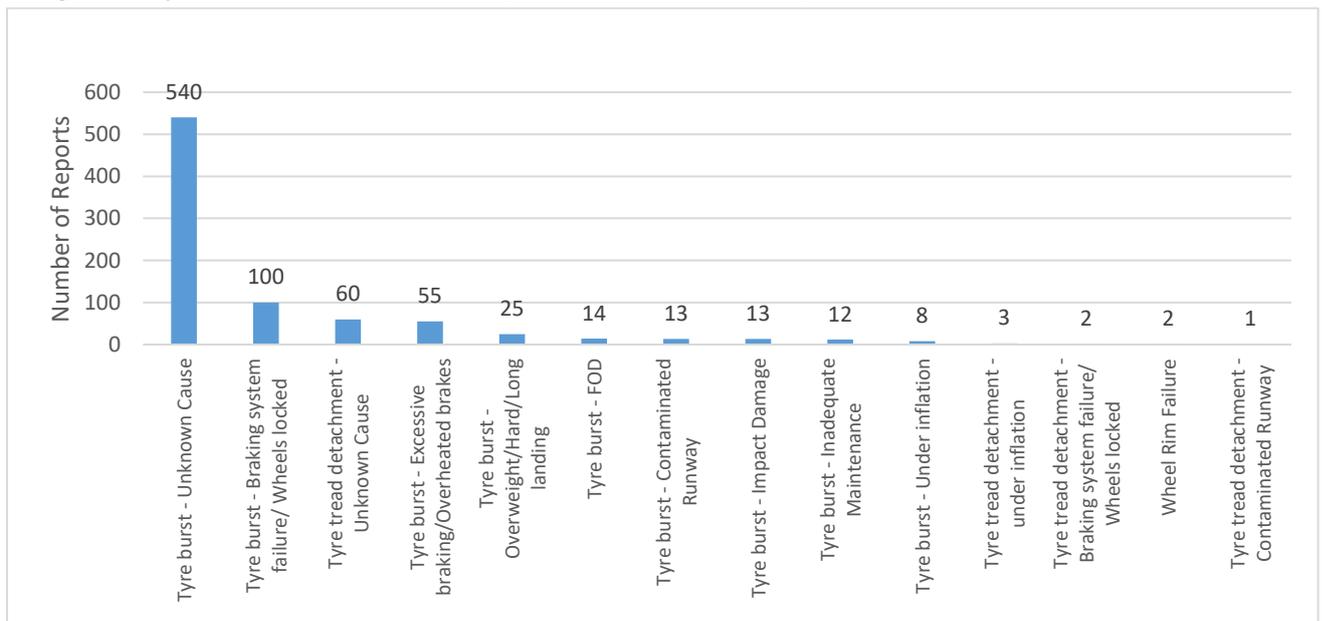
Figure 2: Overview of tyre and wheel failure reports

The following chart reflects the content of the database. It can be noted that the reports often lack sufficient information to establish the root cause of the tyre or wheel failure; the main category is designated ‘tyre burst – unknown cause’ (540 occurrences or 64 %):

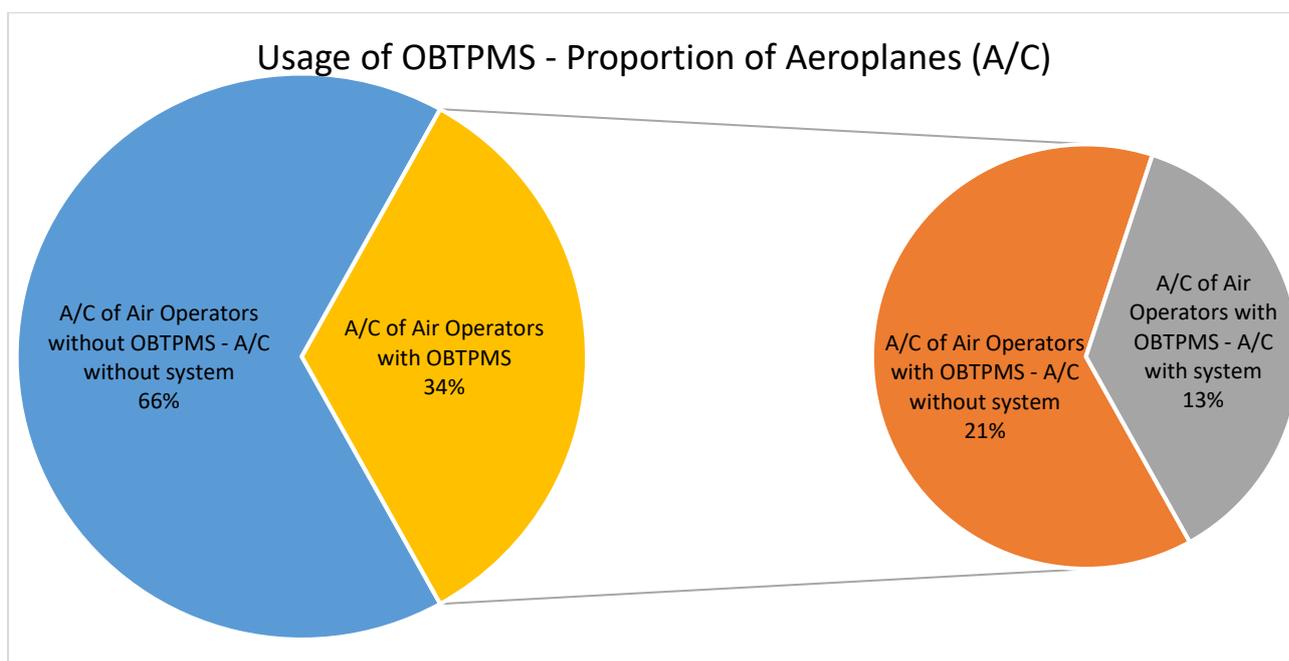
Figure 3 – Usage of OBTPMS as a proportion of the total number of aeroplanes

As far as the current in-service aeroplanes are concerned, it was found from the operator survey that 13 % of the total fleet of aeroplanes have an OBTPMS installed. This result is visualised in Figure 3.

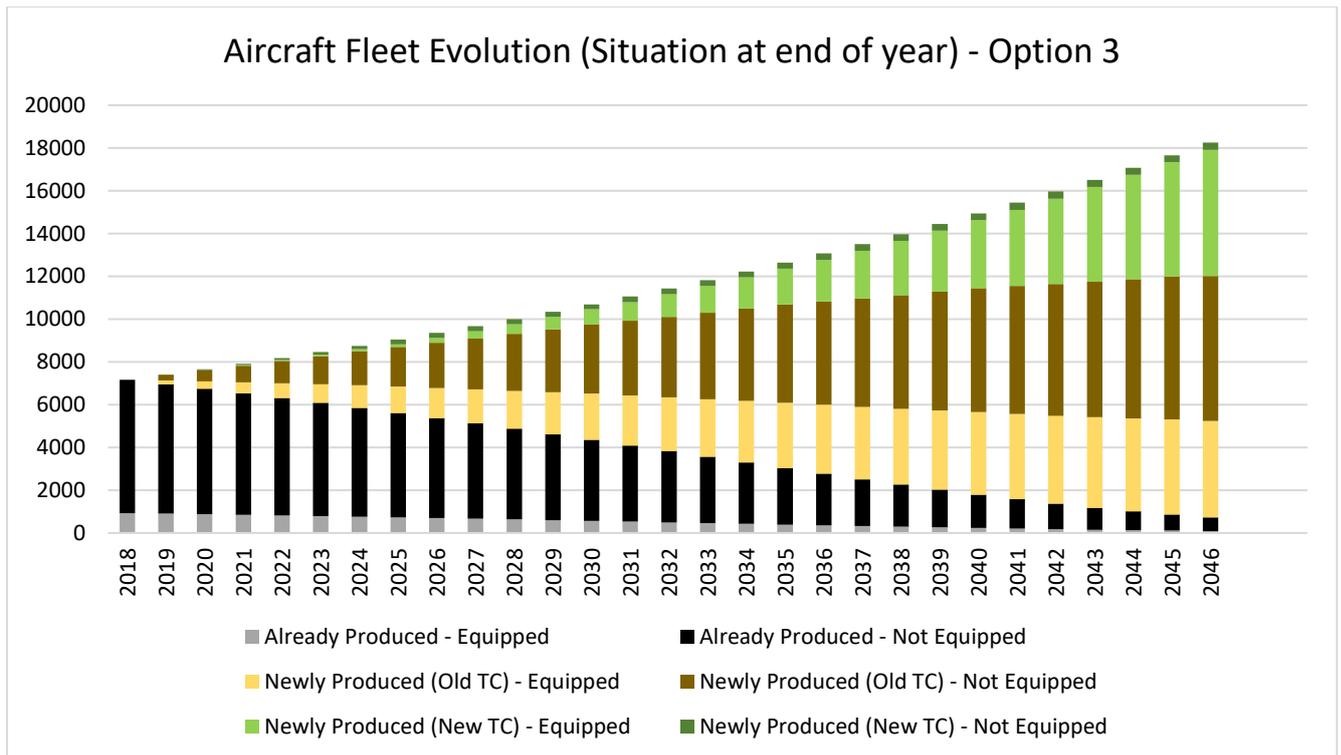
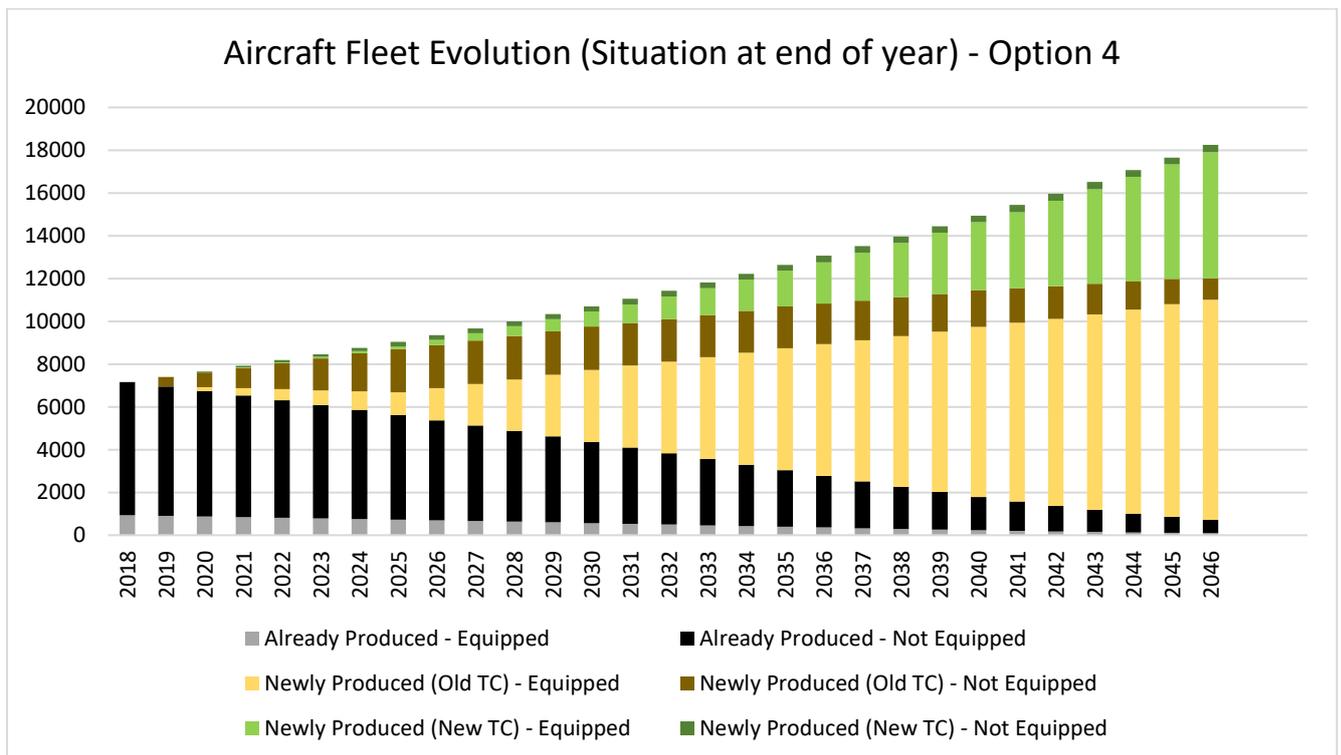
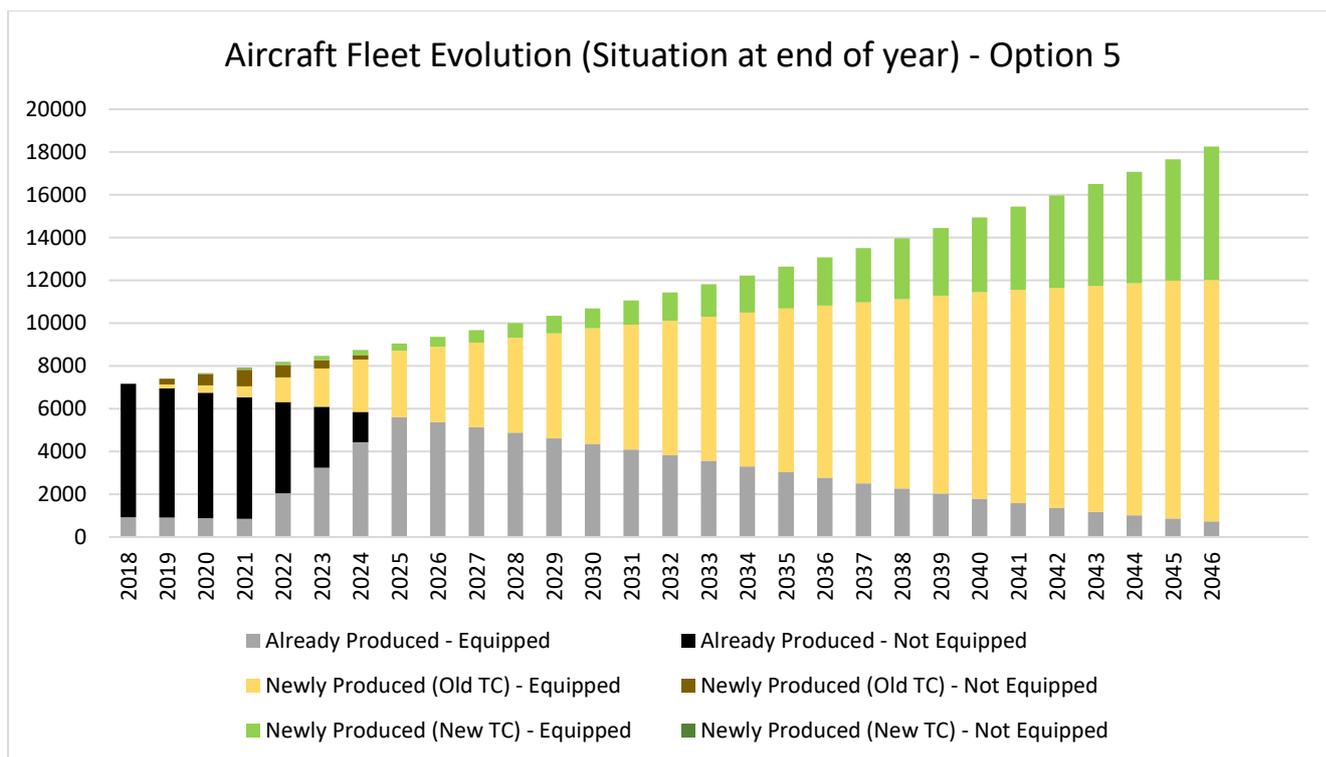
Figure 8 – Aeroplane Fleet Evolution for Option 3 (Equipped = either OBTPMS or GTPIS)

Figure 9 – Aeroplane Fleet Evolution for Option 4 (Equipped = either OBTPMS or GTPIS)

Figure 10 – Aeroplane Fleet Evolution for Option 5 (Equipped = either OBTPMS or GTPIS)

Having established an estimate for the proportion of aeroplanes in operation that are equipped with (one of) the two systems, a fleet development model was used to predict the future number of large aeroplanes, along with the flight cycles and flight hours, until the year 2046. The results of this model can be found in Appendix 4. Applying the different options using this fleet development model enables an estimate of the evolution of the fleet of aeroplanes for each of the options to be made. This shows the evolution of the fleet of aeroplanes that are equipped with either an OBTPMS or GTPIS until the year 2046. This evolution for Option 3, 4, and 5 can be found in Figure 8, Figure 9 and Figure 10 respectively.

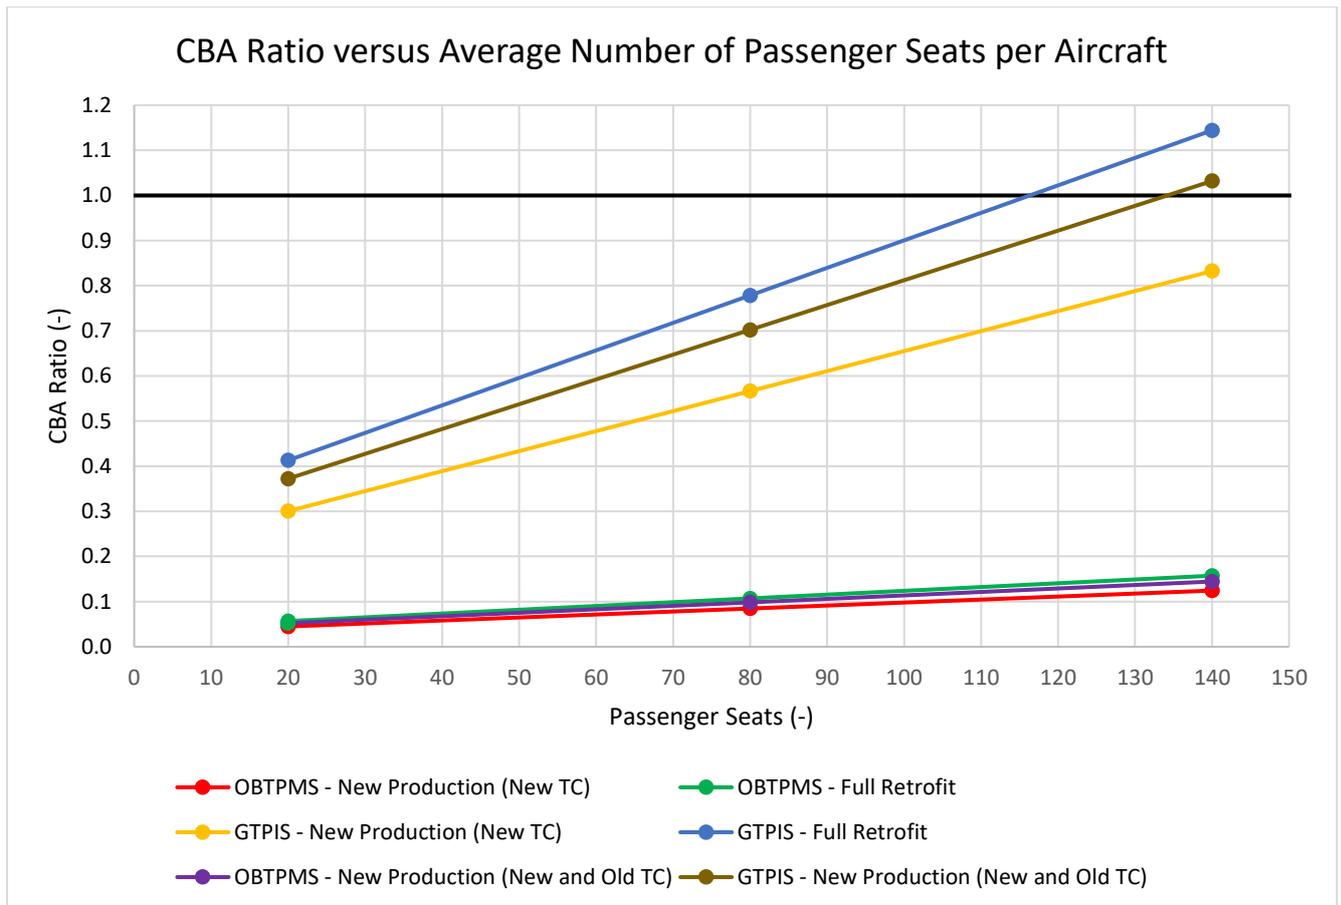
Figure 11 – Variation of CBA Ratio with the average number of passenger seats per aeroplane (OBTPMS and GTPIS)

Figure 11 visualises the trend of the CBA ratio with the average number of passenger seats for the two systems and the three options.

Also, the sensitivity of the cost-benefit ratio to the average number of passenger seats per aeroplane can be assessed from Figure 11. It is clear that all the options related to the GTPIS are more sensitive to the average number of passenger seats, compared with the OBTPMS options. Furthermore, Figure 9 shows that requiring the installation of an OBTPMS, independent of which option is pursued and how high the average number of passenger seats per aeroplane is chosen, will never reach a point at which the benefits outweigh the costs.

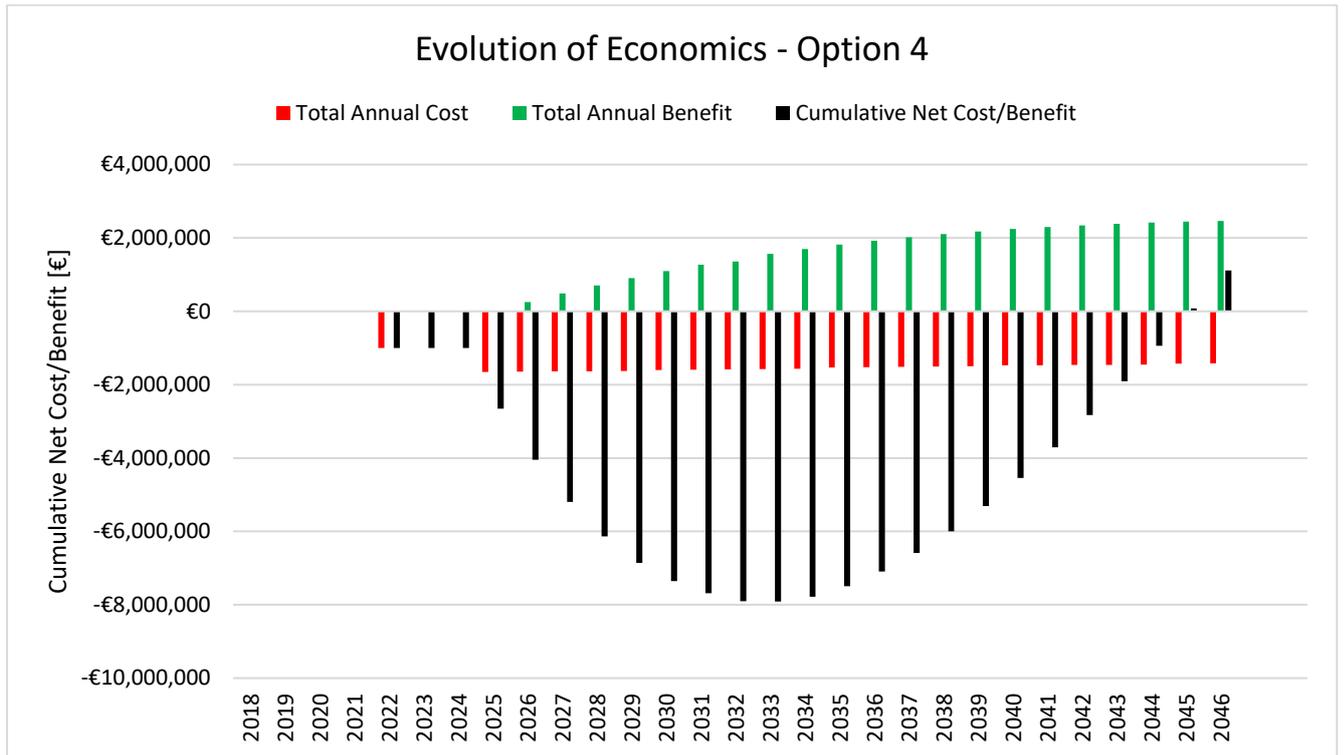
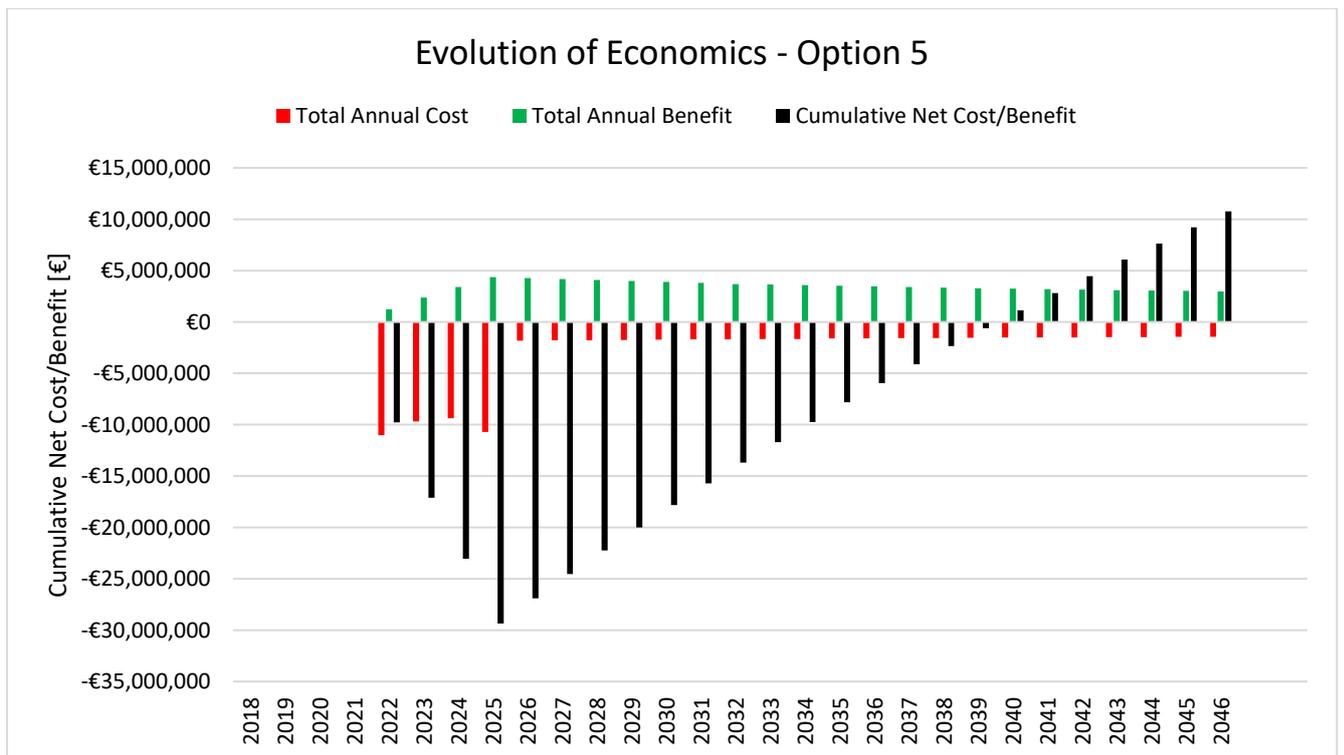
The economics of the two cases, i.e. GTPIS combined with an average 140 passenger seats and Options 4 and 5, are broken down in Figure 12 and Figure 13. Here, the total annual cost, benefit and cumulative net cost/benefit are depicted for each year.

Figure 12 – Evolution of Economics of Option 4 (GTPIS) with an average number of passenger seats per aeroplane of 140

Figure 13 - Evolution of Economics of Option 5 (GTPIS) with an average number of passenger seats per aeroplane of 140

From these figures, it can be seen that a break-even point is reached for Option 4 in 2045, which Option 5 would have already reached in 2040. Nevertheless, the fact remains that Option 5 was optimistically assessed due to the value selected for the cost of retrofit, which has been taken to be equal to the cost of installation on a newly produced aeroplane.

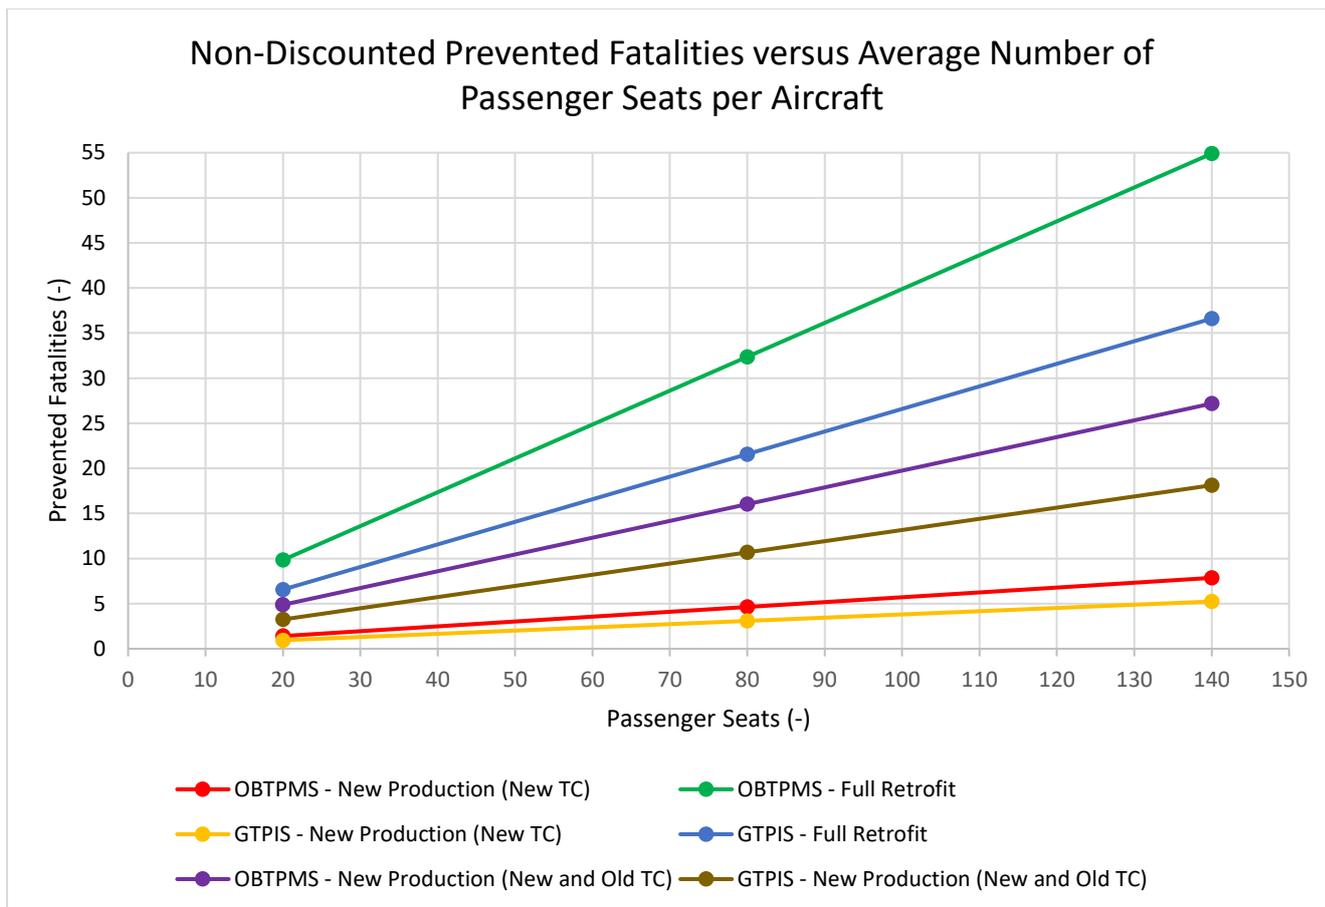
Figure 14 – Variation in the non-discounted prevented fatalities versus the average number of passenger seats per aeroplane

One of the outputs of the cost-benefit analysis is the number of prevented fatalities of Options 3, 4, and 5 between 2022 and 2046, both discounted and non-discounted. Table 5 displays the discounted values for the different scenarios, while Figure 12 shows the variation of the non-discounted prevented fatalities with the average number of passenger seats per aeroplane.

As can be seen from Table 5 and Figure 14, the full retrofit scenario (Option 5) achieves the greatest number of prevented fatalities, followed by targeting all newly produced aeroplanes (Option 4). Mandating the installation of a system only on newly certified aeroplanes (Option 3) prevents the smallest number of fatalities. For each of these options, the OBTPMS prevents more fatalities than the GTPIS due to its higher efficiency.

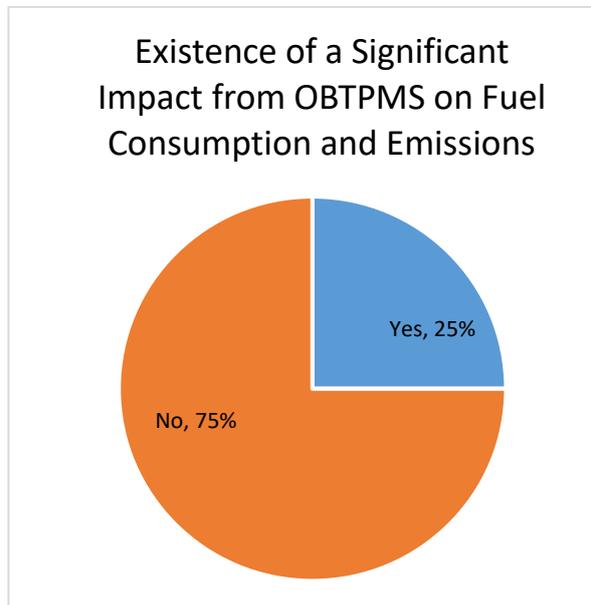
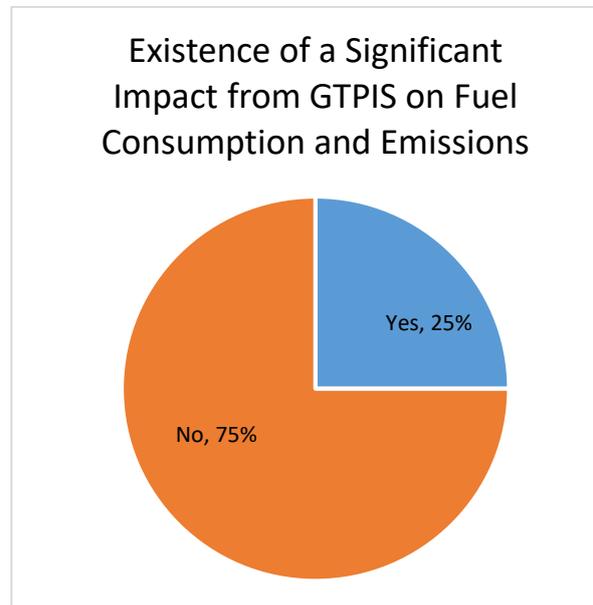
Through the use of the survey that was directed at the manufacturers, the existence of a significant impact from the two systems (OBTPMS and GTPIS) on the fuel consumption and emissions was checked. Figure 15 and Figure 16 show the replies received regarding OBTPMS and GTPIS, respectively.

Figure 15 – Existence of a significant impact on fuel consumption and emissions from OBTPMS

Figure 16 – Existence of a significant impact on fuel consumption and emissions from GTPIS

The majority of the manufacturers believe that adding one of the two systems (OBTPMS and GTPIS) will not cause a significant impact on the fuel consumption or on emissions.

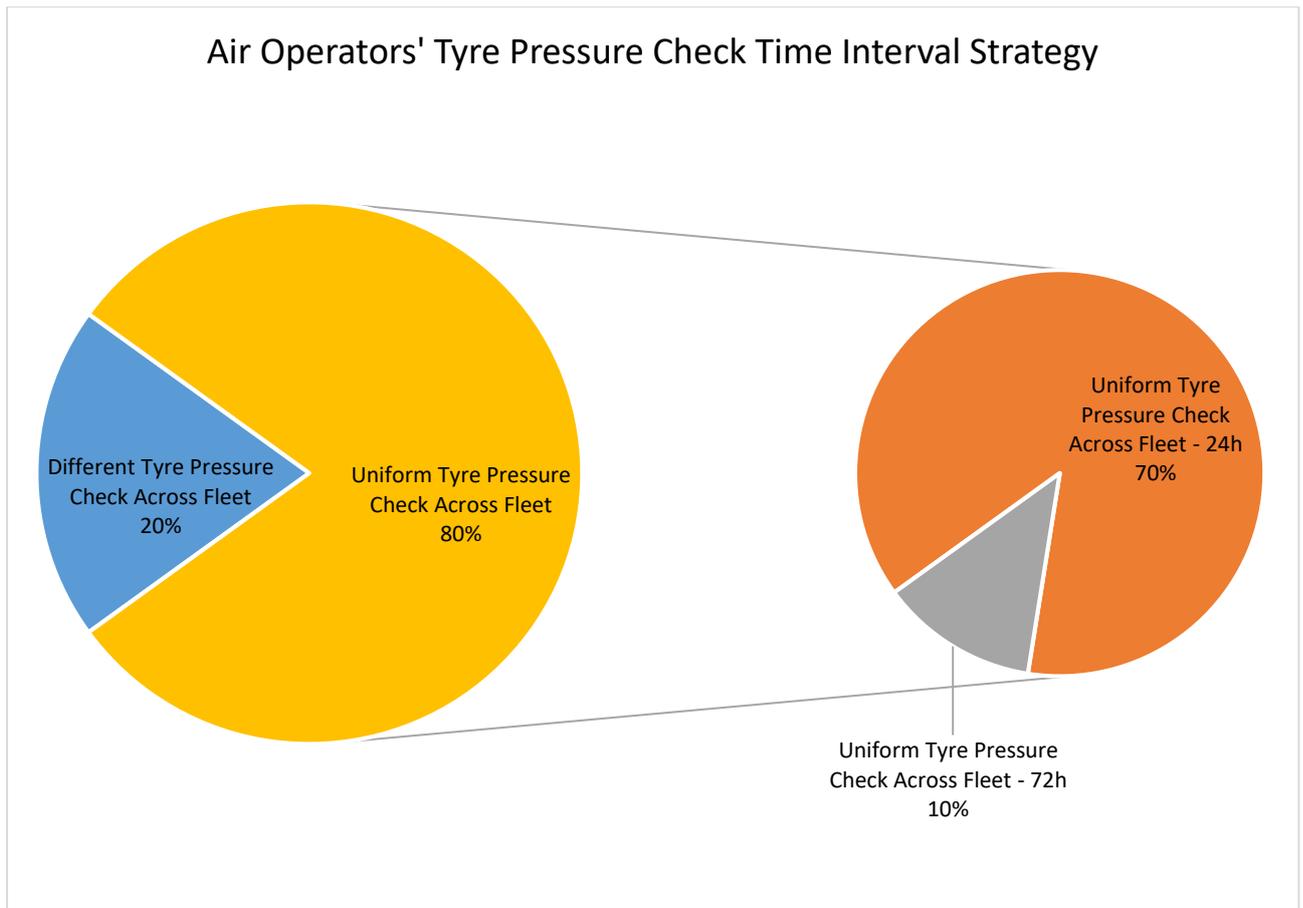
Figure 17 – The time interval between tyre pressure checks, expressed in the maximum elapsed time in hours, of operators

In order to assess the economic impact of applying a daily tyre pressure check, the operator survey results were consulted. Figure 17 displays the current time interval strategy between tyre pressure checks of the operators, expressed in the maximum elapsed time in hours.

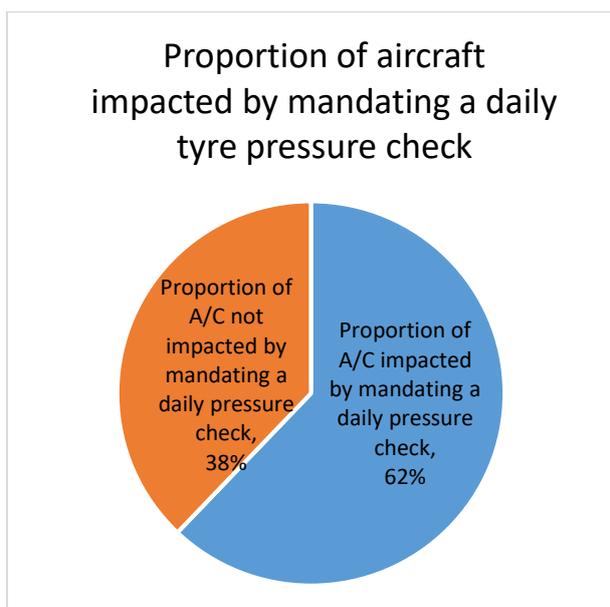
Figure 18 – Proportion of aeroplanes that would be impacted by mandating a daily tyre pressure check

In order to also incorporate the size of the different operators, the proportion of aeroplanes that would be impacted by the application of a mandatory daily tyre pressure check is shown in Figure 18.

Although most of the operators conduct daily tyre pressure checks on their aeroplane fleets (i.e. 70 %), when looking at the corresponding number of aeroplanes, it appears that the majority of them (62 %) would actually be affected if a daily tyre pressure check was mandated. As a result, there is still a minor economic impact to be expected when a daily tyre pressure check is introduced, albeit less than from the installation of a new system on the aeroplane (OBTPMS or GTPIS).
